# Westerschelde: plastic nurdles

Sources, transport, deposits

Autumn 2021

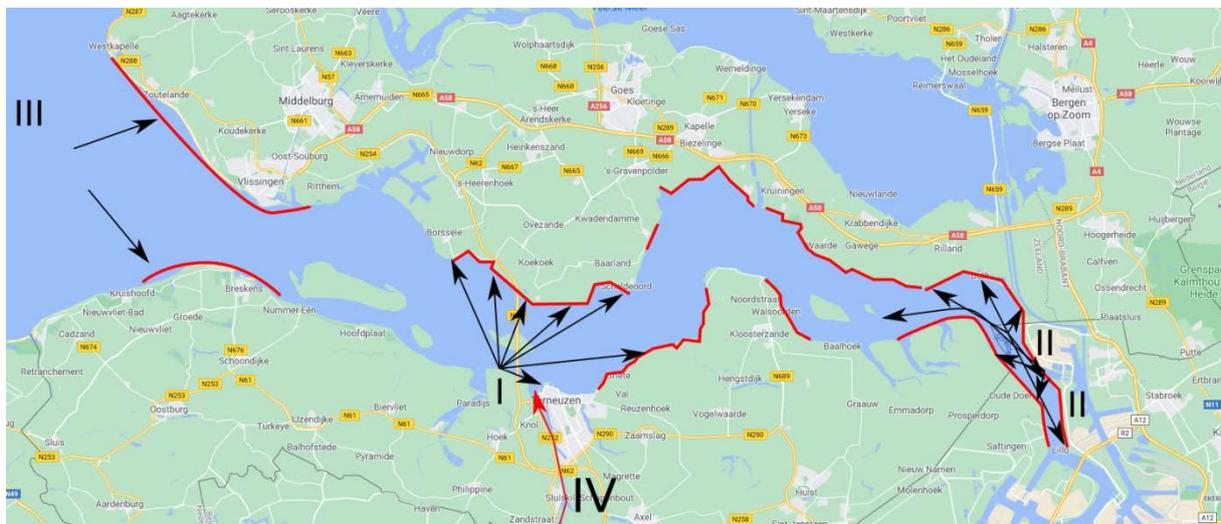
Illustration 1-1: four nurdle subareas in the Westerschelde

I Terneuzen, middle

II Antwerpen/Schelde east

III North Sea, west

IV Kanaal Gent-Terneuzen

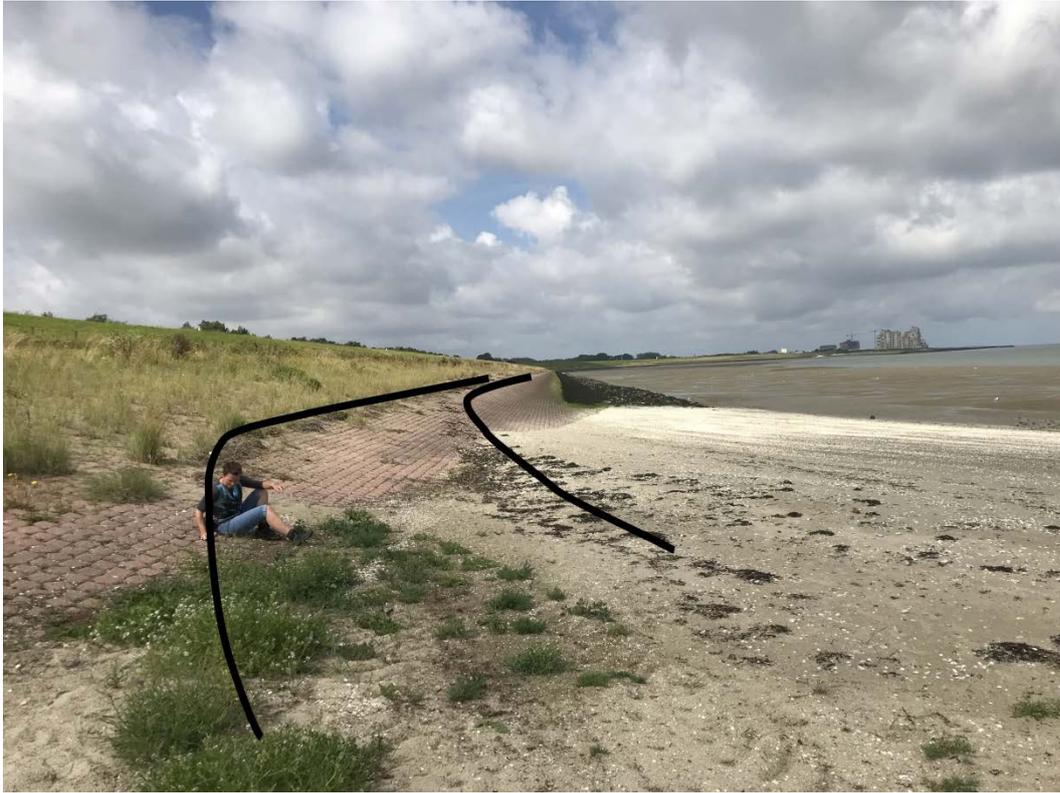
That this physical process is of a considerable strength is shown in the picture below. The (black) debris lines show that when the beach hampers the transport process, the water level decreases about 1 to 2 meters and part of the transported media are deposited.

Illustration 1-7: Debris lines at Breskens: a volunteer is gathering nurdles where the line 'goes down'.

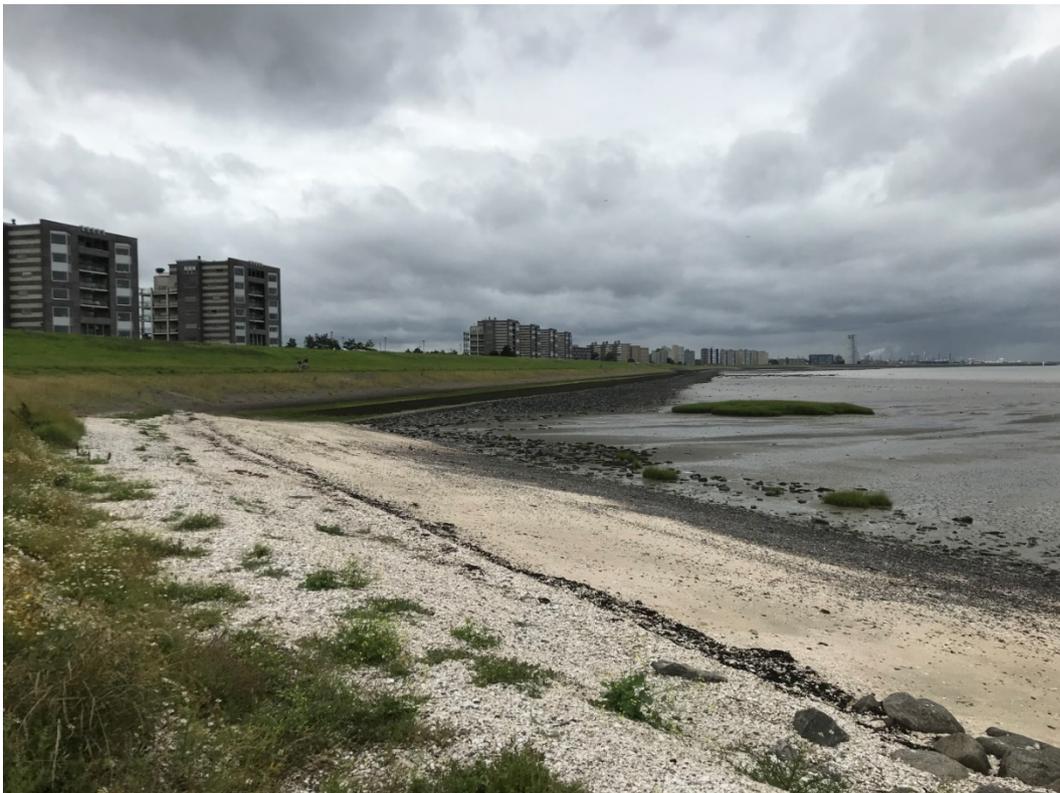
Illustration 1-8: Shell beach at Terneuzen: one of the deposits of nurdles

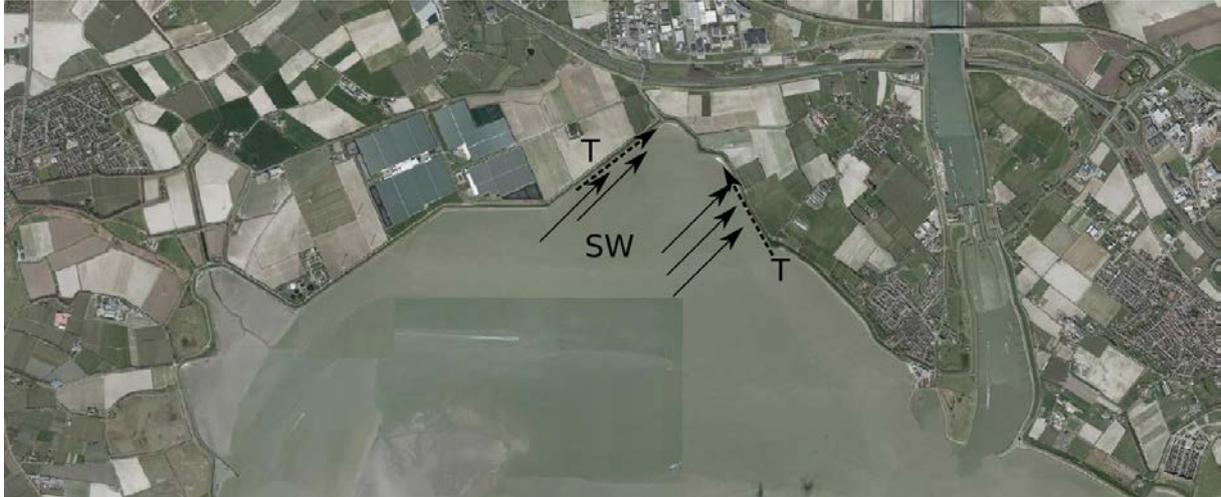
Illustration 1-9: Bank transport (T) with southwest winds on the North bank at Bath

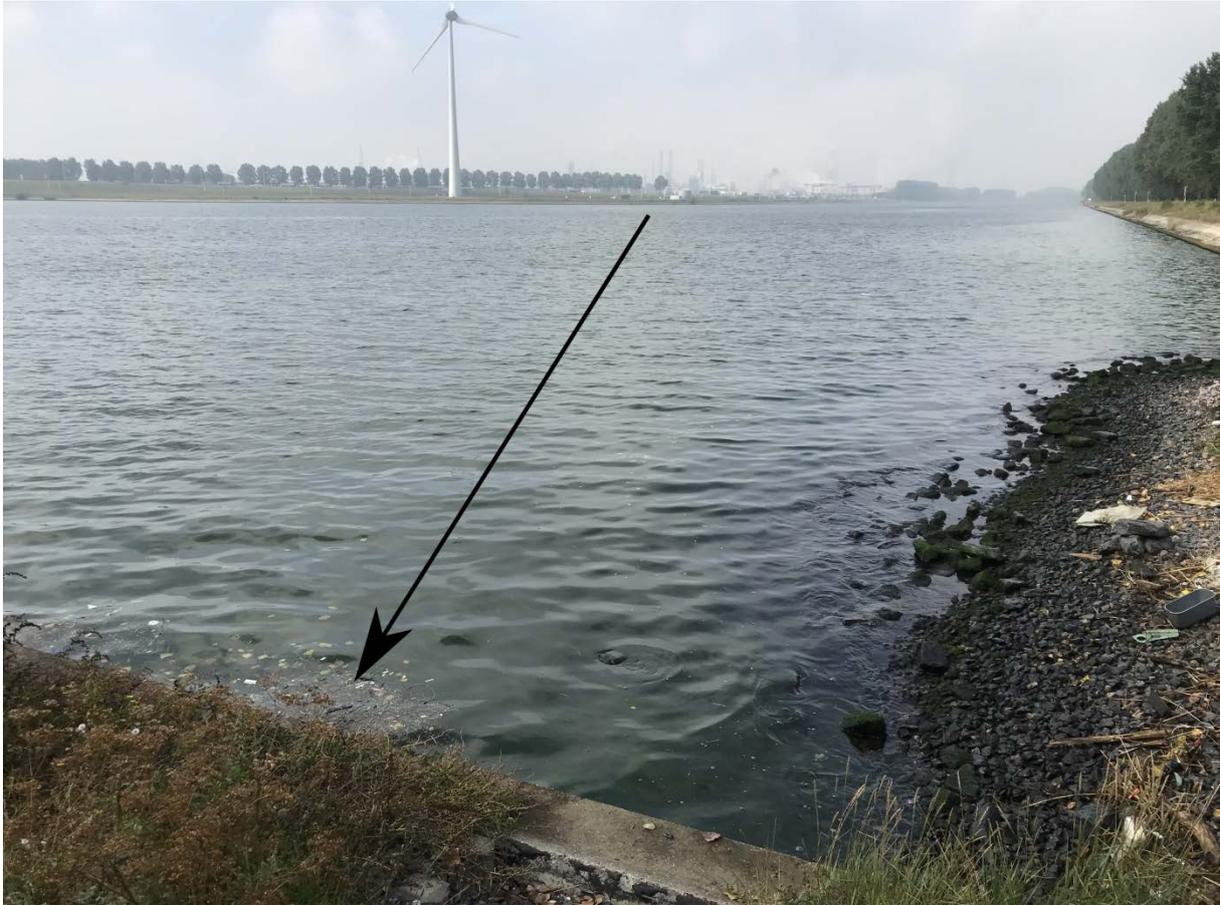
If one should want to catch the nurdles this is a very good location to do so. It is also relatively easy to scoop out those nurdle masses/clouds with a net.

Illustration 2-3: NE-corner Rijn-Scheldekanaal, in the background the BASF-site, black arrow pointing at the floating mass of nurdles

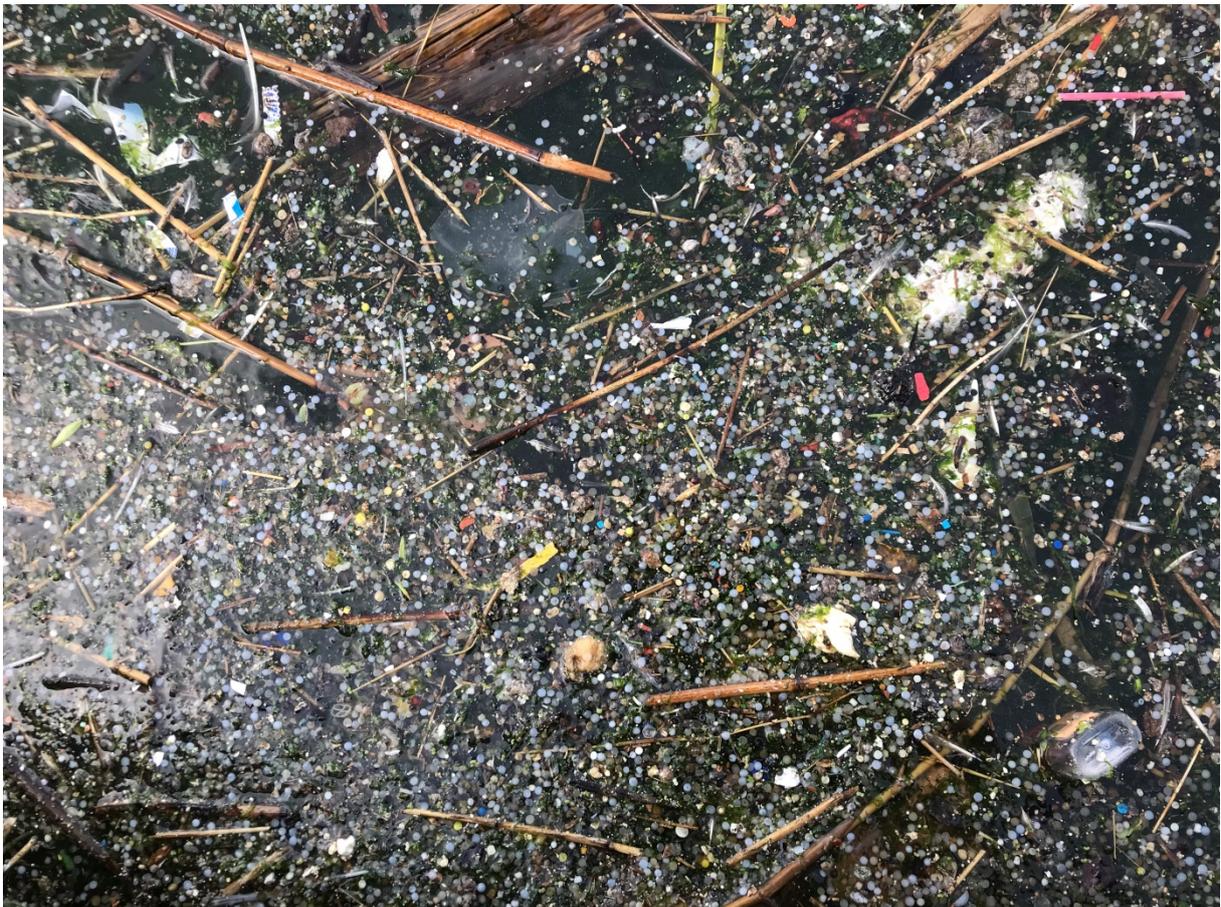
Illustration 2-3b: in more detail

Even though wind conditions are less favourable for pushing nurdles to the sluices (Zandvliet and Berendrecht), this will occur with wind coming from easterly directions (20-30% of the time). The nurdles are then 'sluiced' into the Schelde.

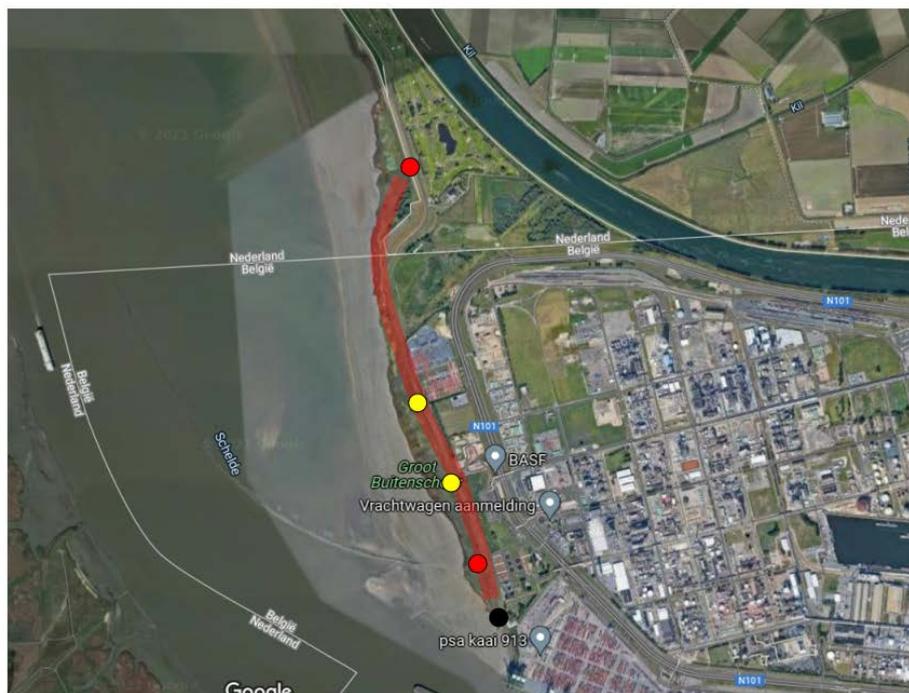
Illustration 2-4: Nurdle deposits Groot Buitenschoor

After washing ashore somewhere on the outer bounds of the 'Buitenschoor' storms from the north west will transport them further into the reeds (yellow dots and reddish band) and into corners (red and black dots). On this bank there are several millions (see Annex VI).

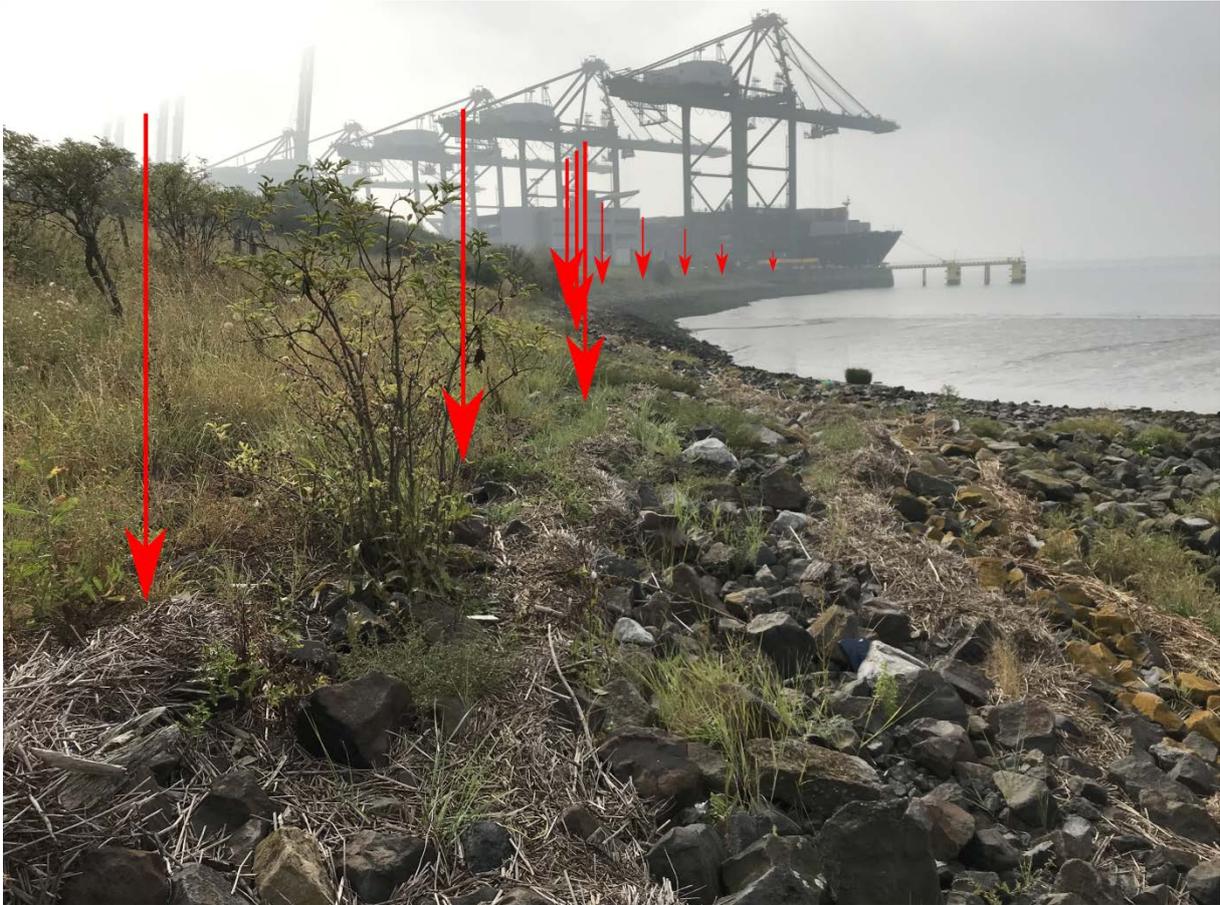
Illustration 2-5: Nurdles in high concentrations over a distance of about 600 m (red arrows) where PSA-kaai 913 ends.

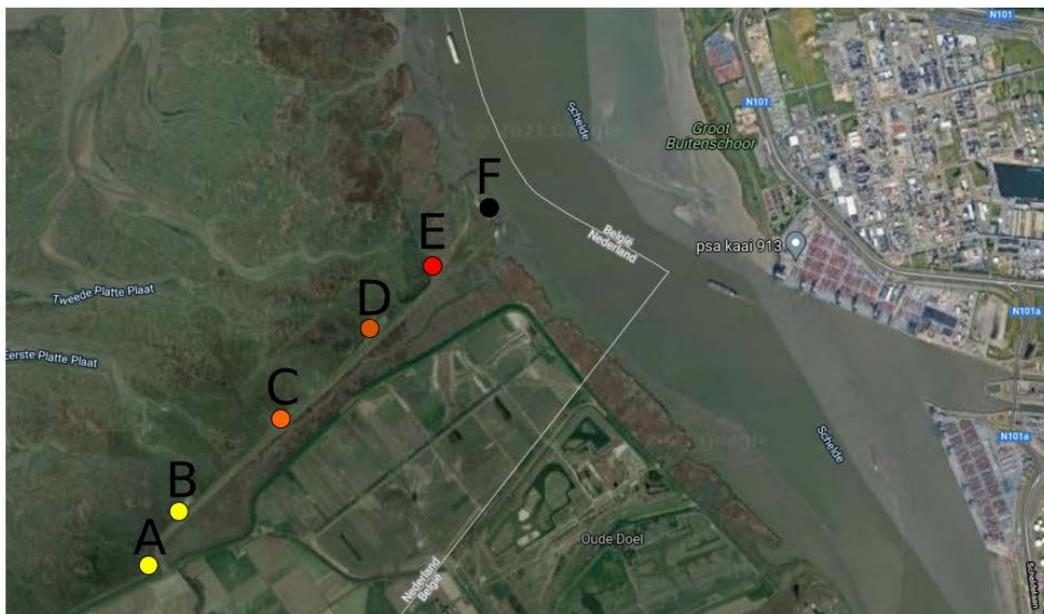
Illustration 2-7: Number of nurdles increases towards the east

In Annex IVB the ABCDE deposits (Illustration 2-7) are illustrated more closely. It is shown that the nurdles follow about the same path as the organic debris does. The gullies also play a role in this process. The number of nurdles increases towards deposit E.

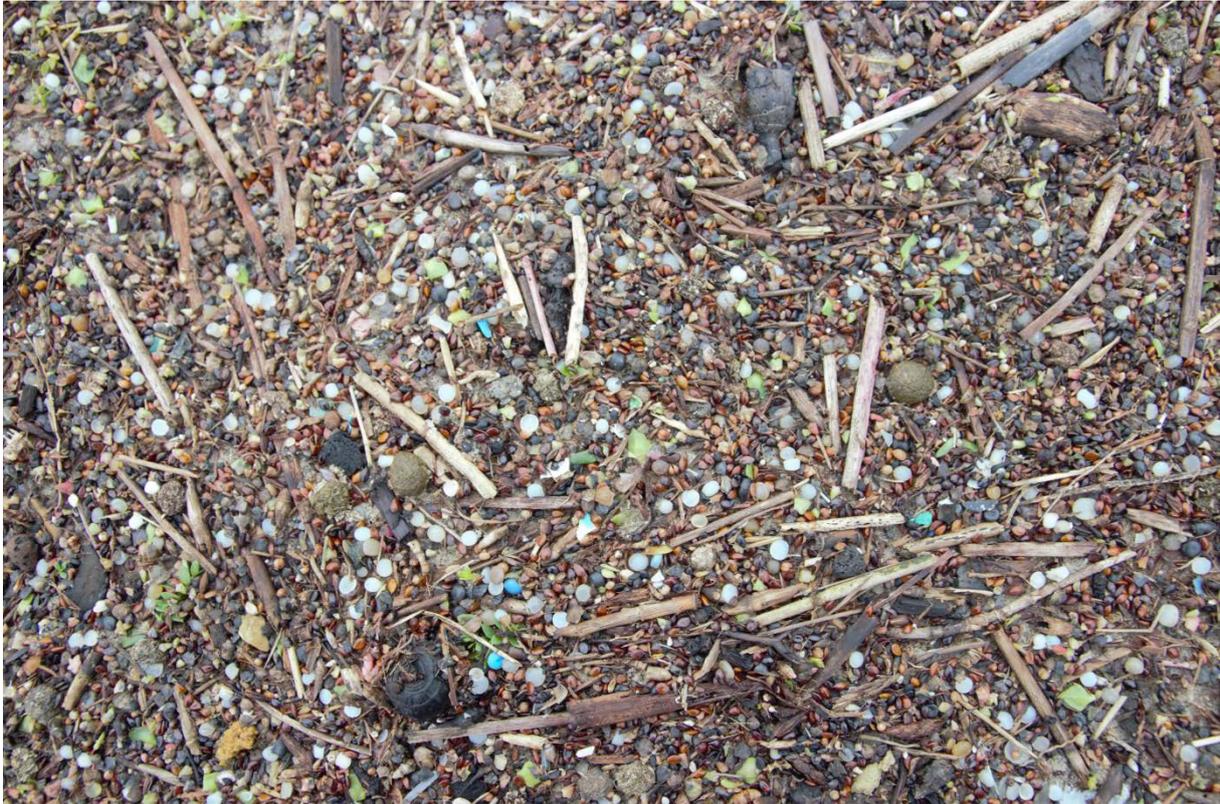
Illustration 2-9: Deposits in F in detail

The deposits in F are high (Annex IV). This means that the whole stretch of the west bank here will have about these concentrations of nurdles.

Because the nurdle concentrations along the west bank here are as high as in deposit F, it is likely that it will take only a few years before the nurdles will have spread over this system of gullies in considerable concentrations. This symptom could be treated by catching them on the surface in the inlet with some sort of installation. It is much more effective however to close the leaks.

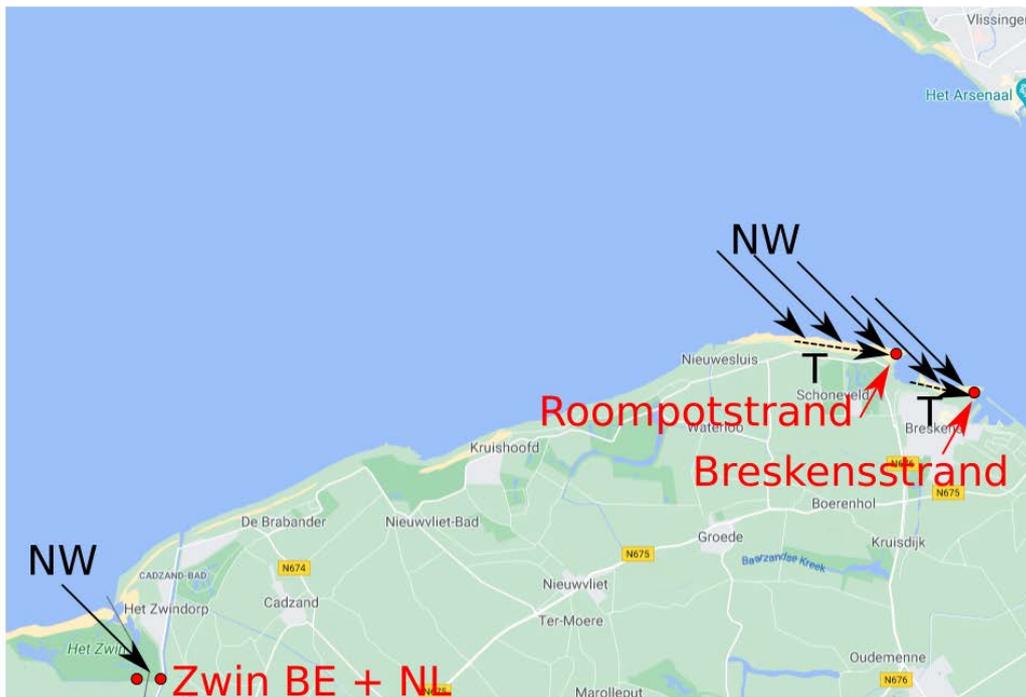
They tend to accumulate in southeast corners and are always found close to the highest waterline

NW-wind engenders transport (T) along east-west orientated banks

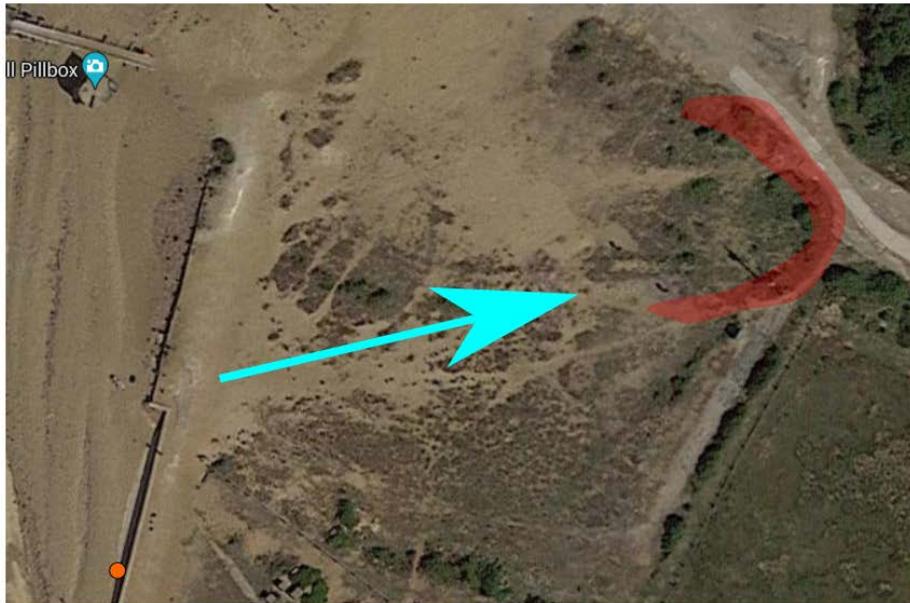
The nurdles shown in Annex II were found at the orange dot. With north westerly storms the water will be high here, the waves coming from the inside of the harbour will also be high and top over the defence. This is visible in the picture by the dry gullies oriented west-east (blue arrow). It is assumed that there must be more nurdles in the red area at the highest waterline.

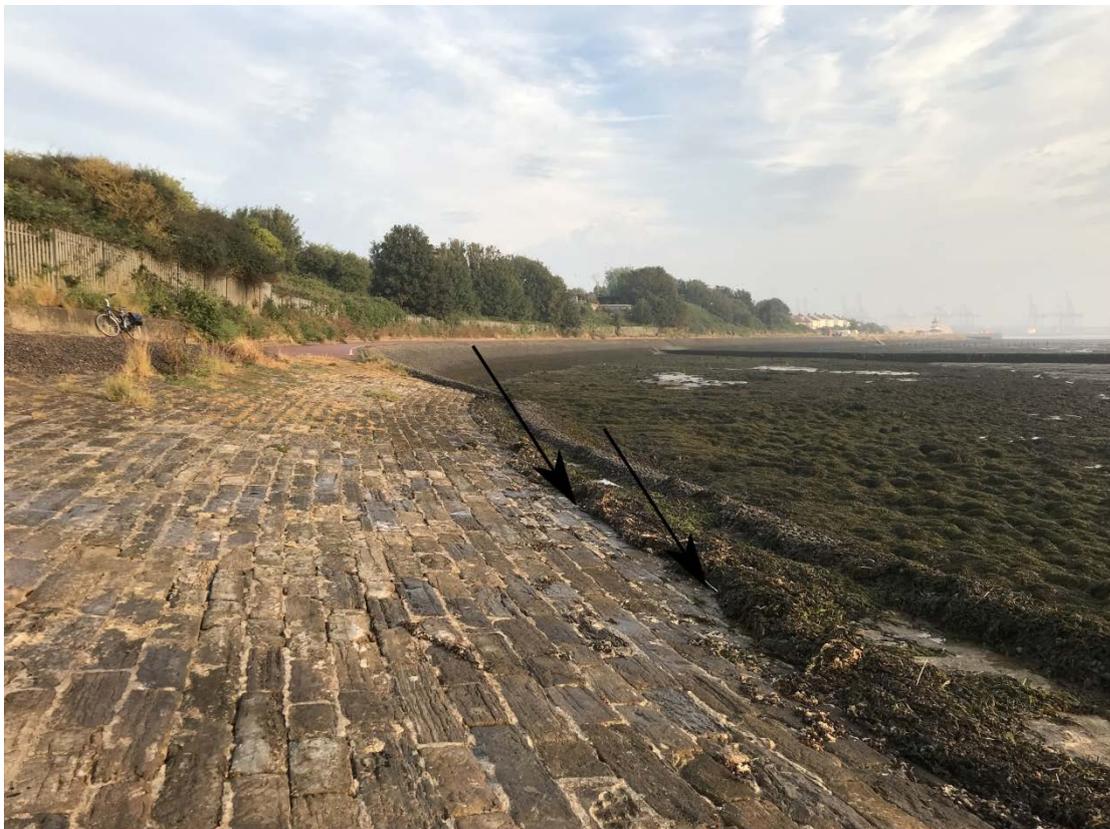
The nurdles were found in and under the (fresh) seaweed roll

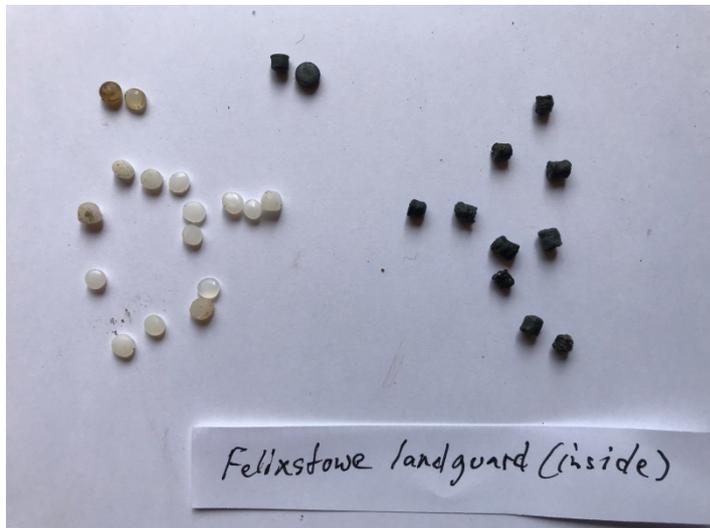
location	2
location	Felixstowe landguard (inside)
date	9-9-2021
number per m <sup>1</sup>	5
length of deposit	10
surface total	50

Nurdles landguard: the black ones on the right are Bio Beads

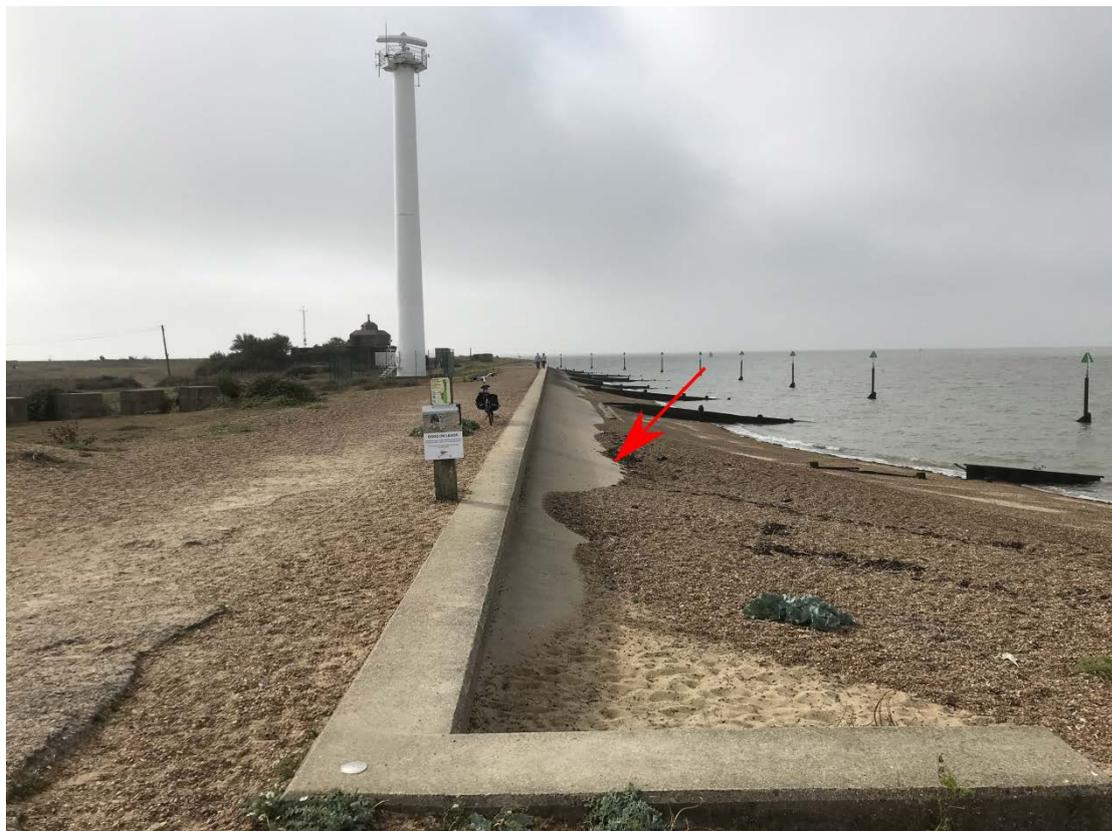
Deposit Landguard: nurdles were found in and under the weed

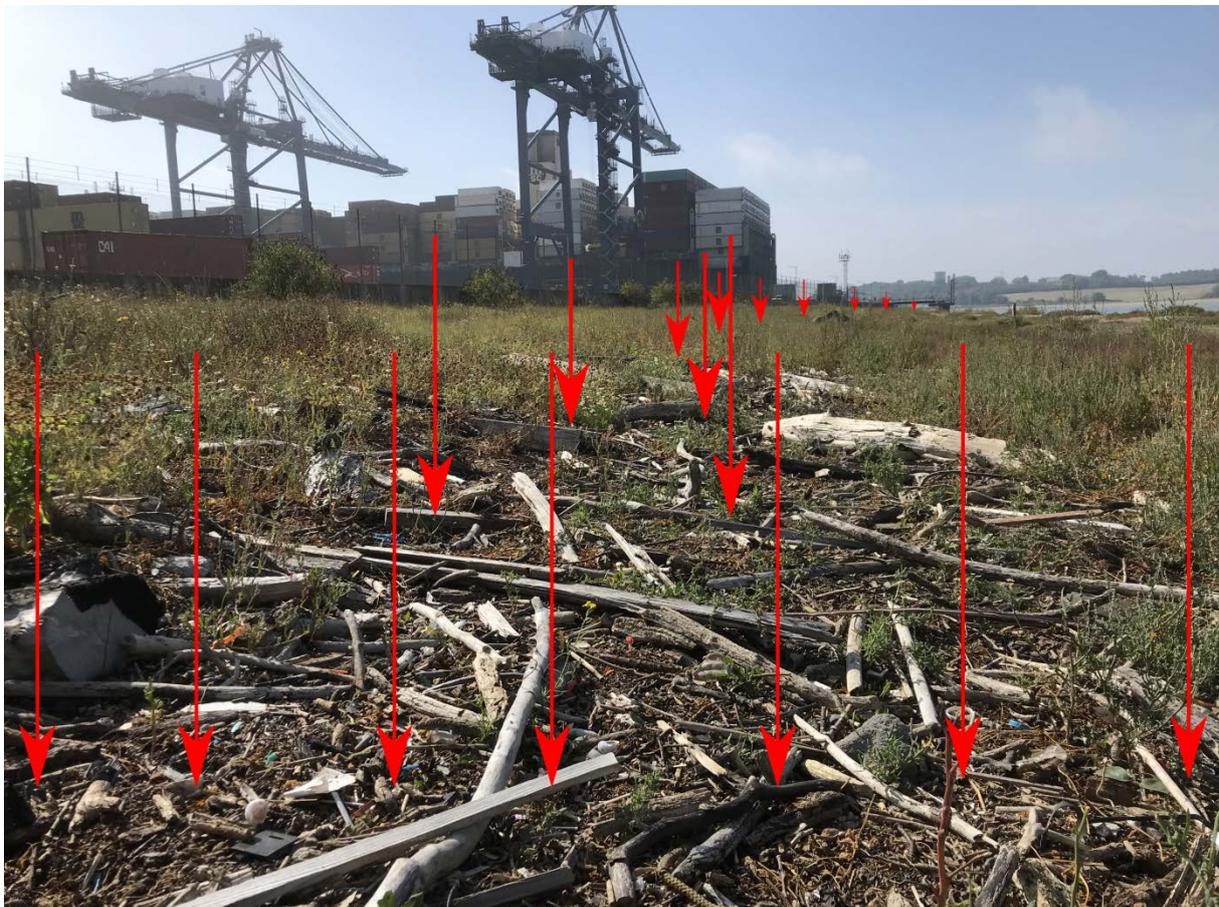
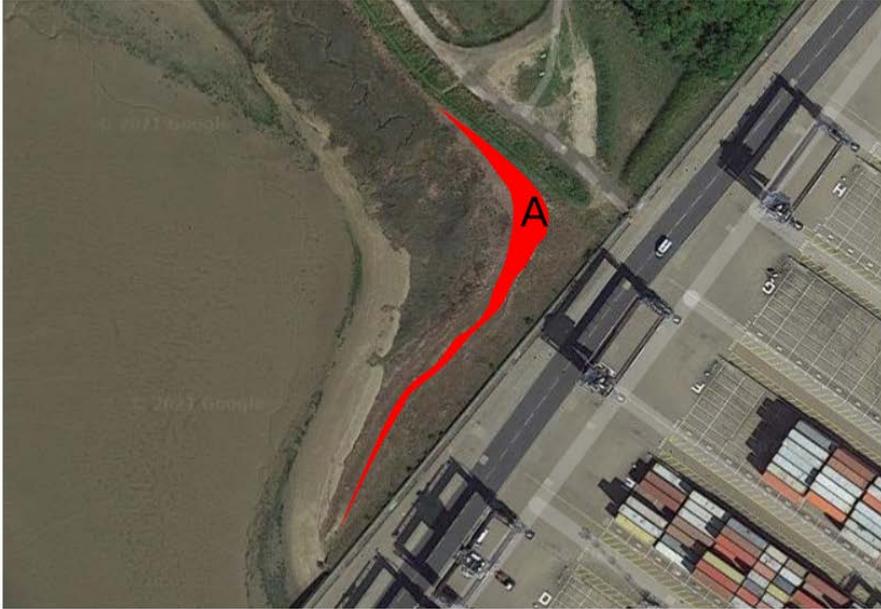
location	3
location	Felixstowe harbour west
date	9-9-2021
number per m <sup>1</sup>	Hundreds/ thousands
length of deposit	200
surface total	100,000 – 1,000,000

The quantities in the angle (A) of the deposit are the largest. Estimation by surface counting wasn't possible here. There are too much nurdles on a width of several meters. When digging into the organic debris more nurdles are found. There could be up to one million here.

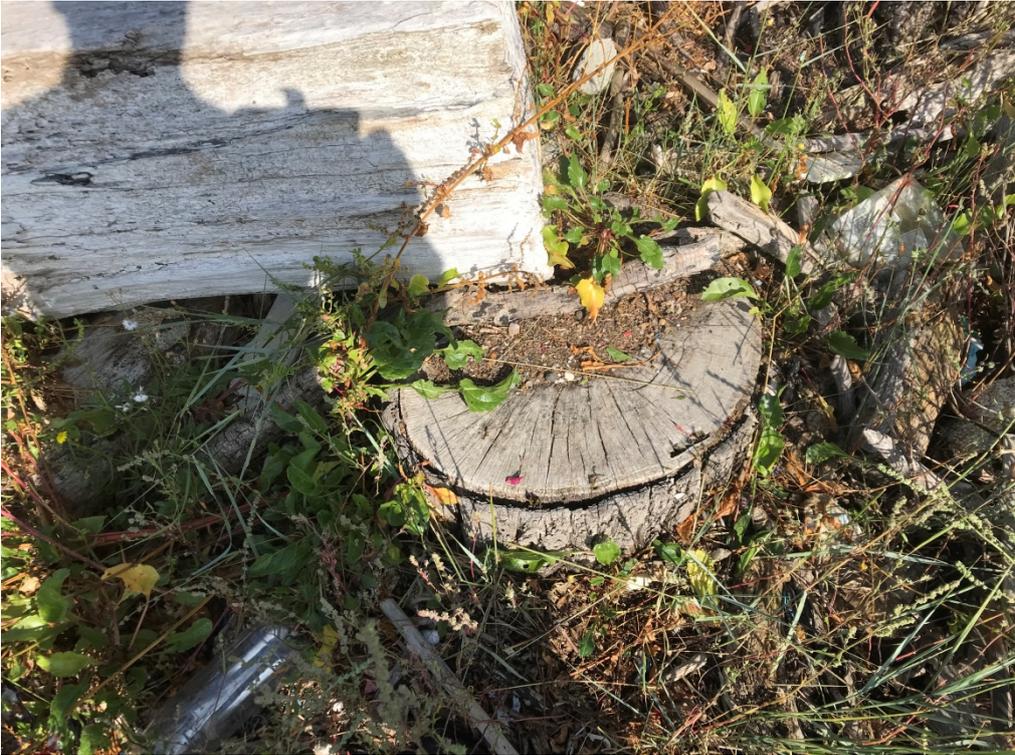
Picture of nurdles on a trunk

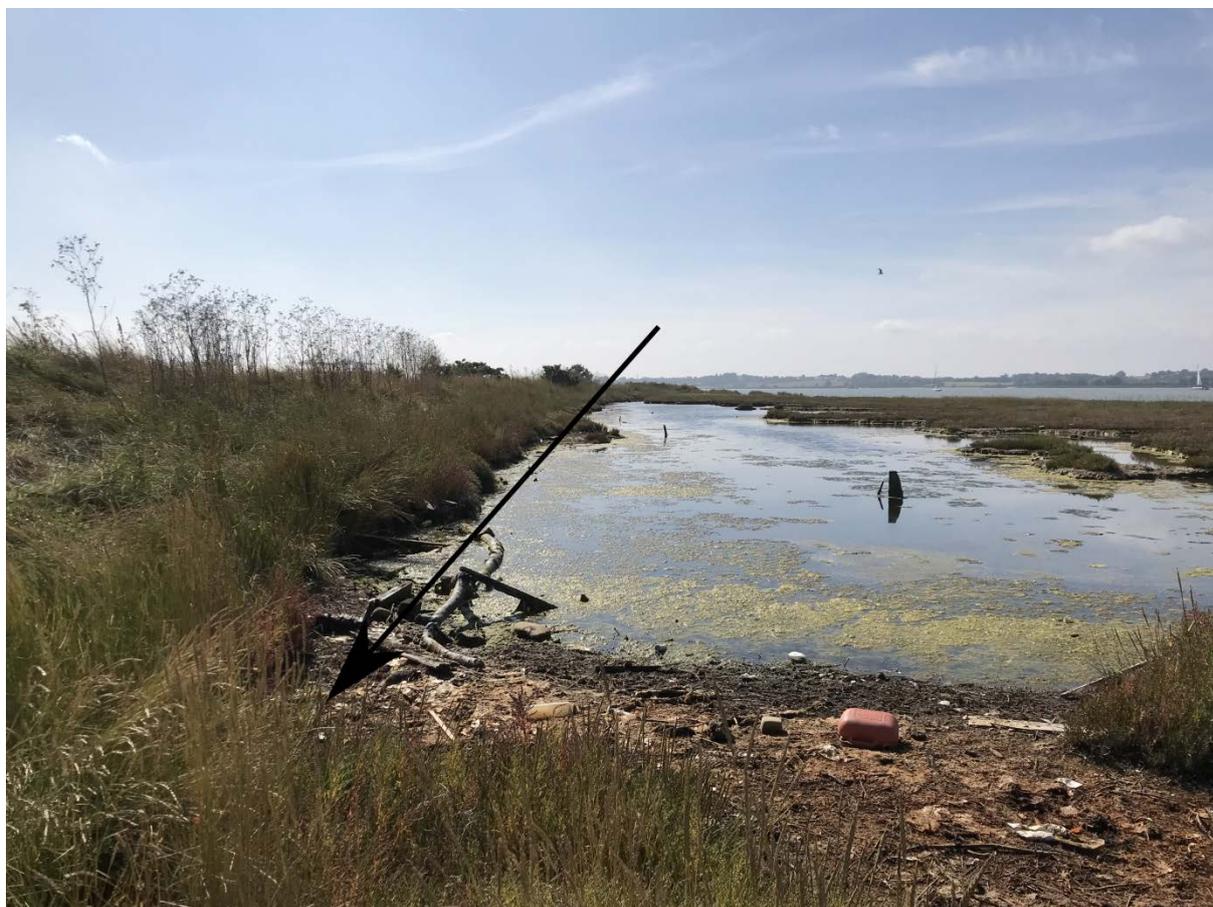
location	5
location	Ipswich Orwell bridge
date	9-9-2021
number per m <sup>1</sup>	10
length of deposit	100
surface total	1000

The wheel shaped plastic item indicated by the pen is also a bio medium which is used in waste water treatment [Assisted Moving Bed \(AMB\) Bio Media | MBBR Wastewater Filter \(dasusa.com\)](https://www.dasusa.com/)

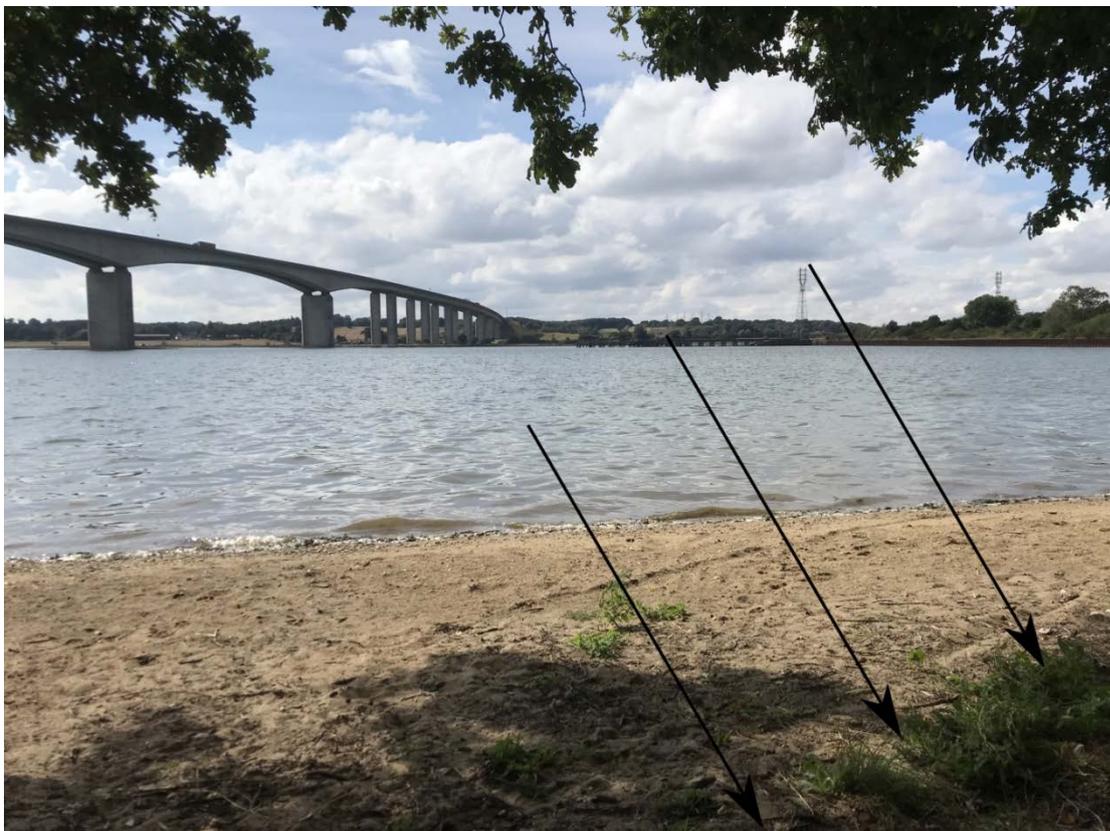
The nurdles were found where the beach meets the vegetation

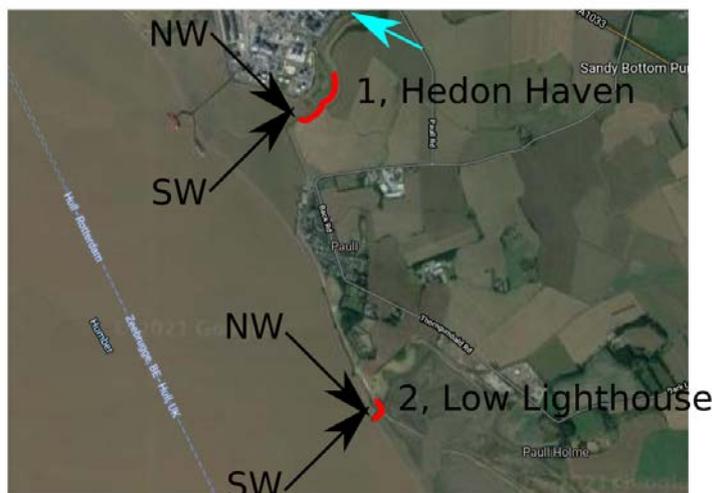
Accumulation of nurdles.

(The blue arrow points to one of the runoff water outlets of Salt End: it doesn't play an important role for the nurdles found in Hedon Haven)

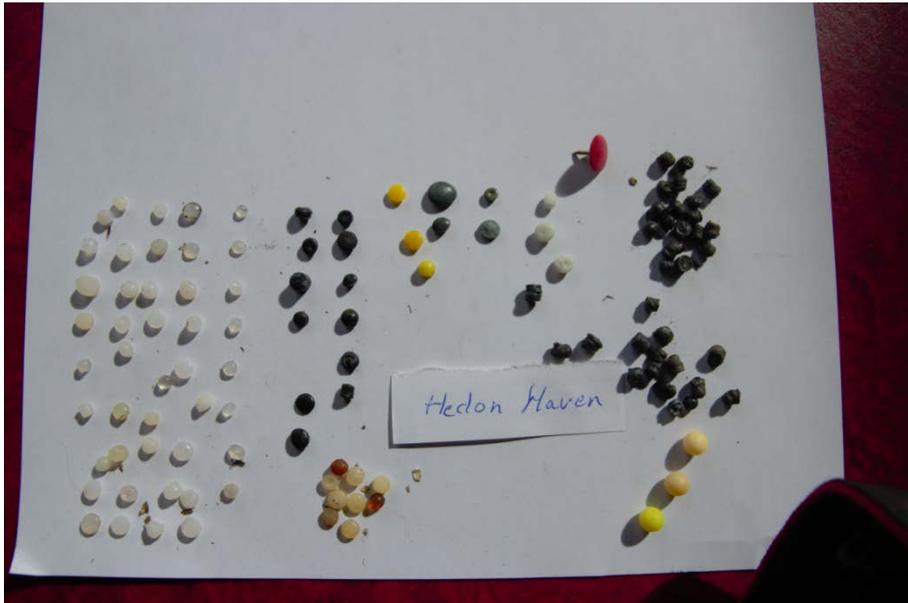
Nurdles Hedon Haven: the black, deteriorated, ones upper right (near thumbtack) are Bio Beads, the 3 balls down right are BB-Gun pellets (children's toy)

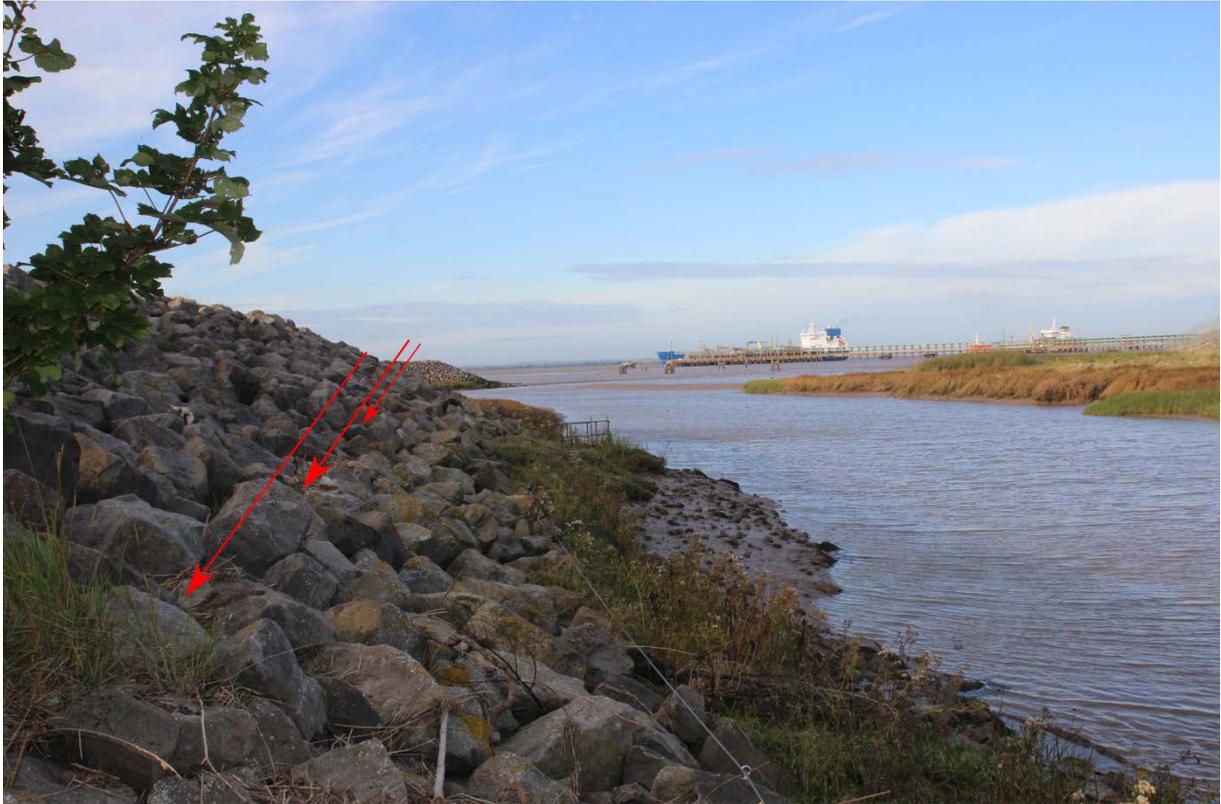
Hedon Haven: most nurdles (and plastic) disappear between the armour rock

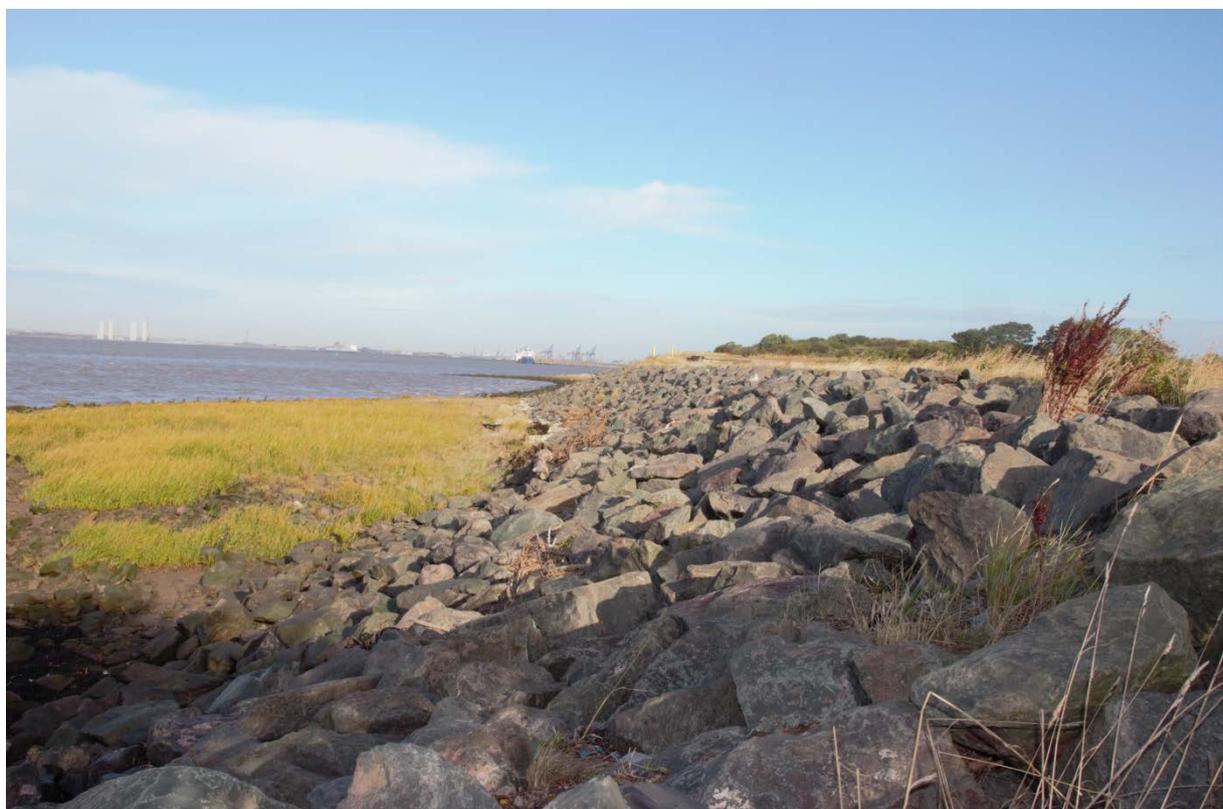
Same situation: most nurdles disappear in the armour rock bank. In the background Hull

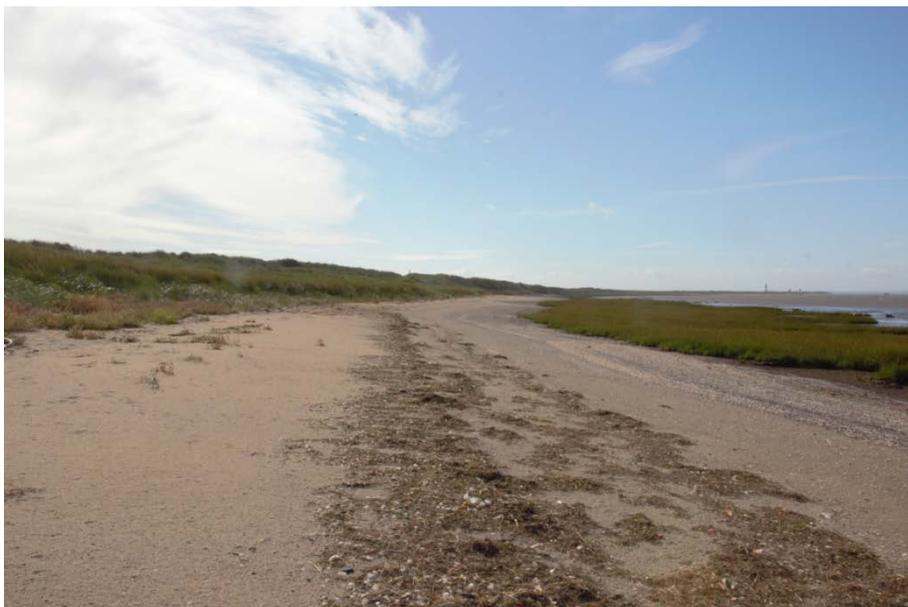
Spurn Bight: nurdles disappear under the sand. In the background Spurn Point.

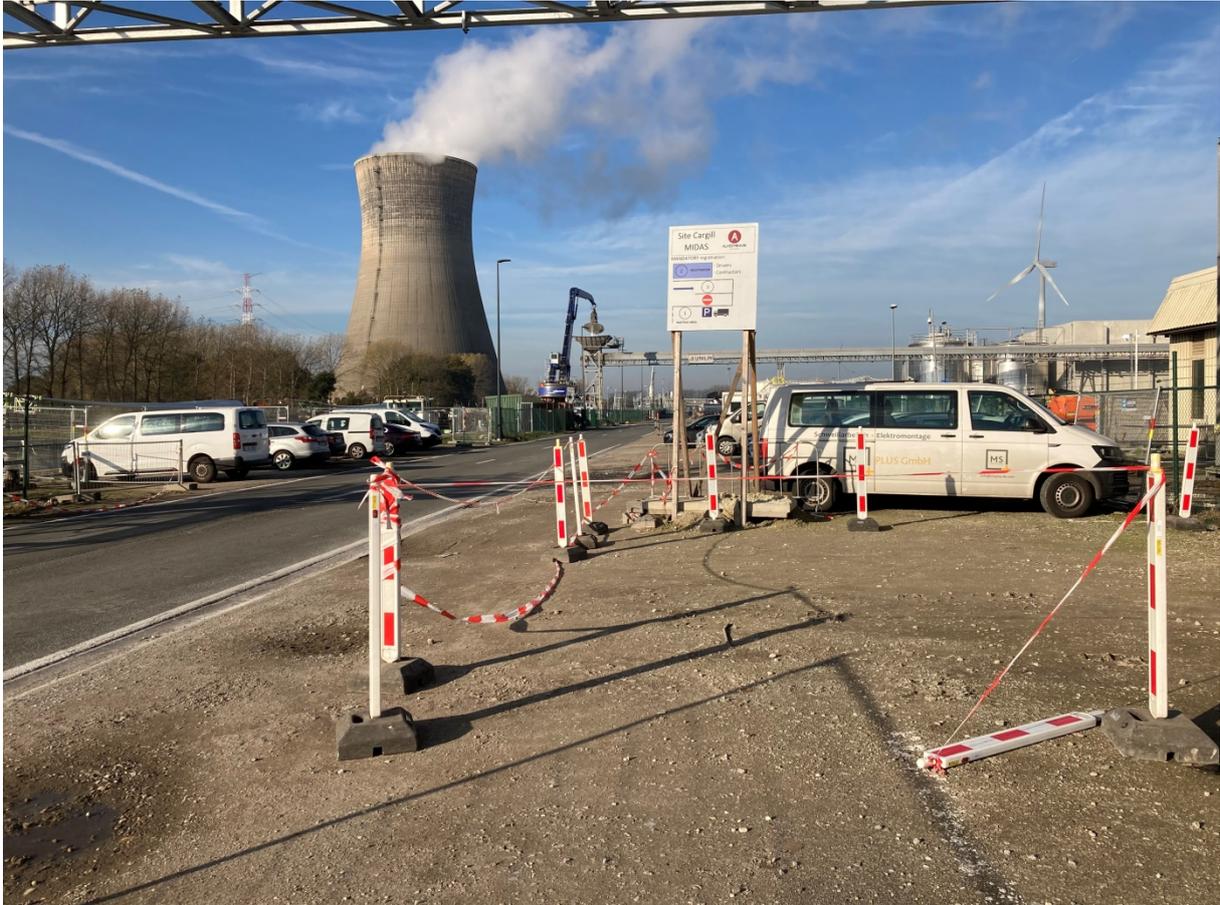
Another example of the fact that theory and practice do not match is 'UNILIN' at the Moervaartkaai (deposit 1).

The UNILIN-crane loads a white grain material onto a conveyor belt
