# Westerschelde: plastic nurdles

Sources, transport, deposits

Autumn 2021

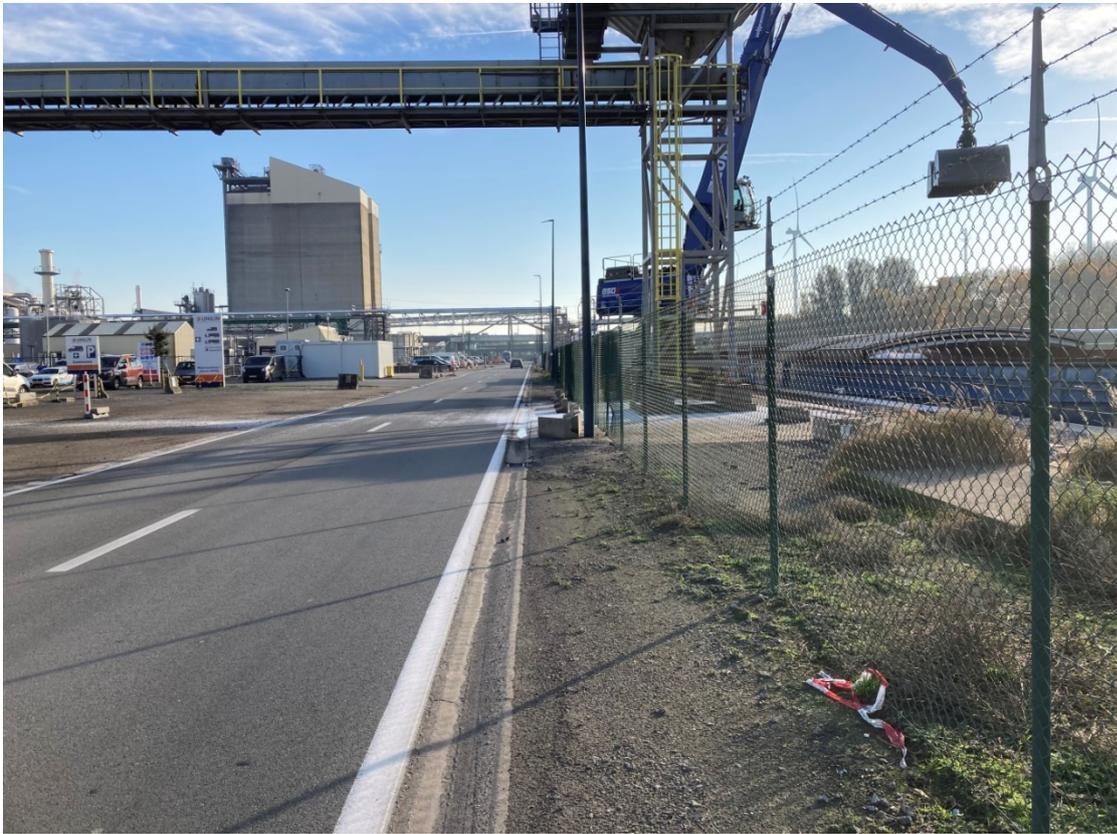
Picture taken from the other side. The white track beneath the conveyor belt and on the quay are spilled grains.

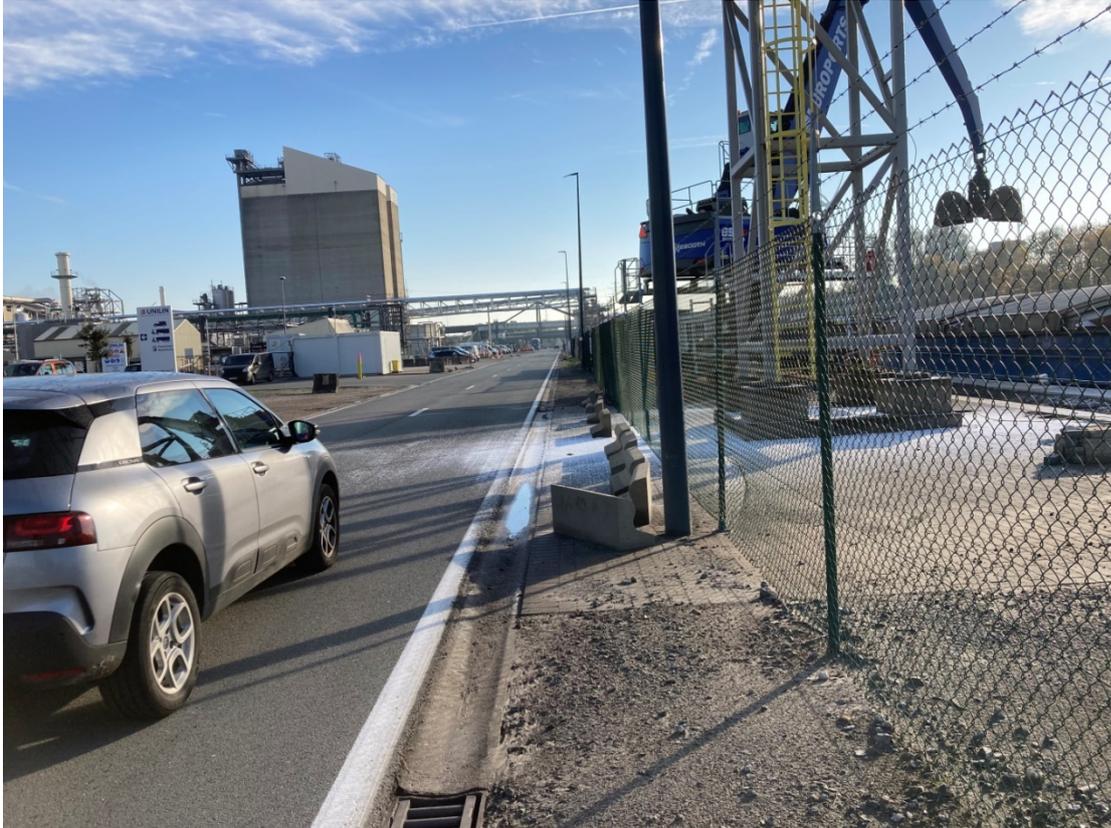
More closely: the white cloud in front of the passing car and on the quay is spilled material

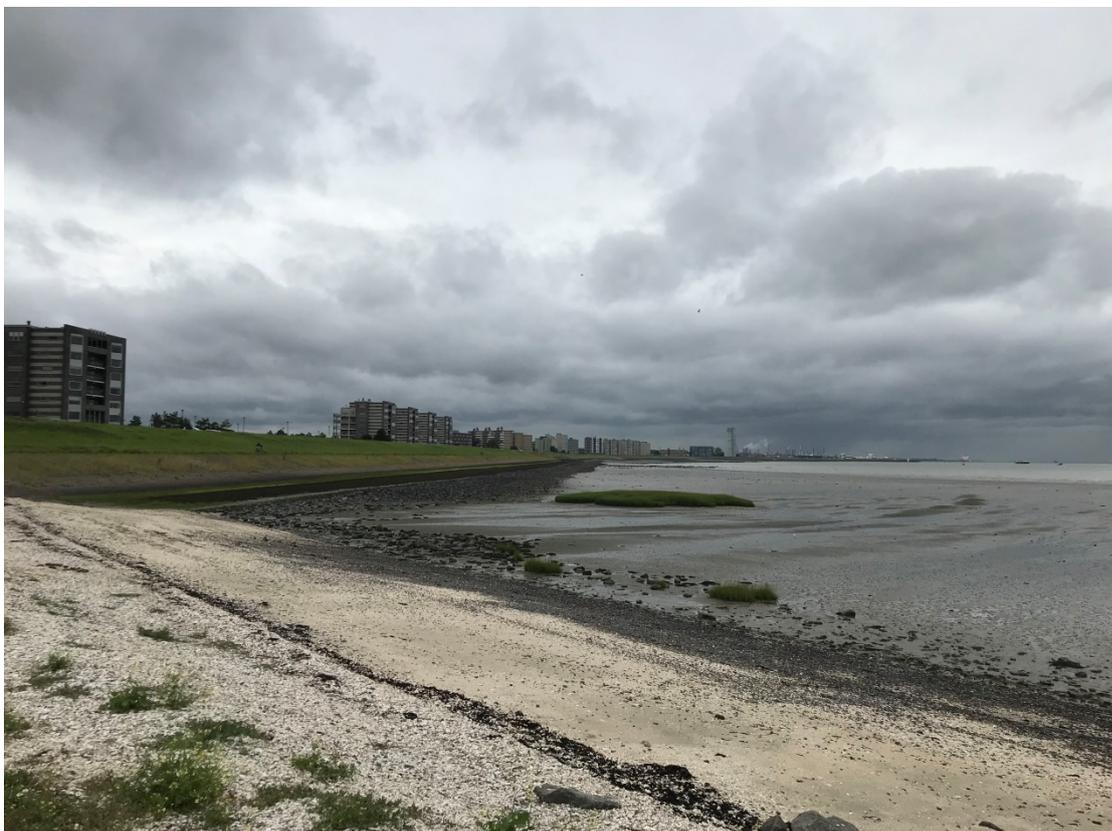
Location	1
Location	Terneuzen oostrand
Date	9-8-2021
coordinates	X=49080; Y=373014
number per m <sup>1</sup>	10-100
length of deposit	100 m
surface total	5,000

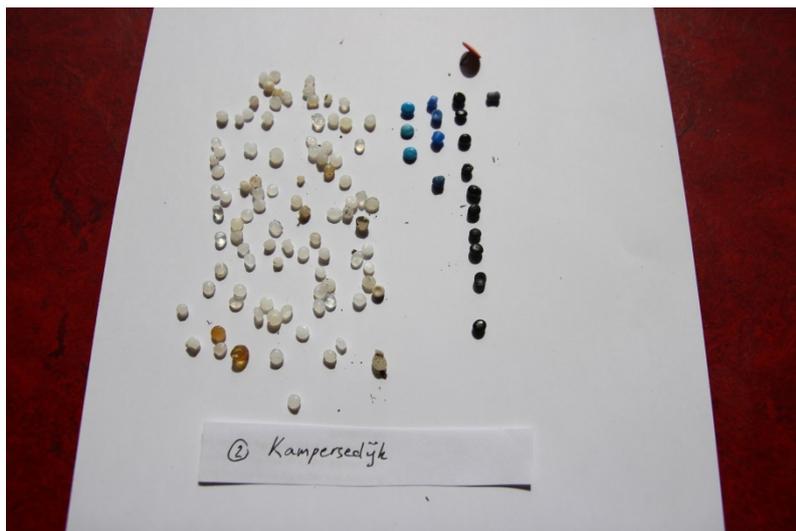
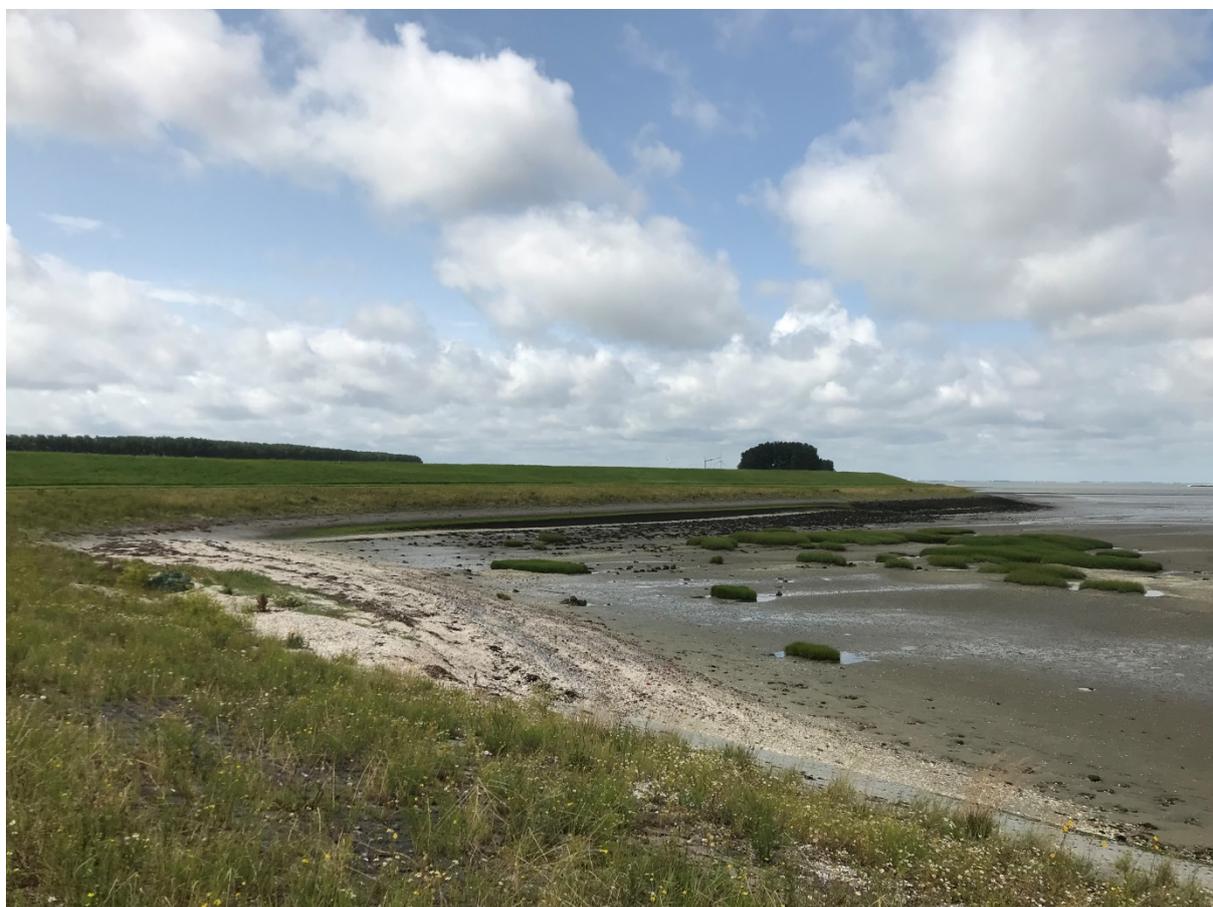
location	2
location	Kampersedijk
date	9-8-2021
coordinates	X= ; Y=
number per m <sup>1</sup>	10-100
length of deposit	100 m
surface total	5,000

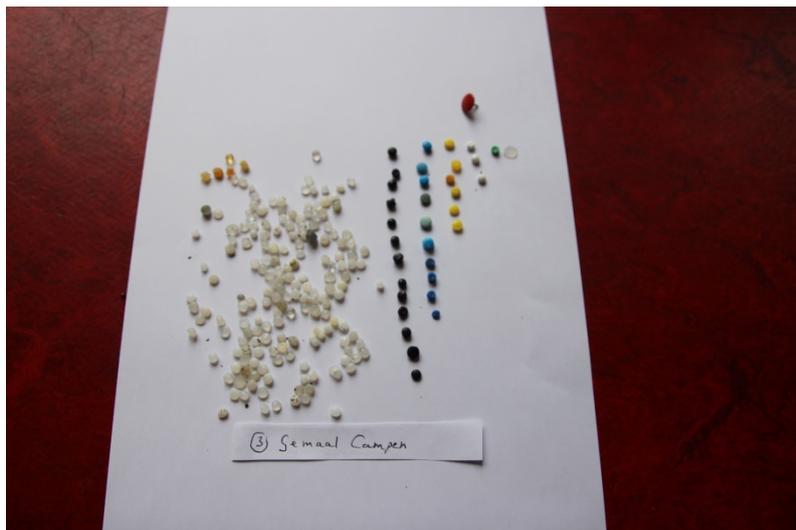
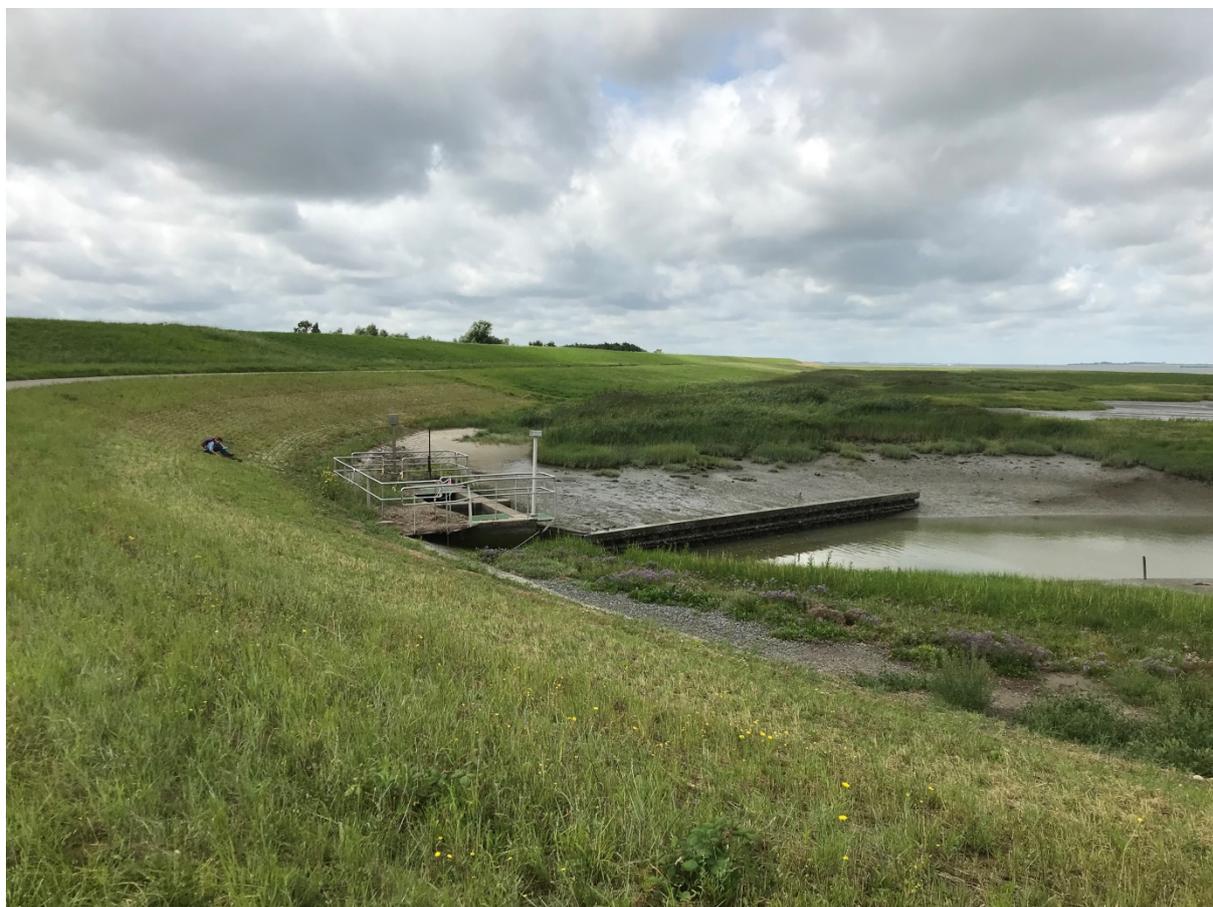
location	3
location	Gemaal Campen
date	9-8-2021
coordinates	X= 55482 ; Y=376091
number per m <sup>1</sup>	100-500
length of deposit	500 m
surface total	150,000

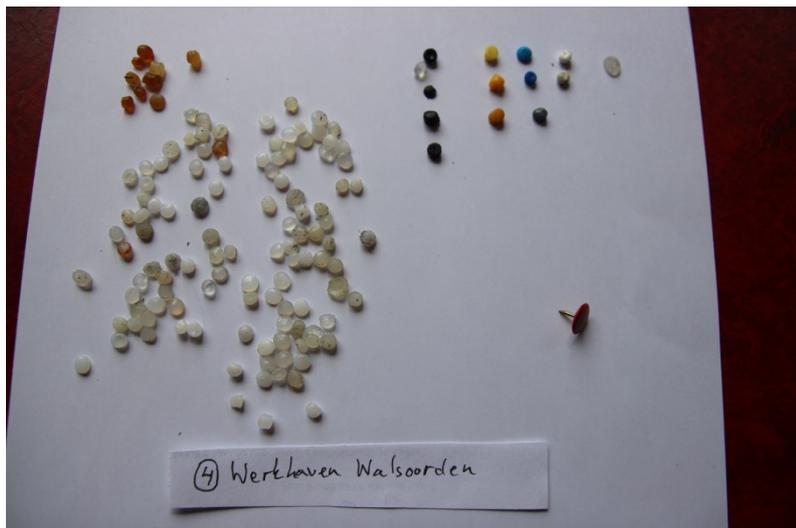
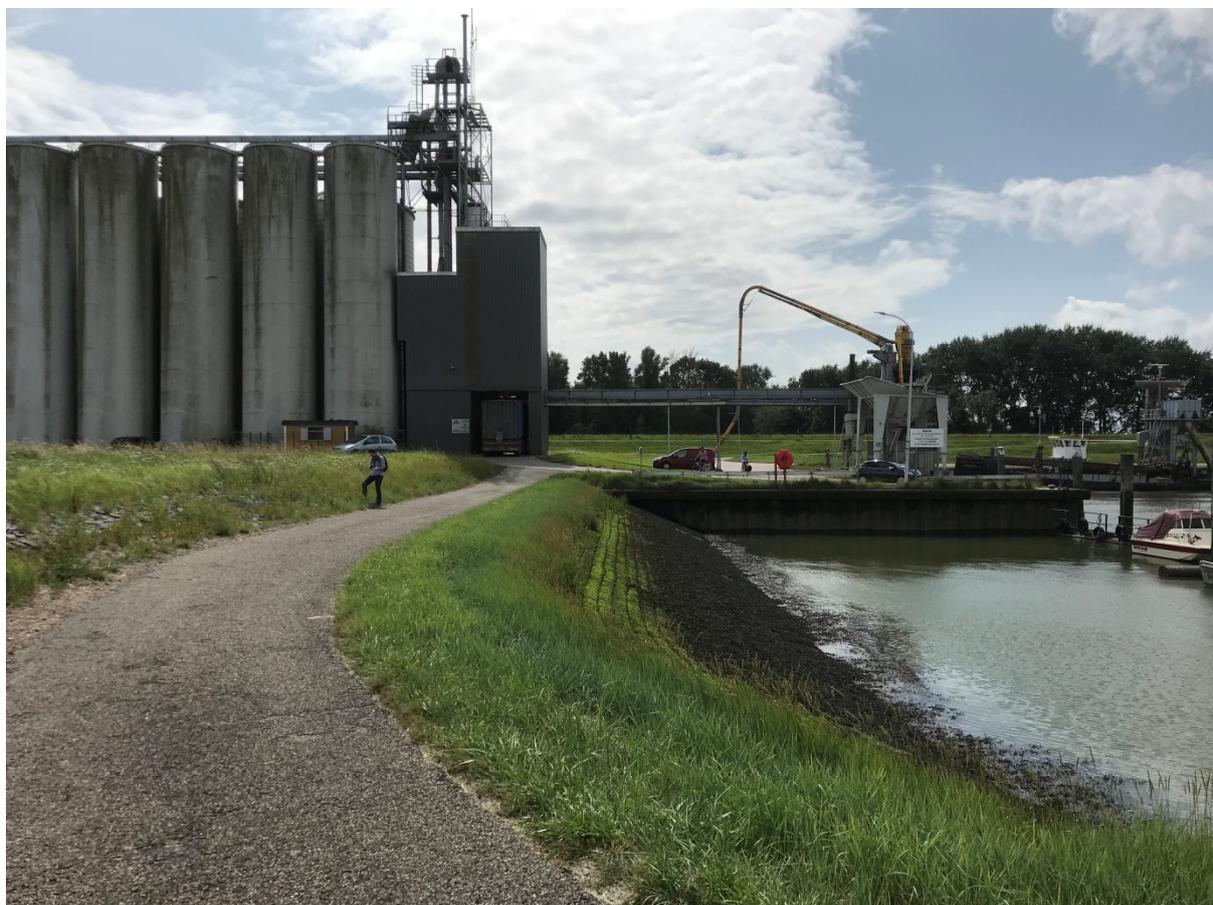
location	4
location	Werkhaven Walsoorden
date	9-8-2021
coordinates	X=60892 ; Y=377760
number per m <sup>1</sup>	100-500
length of deposit	100 m
surface total	30,000

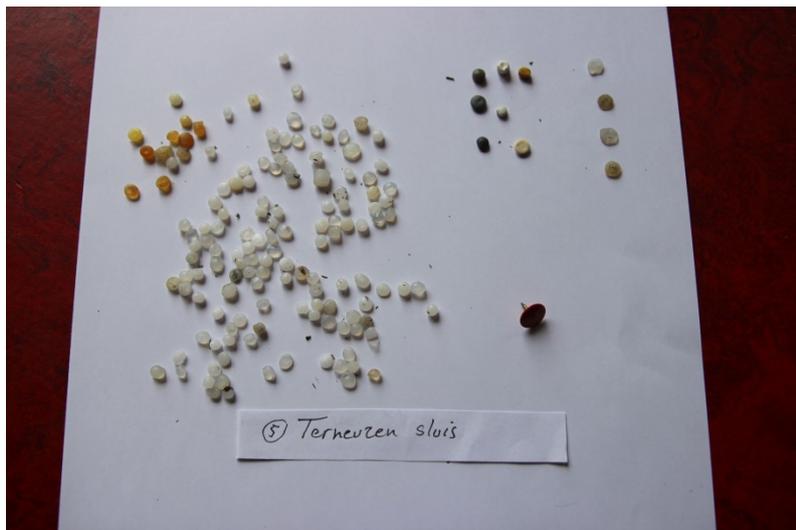
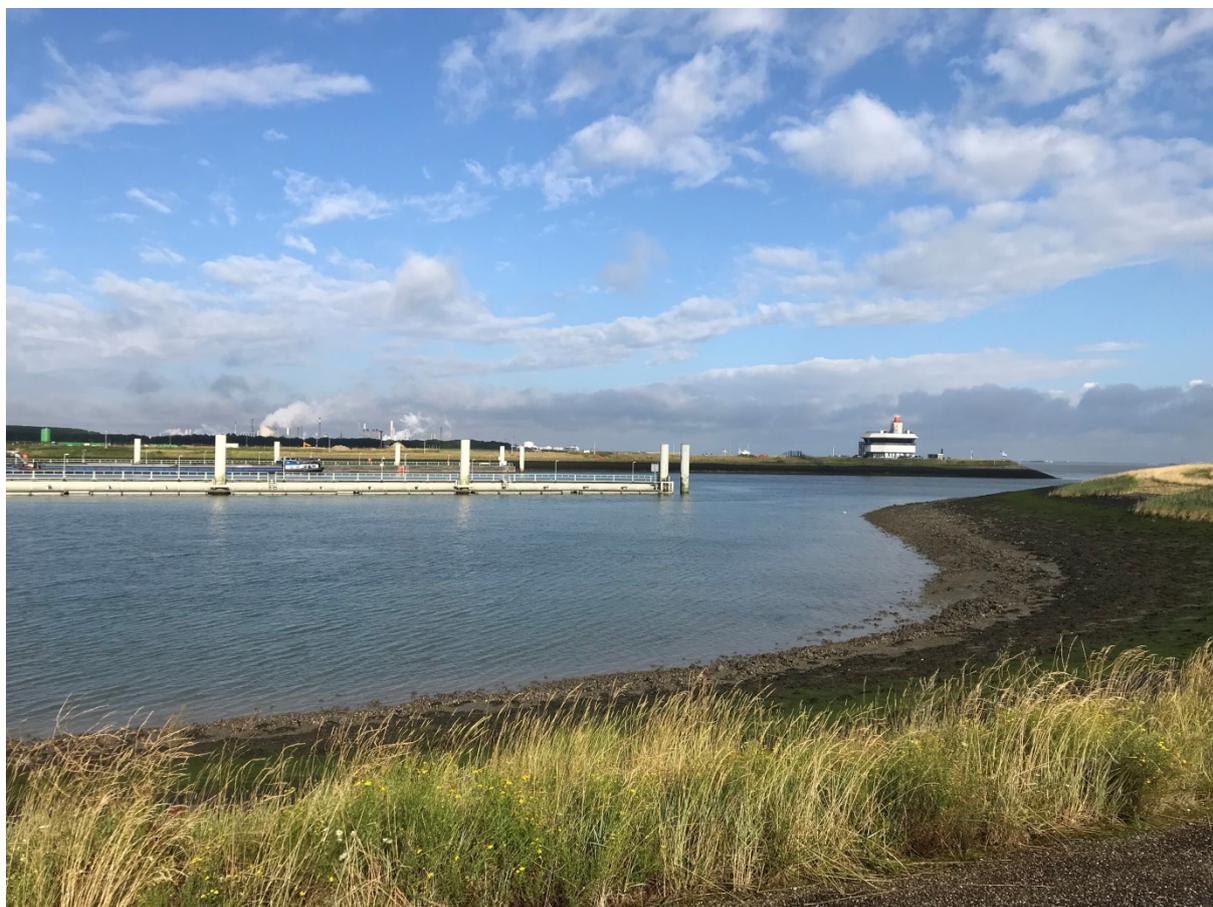
location	5
location	Terneuzen sluis
date	10-8-2021
coordinates	X=45947 ; Y=373512
number per m <sup>1</sup>	10-100
length of deposit	250 m
surface total	12,500

The canal Gent-Terneuzen is the source for the nurdles found outside the sluice at Terneuzen (deposit 7).

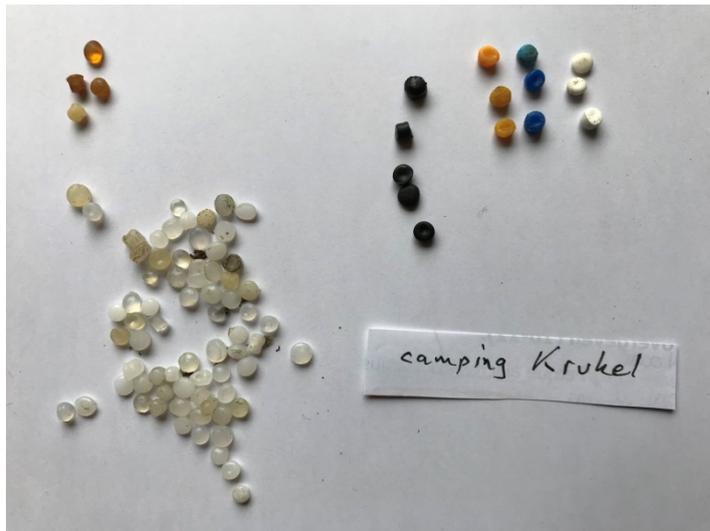
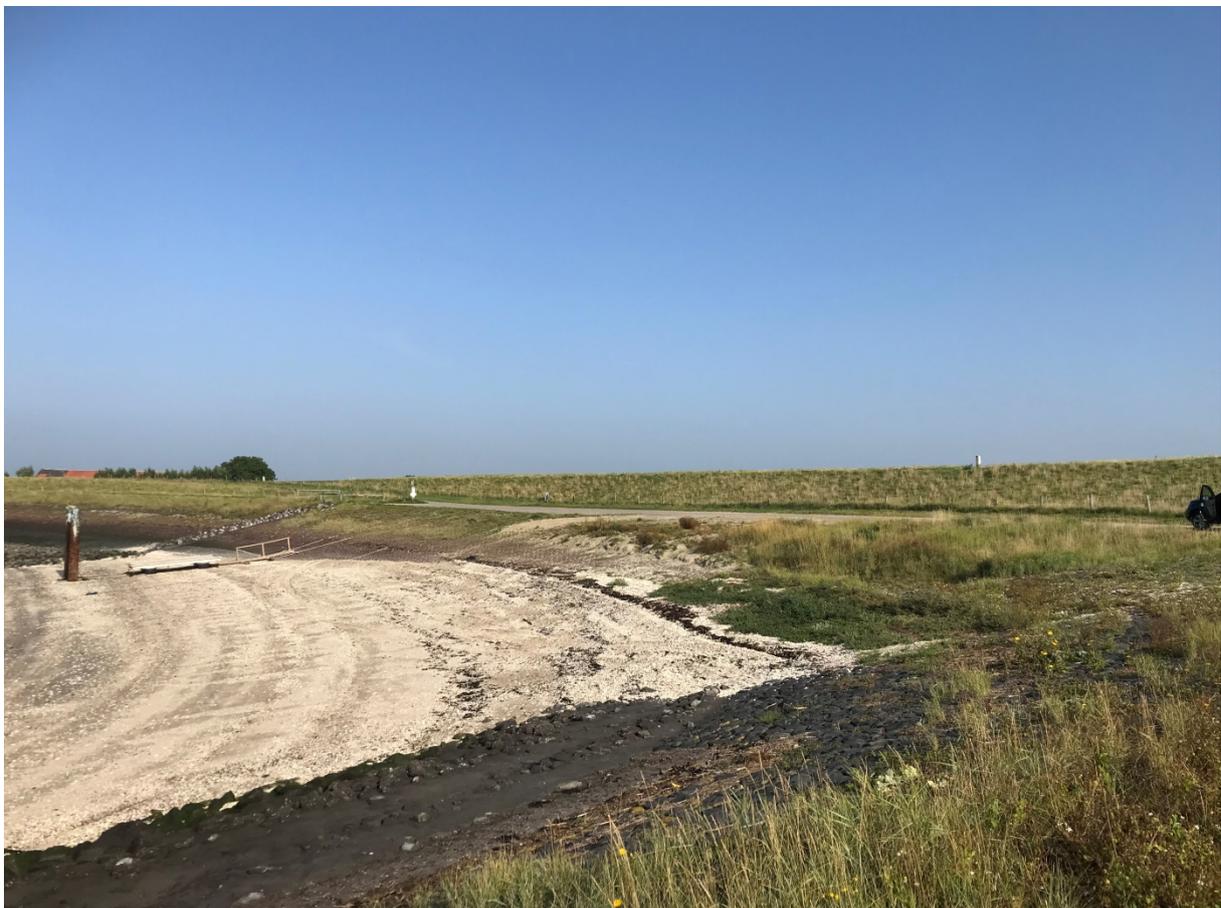
location	
location	Camping Krukel
date	3-9-2021
coordinates	X=41522 ; Y=381873
number per m <sup>1</sup>	20
length of deposit	50
surface total	1,000

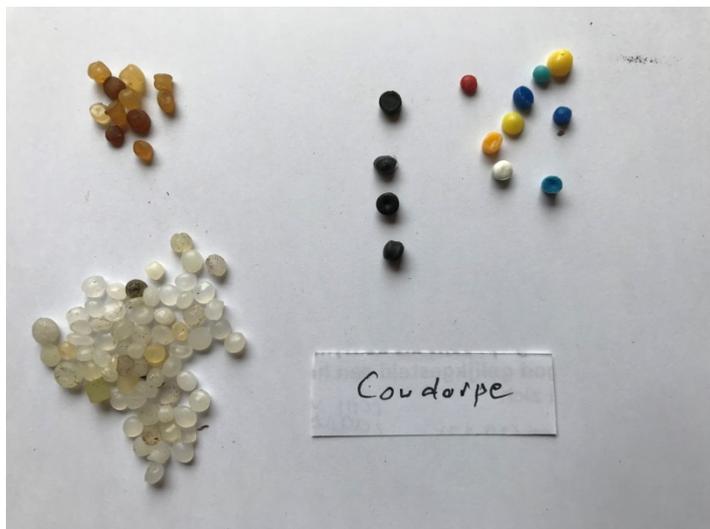
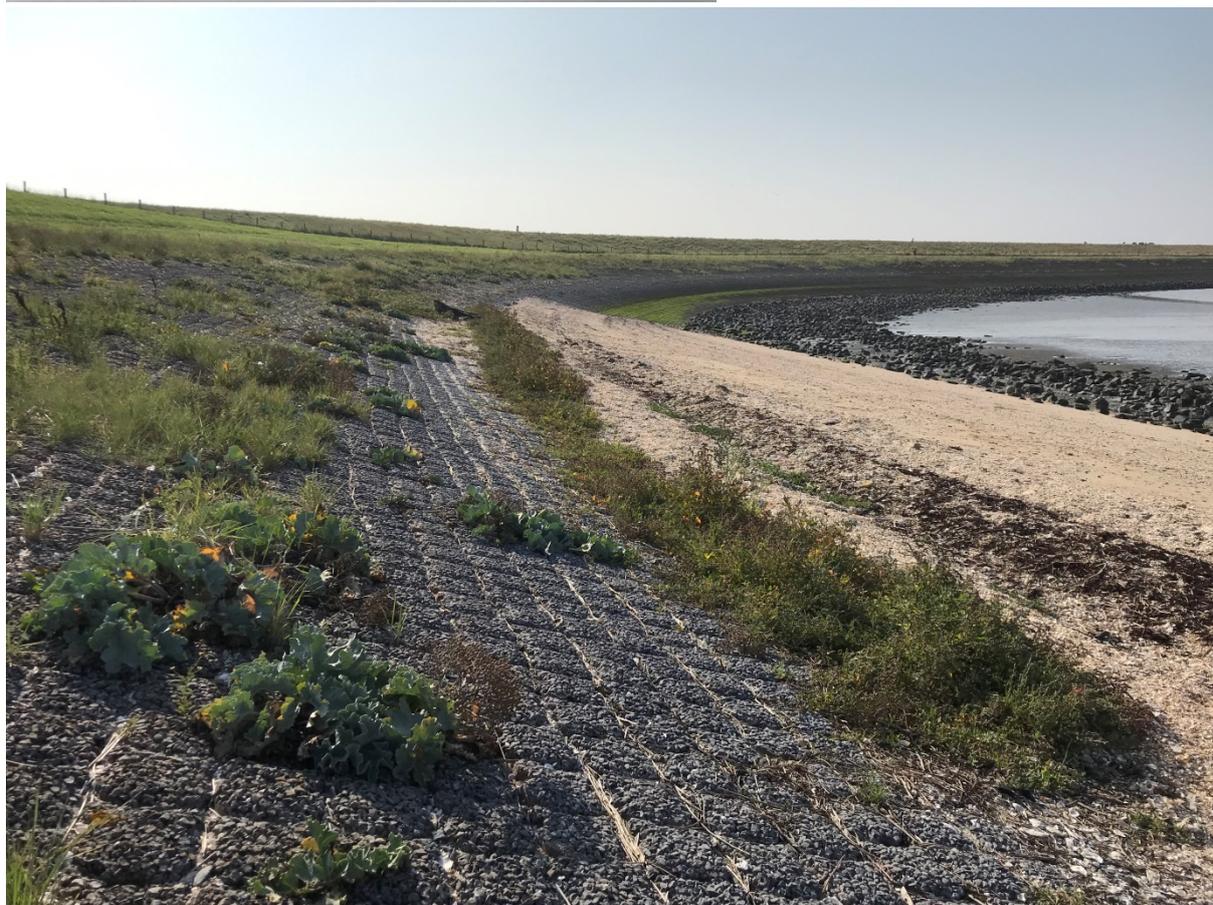
location	
location	Coudorpe
date	3-9-2021
coordinates	X=43013 ; Y=381315
number per m <sup>1</sup>	30
length of deposit	150
surface total	4,500

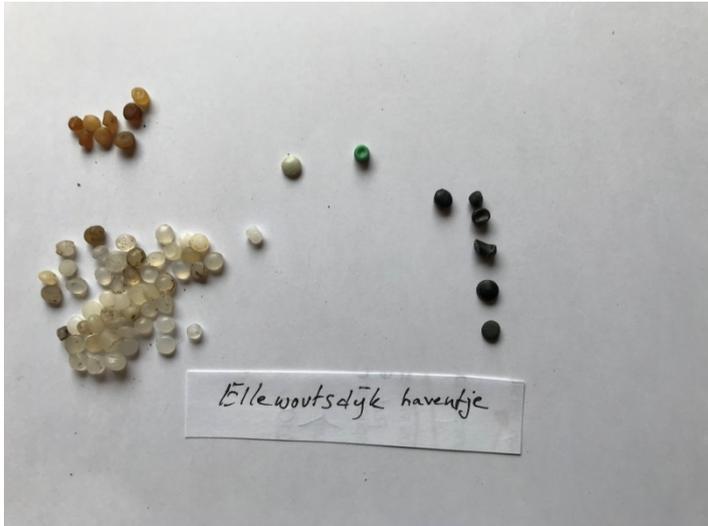
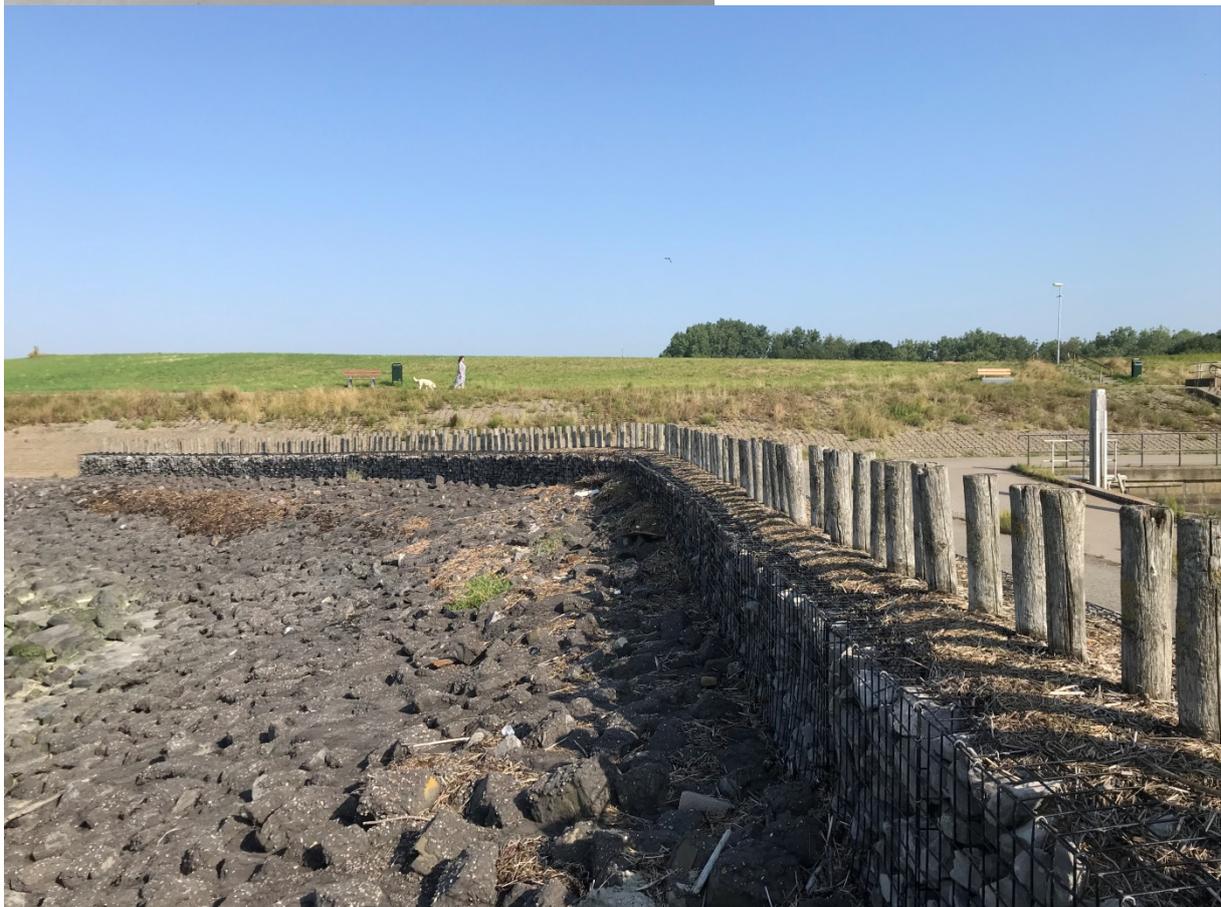
location	
location	Ellewoutsdijk haventje
date	3-9-2021
coordinates	X=45690 ; Y=378591
number per m <sup>1</sup>	20
length of deposit	100
surface total	2,000

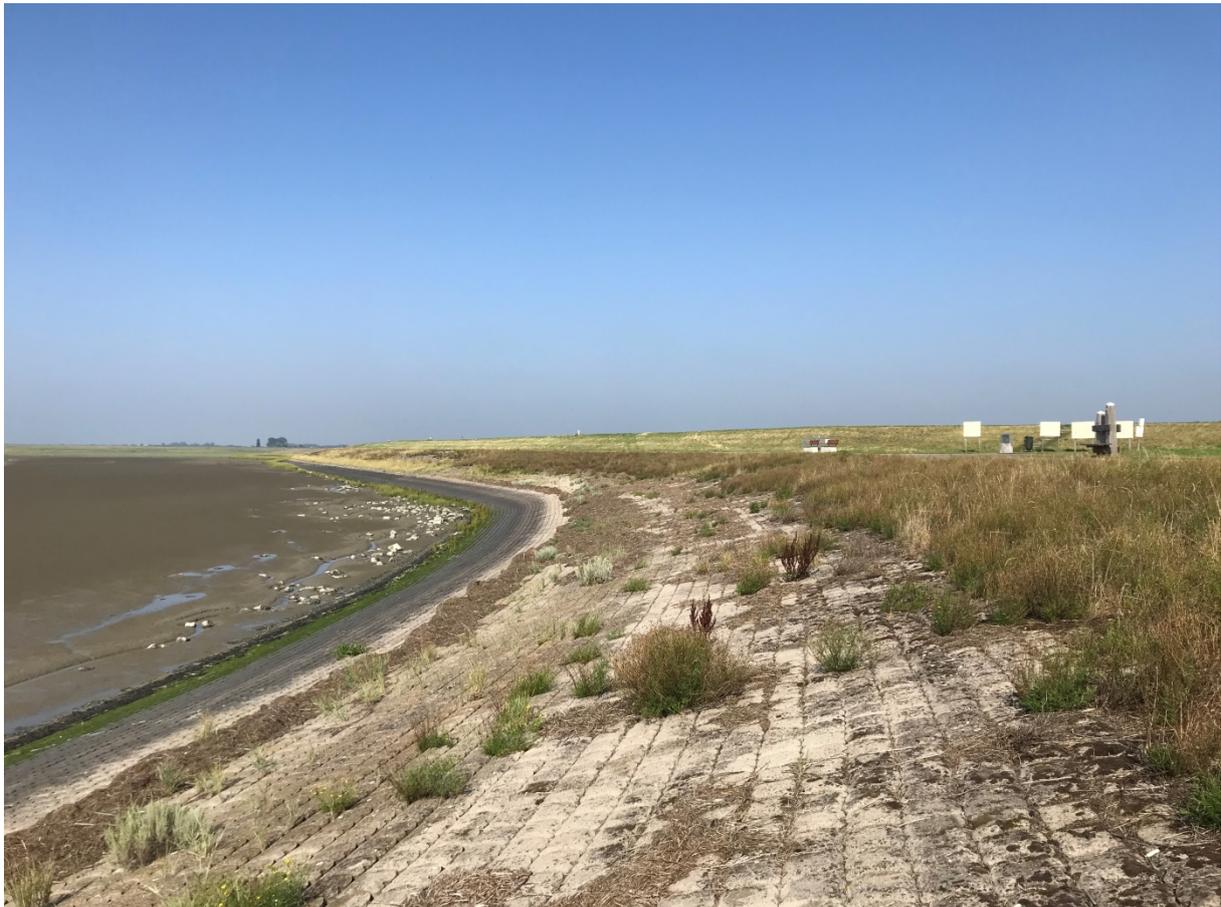
location	
location	Scheldeoord
date	3-9-2021
coordinates	X=50988 ; Y=379404
number per m <sup>1</sup>	1
length of deposit	200
surface total	200

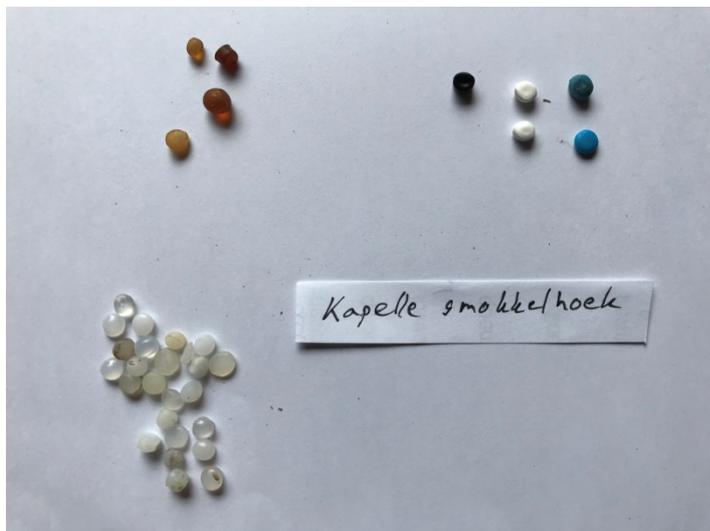
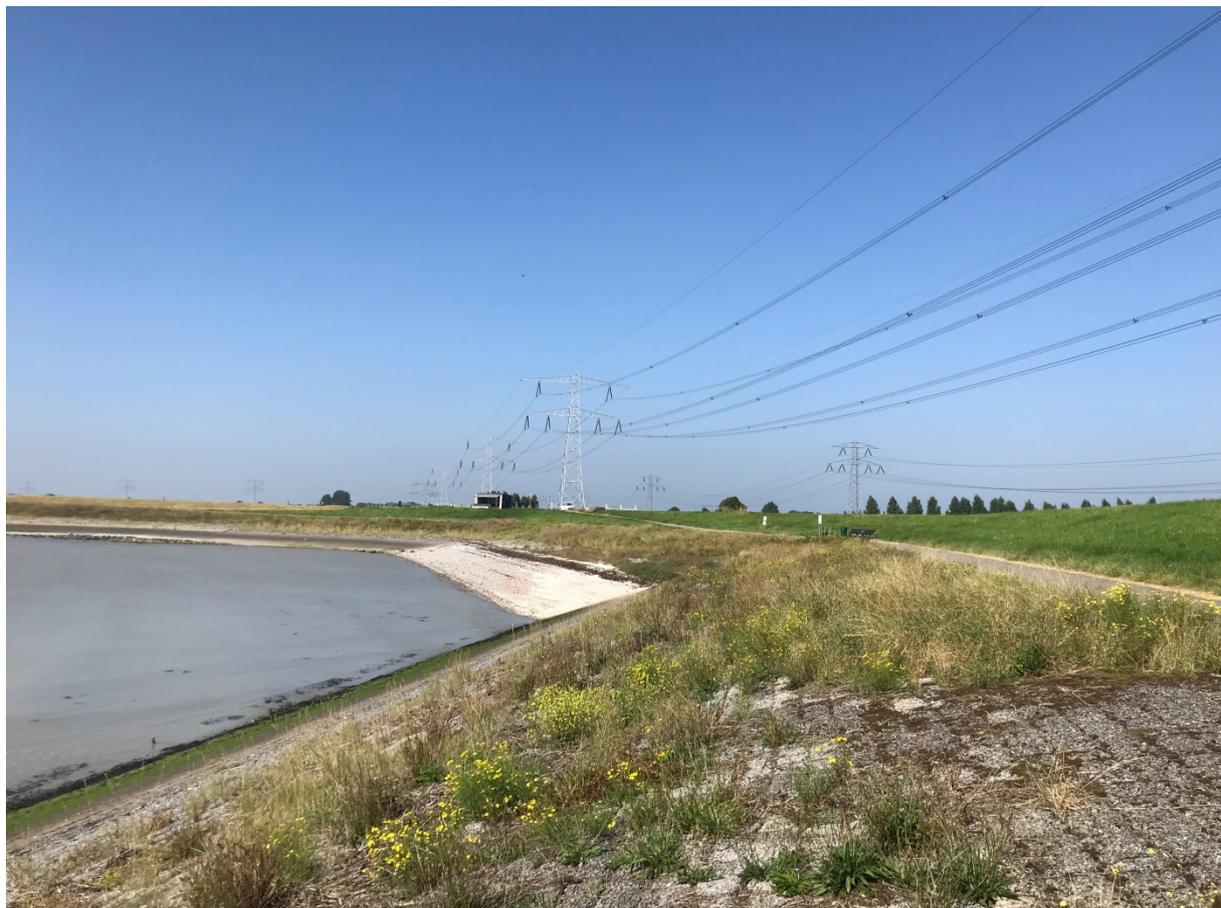
location	
location	Kapelle smokkelhoek
date	3-9-2021
coordinates	X=56947 ; Y=386874
number per m <sup>1</sup>	10
length of deposit	100
surface total	1,000

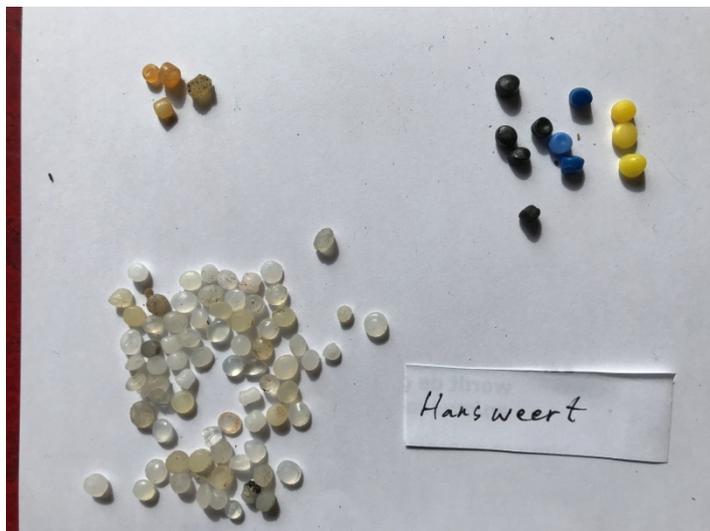
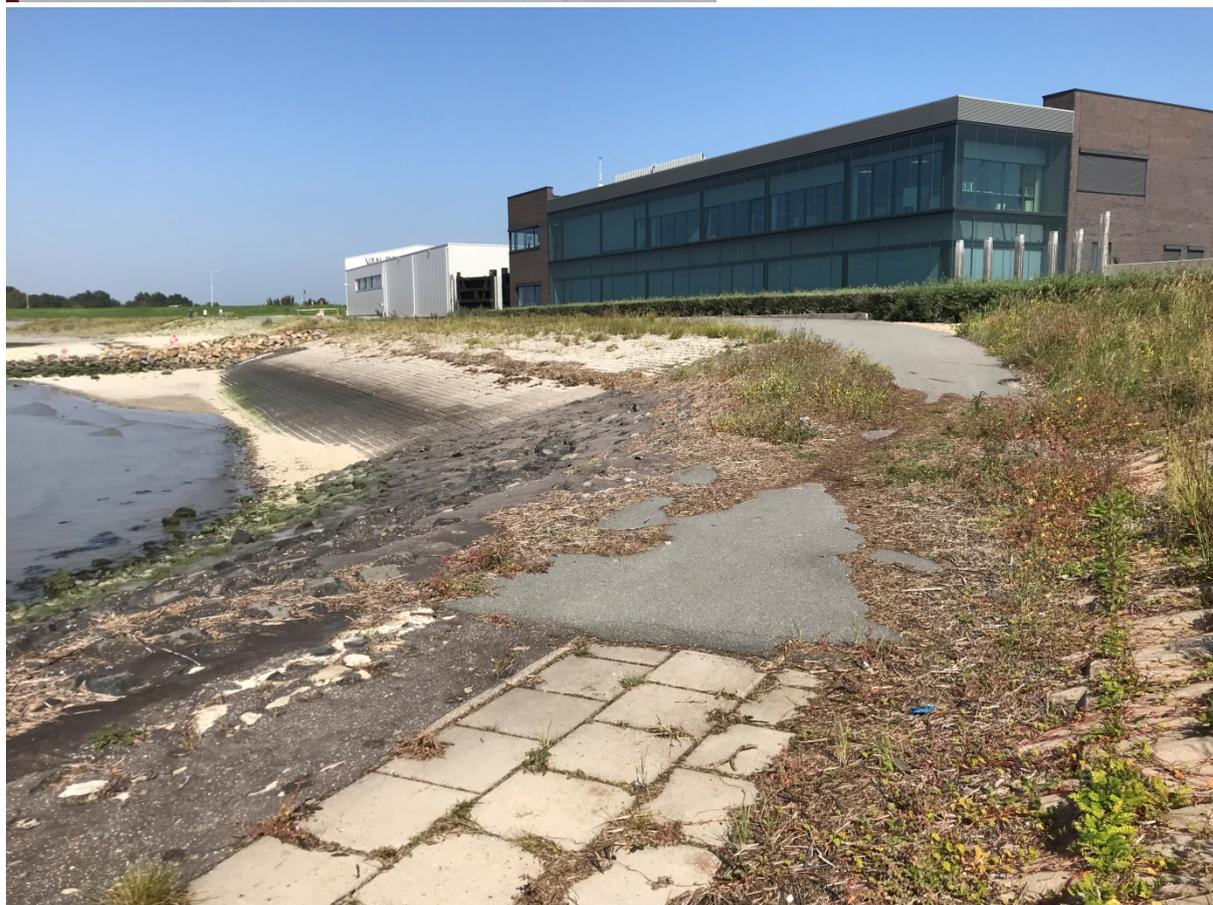
location	
location	Hansweert
date	3-9-2021
coordinates	X=58833 ; Y=384863
number per m <sup>1</sup>	200
length of deposit	150
surface total	30,000

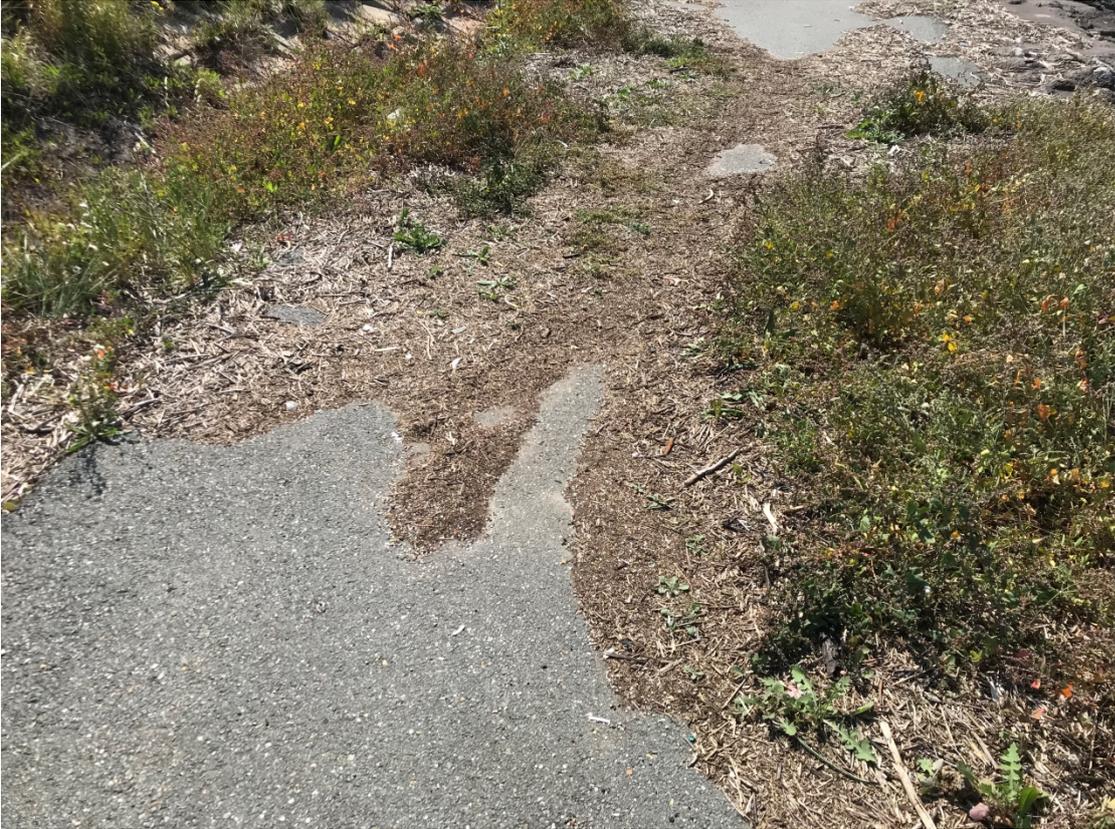
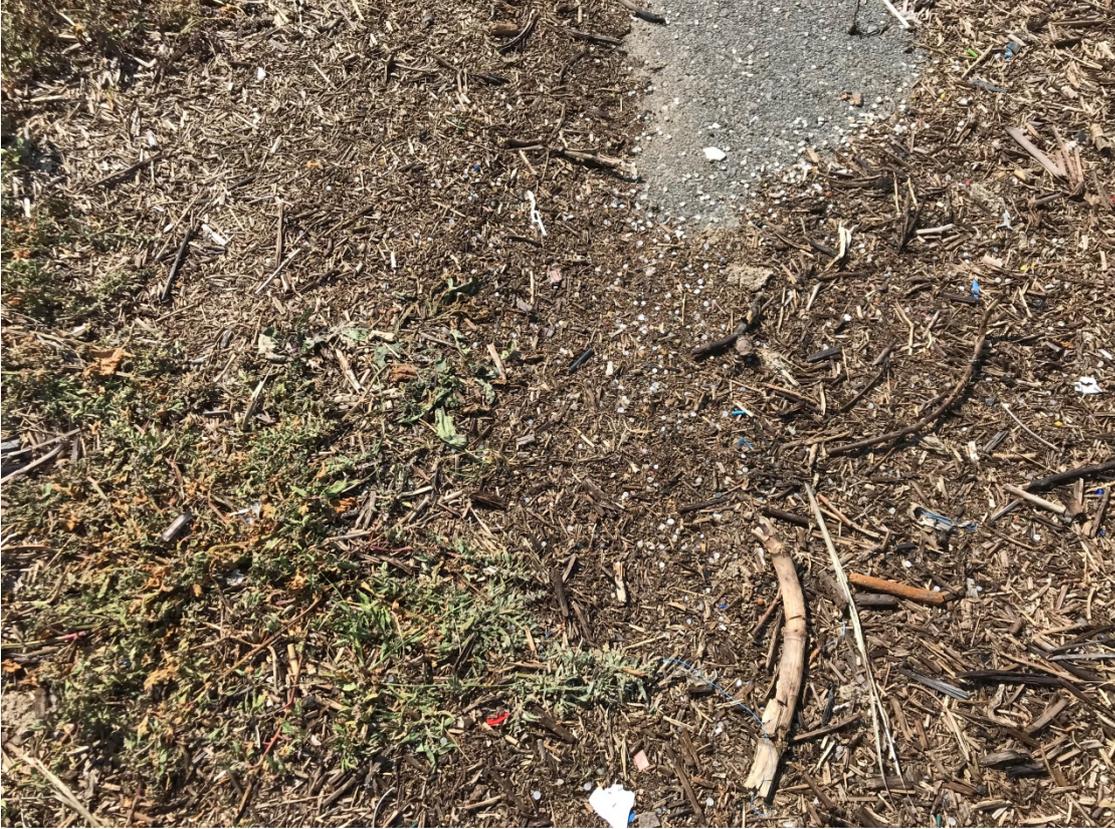
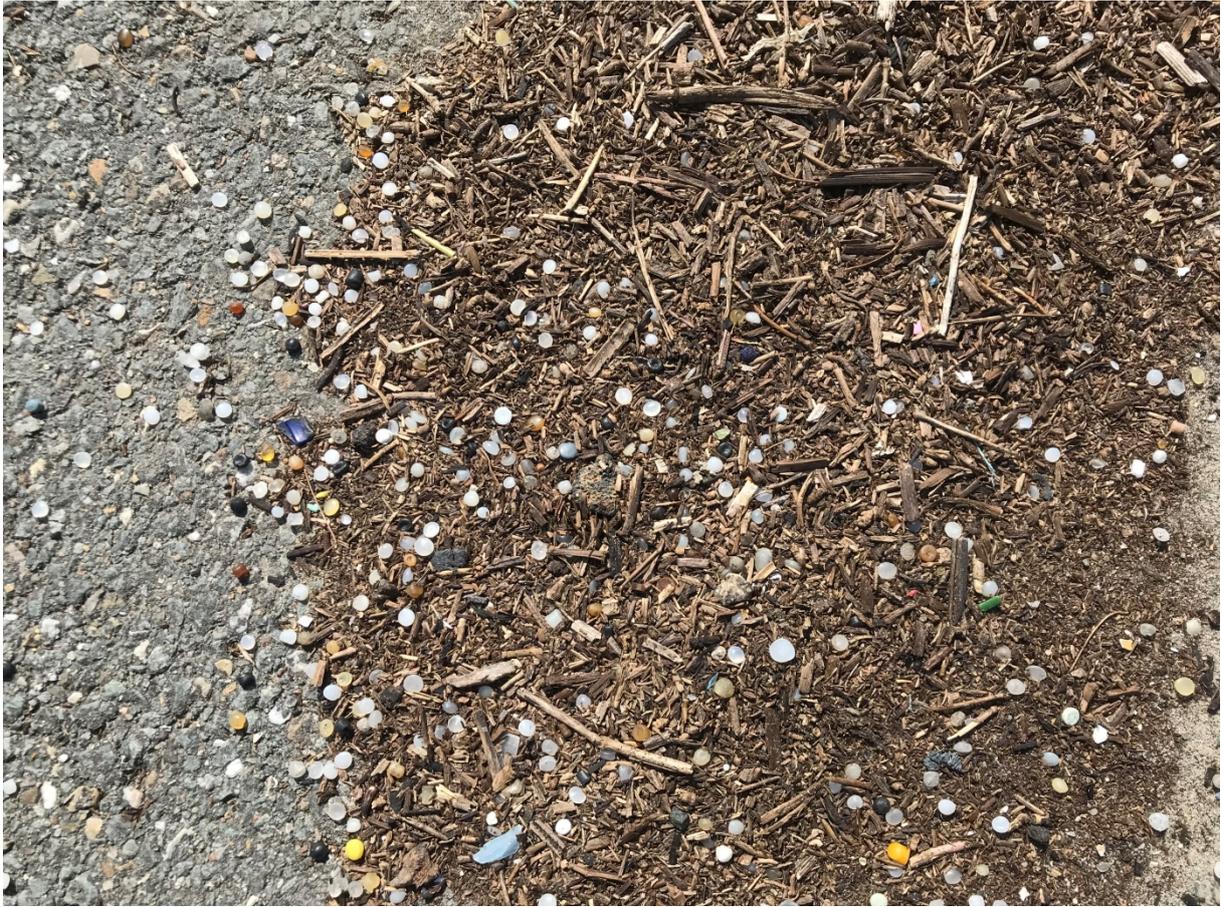
Hansweert zoom in

In more detail

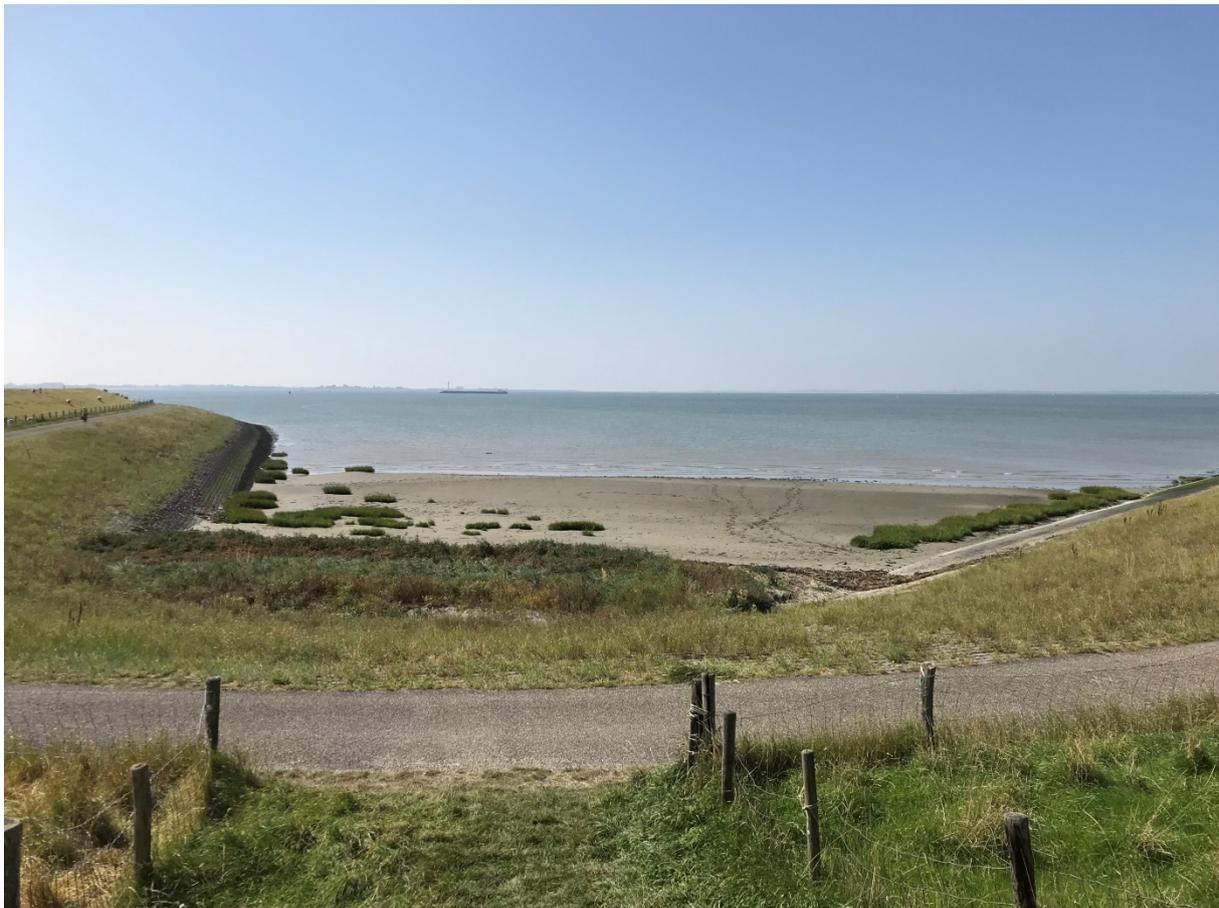
Kruiningen: corner Vroondijk-Inkeldijk

location	
location	Kruiningen Vroondijk/Inkeldijk
date	3-9-2021
coordinates	X=62080 ; Y=383143
number per m <sup>1</sup>	100
length of deposit	50
surface total	5,000

Nurdles Kruiningen: 'vispluis' (blue thread on picture) was found on all locations

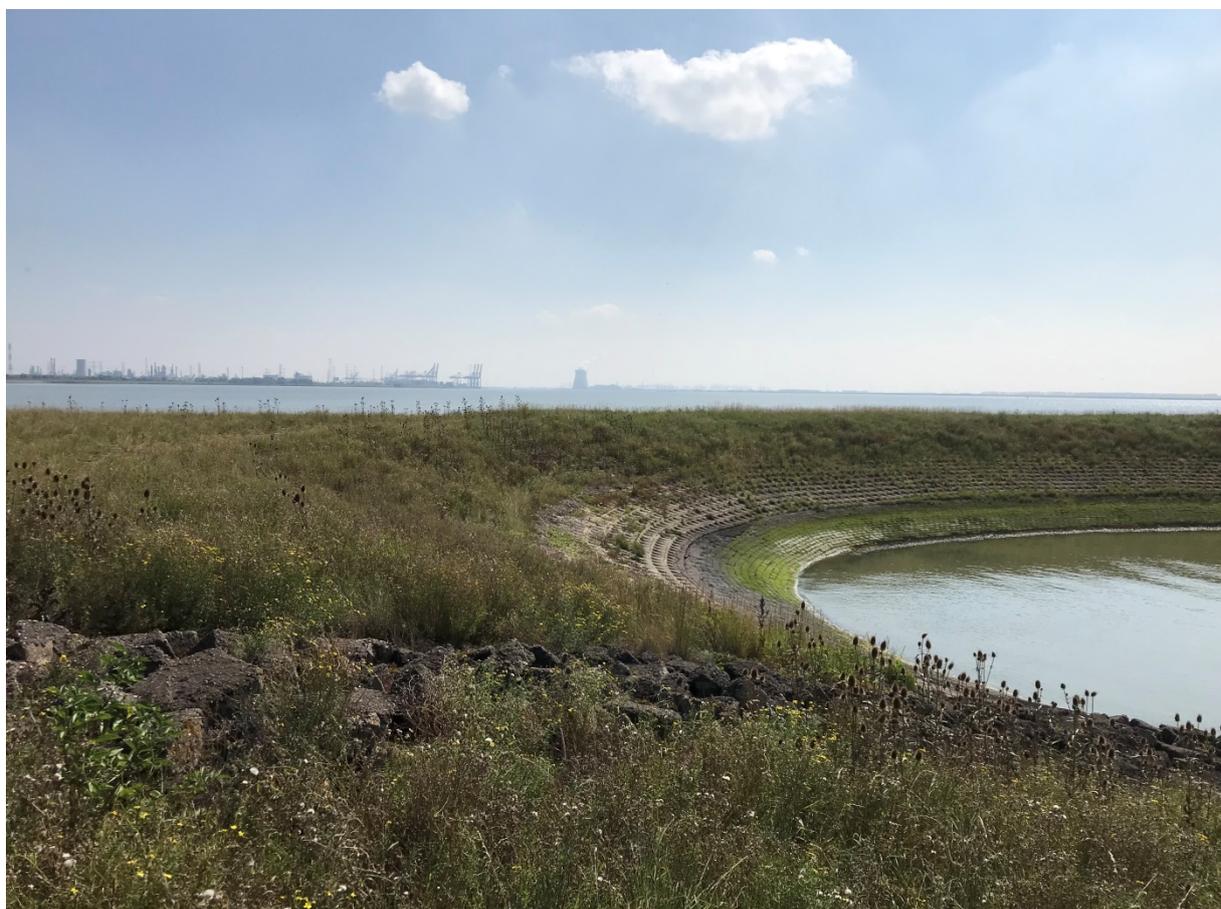
location	
location	Bath berging spuisluis 2x
date	3-9-2021
coordinates	X=73601 ; Y=379570 X=73731 ; Y=379498
number per m <sup>1</sup>	2 x 25 = 50
length of deposits	2 x 50 = 100 m
surface total	5,000

Bath berging spuisluis inside corner. Harbour of Antwerpen in the background
