# Westerschelde: plastic nurdles

Sources, transport, deposits

Autumn 2021

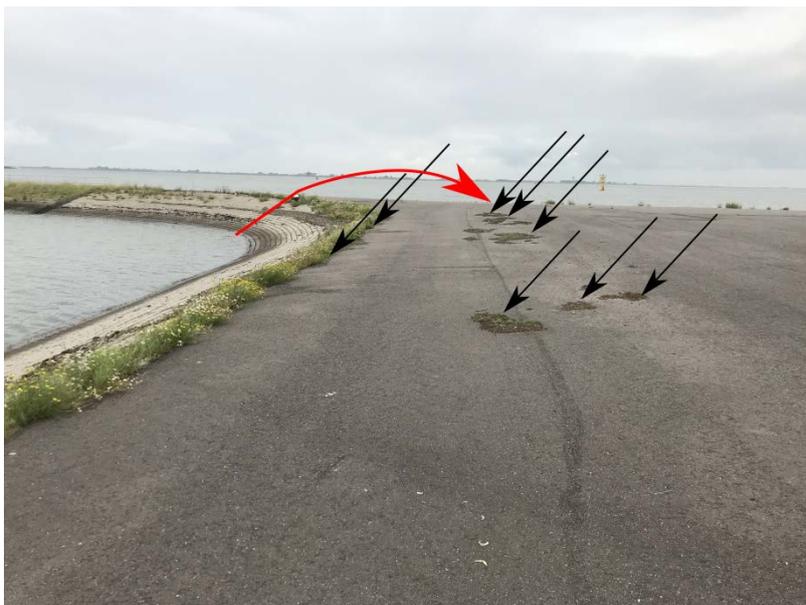
Once in the harbour the wind regains its grip and transports the nurdles to the southeast corner (2). If the storm is strong enough and the water high enough the nurdles leave the harbour (b) over the breakwater/groyne (level NAP + 3,5 m).

SE-corner Veerhaven red arrow = b, black arrows are findings of nurdles

Part of the nurdles flow into the Perkpolder (b) and remain there because the dike level is at NAP + 8,5 m (findings 4 and 5). Another part flows over the groyne (level NAP + 3,5 m) and is transported along the bank (c). Another part of them might leave the shore (?).

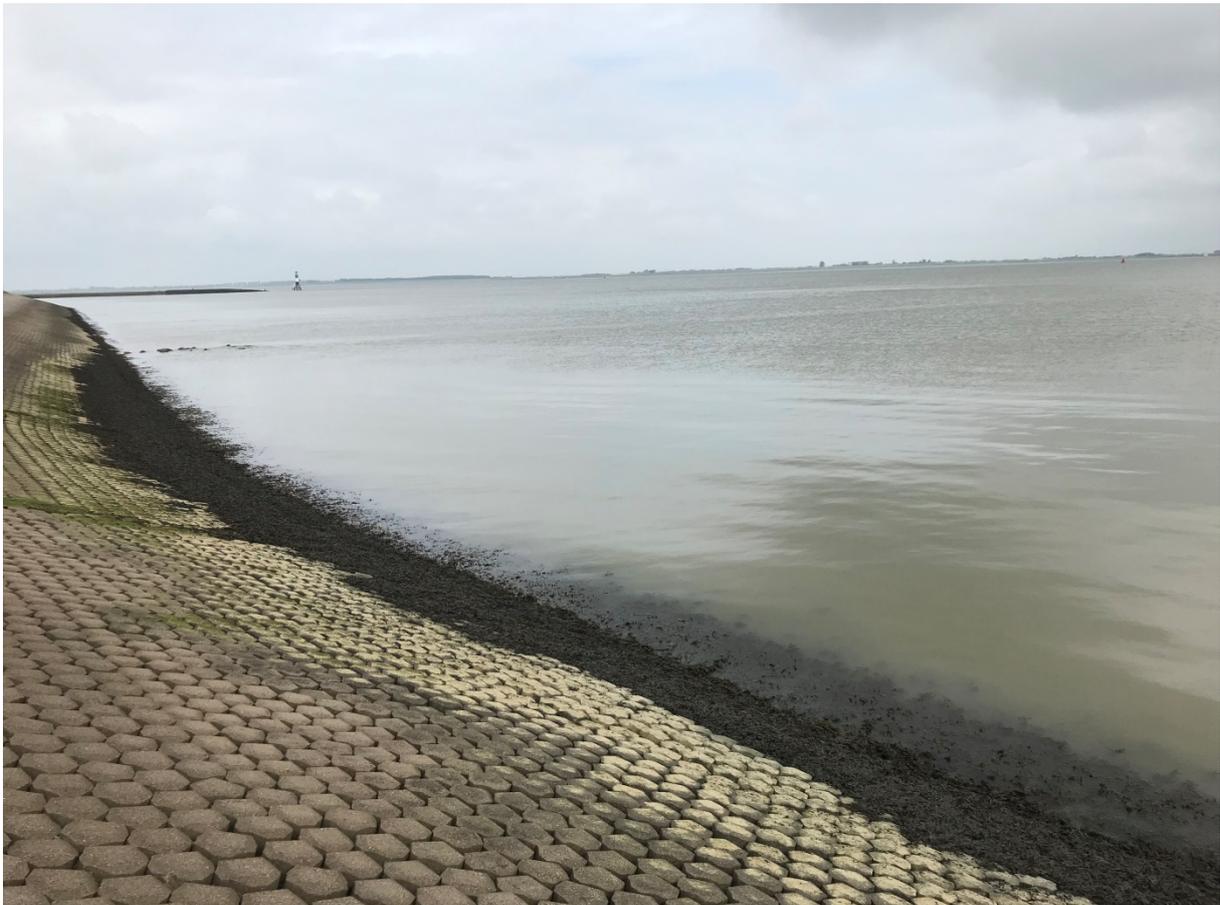
Ad 2. If the wind is blowing from a direction perpendicular to the dike there will be overpressure on the windward side and underpressure on the leeward side (lit. nr? Plaisier, A. et al; Windklimaat in de gebouwde omgeving, 2016 PAO SKB).

With westerly winds an easterly wind stream will develop behind the dike to fill up this underpressure.

Flat calm behind the dike at Perkpolder with WSW 3 Bft

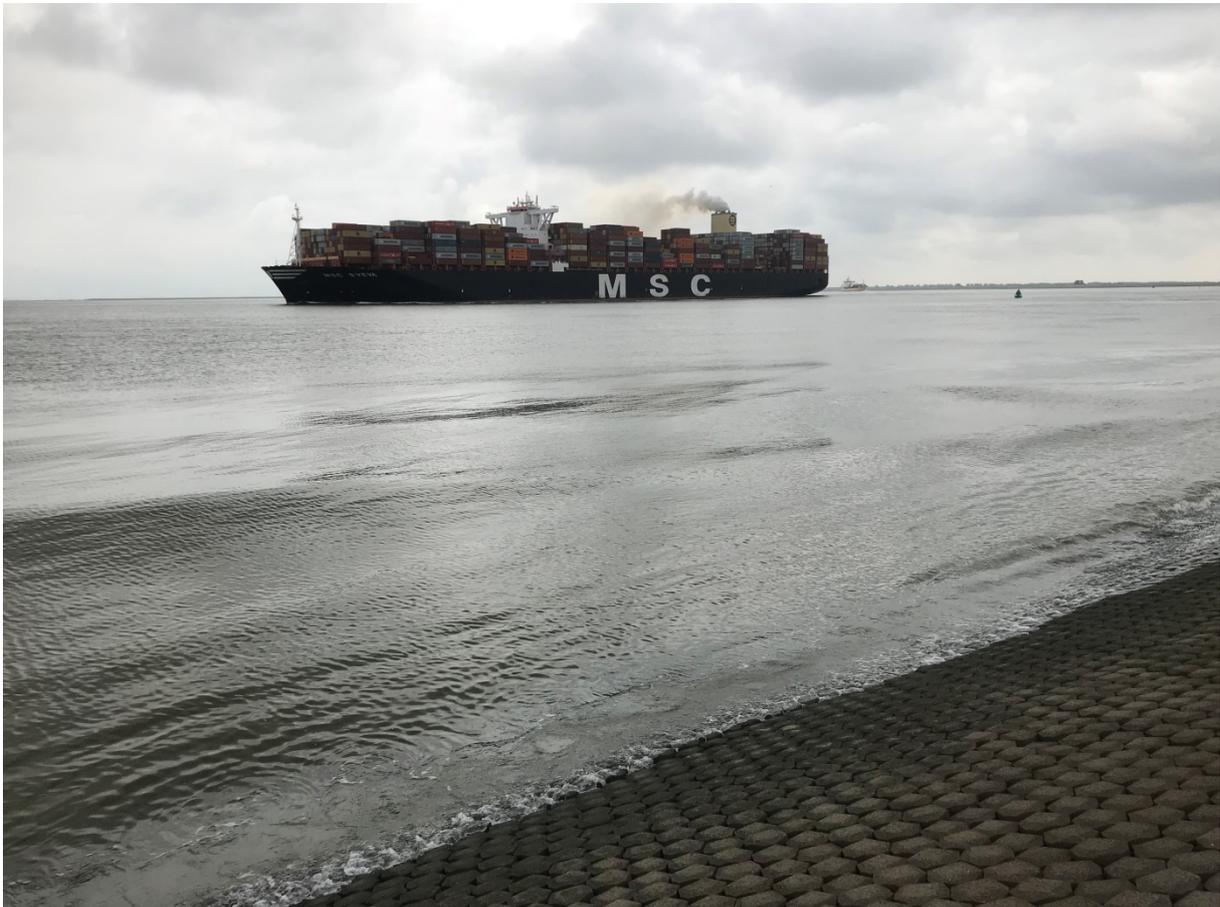
Container vessel coming from Antwerpen at the height of Perkpolder

Especially with the water displacement caused by the ships coming from Antwerpen the debris travelled further in the direction of Walsoorden than it did in the reversed way. After half an hour and 4 ships it had covered a distance of about 30 m.

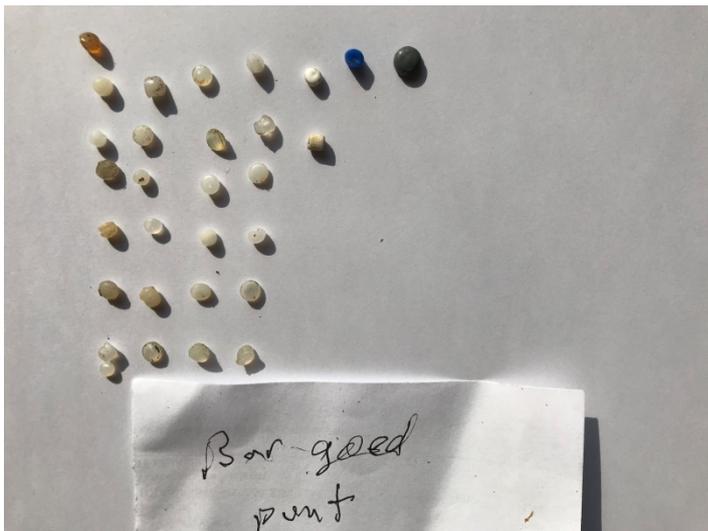
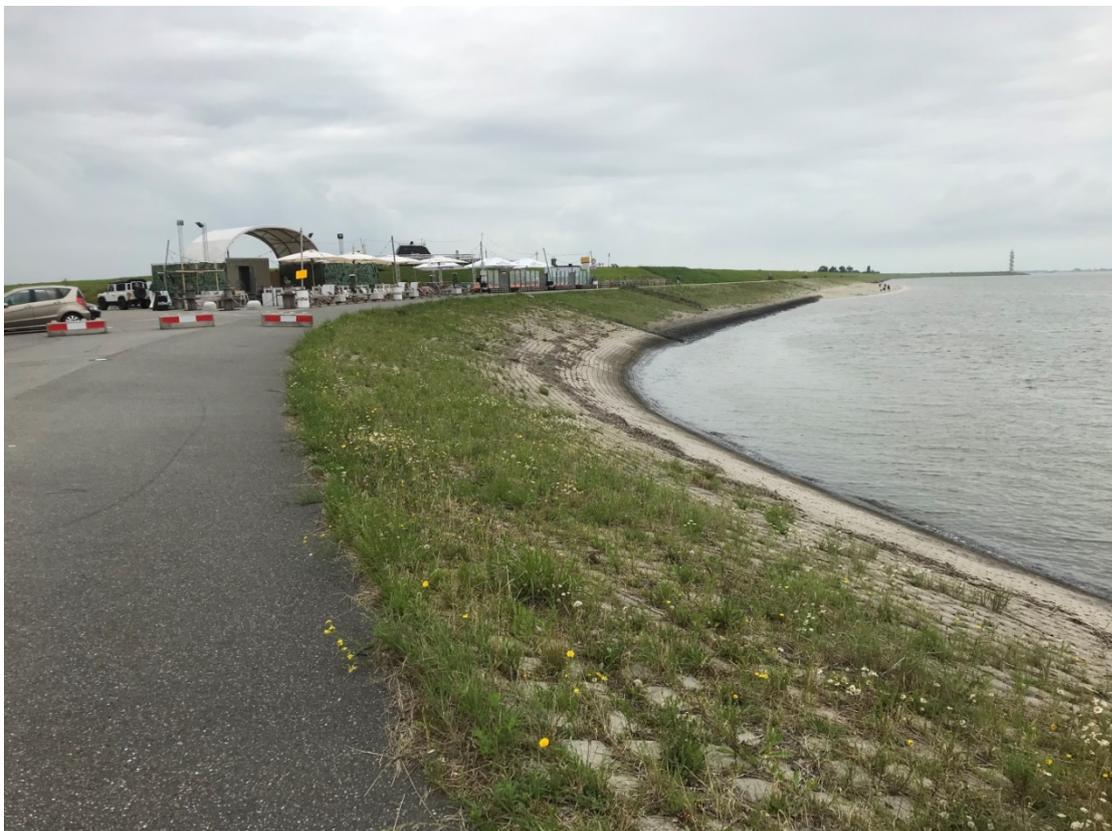
location	1
location	VeerhavenNO-pier/ Bar Goed
date	20-8-2021
coordinates	X=59756 ; Y=380004
number per m <sup>1</sup>	10
length of deposit	25
surface total	250

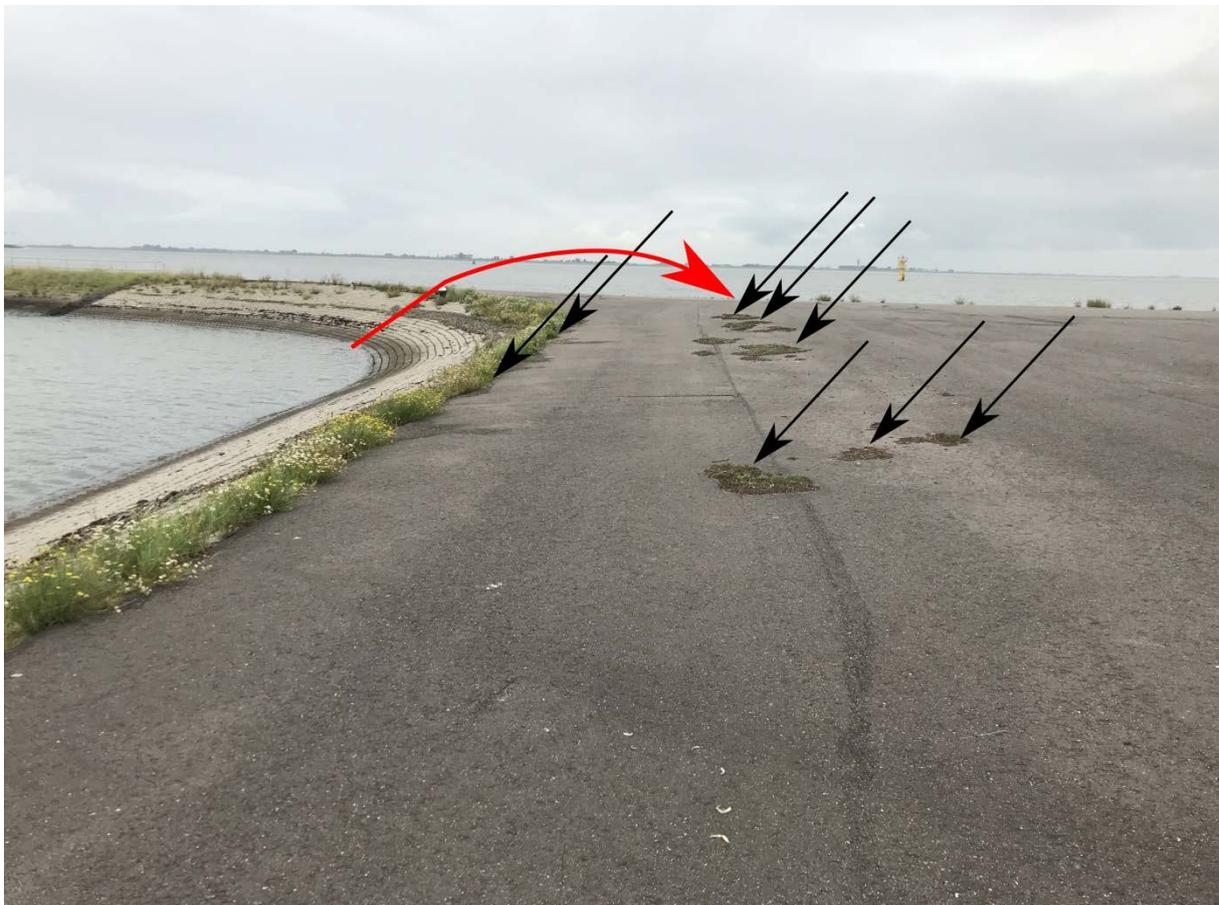
SE-corner Veerhaven

location	2
location	Veerhaven ZO-hoek
date	20-8-2021
coordinates	X=59991 ; Y=379642
number per m <sup>1</sup>	200
length of deposit	50
surface total	10,000

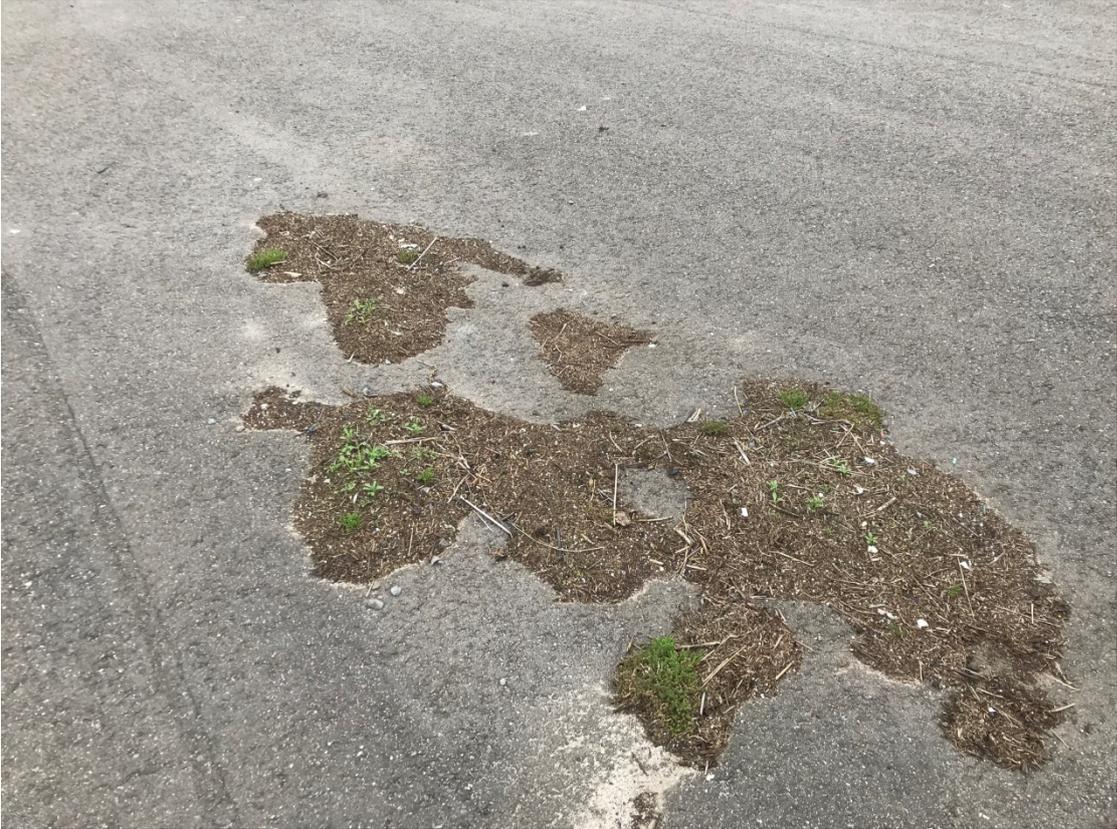
SE-corner Veerhaven (2) the white spiccles on the organic (brown) debris are nurdles

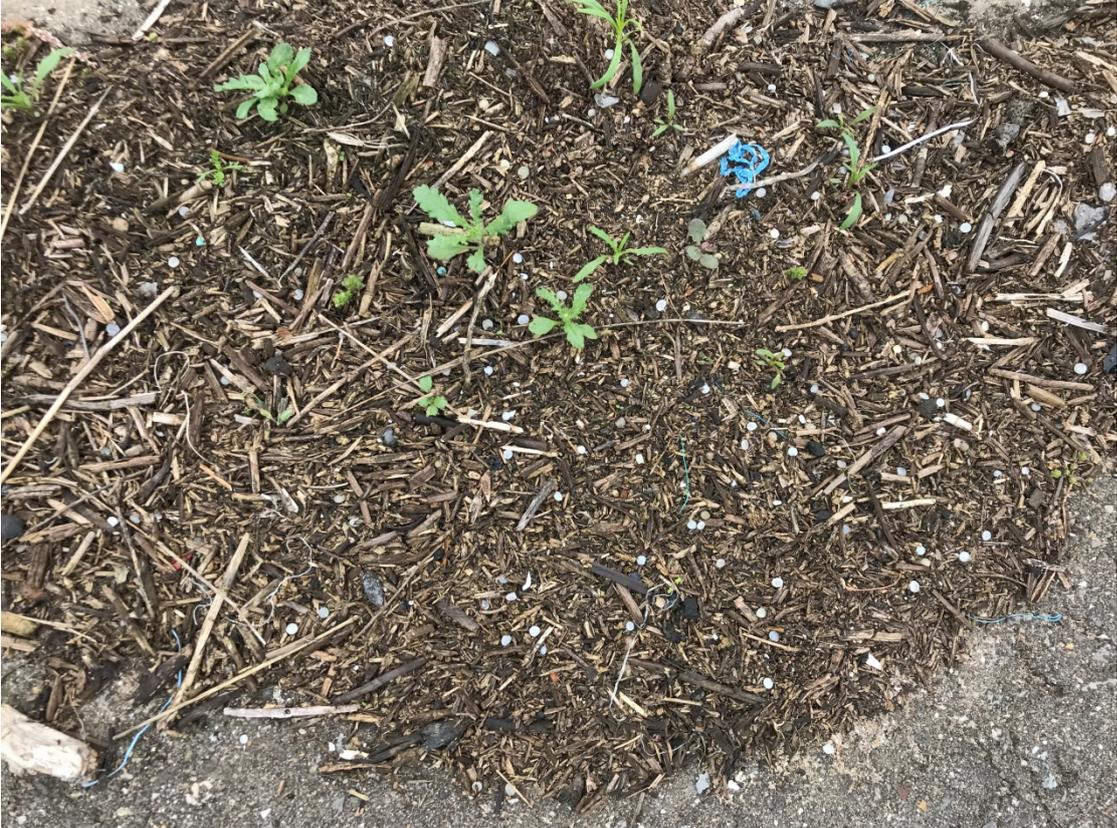
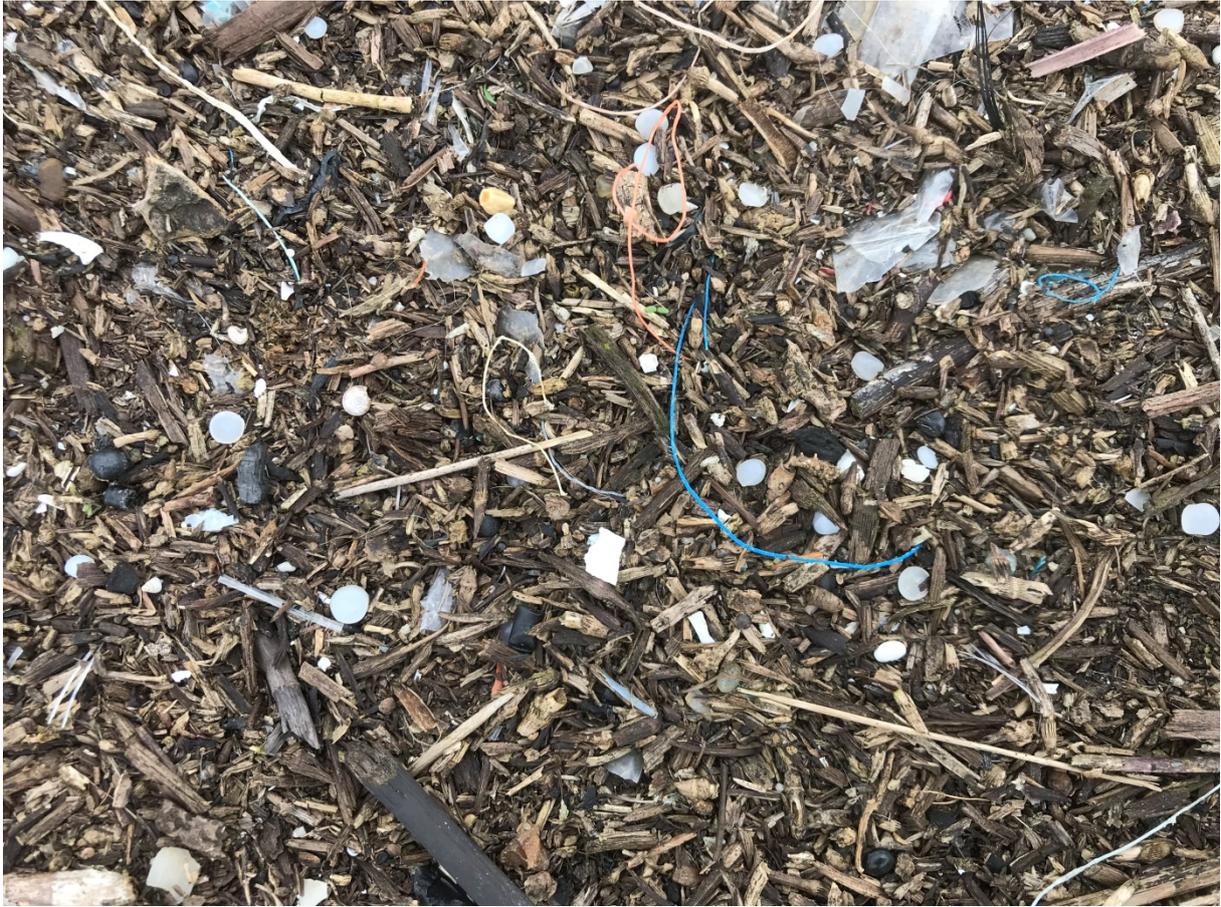
Next picture in more detail

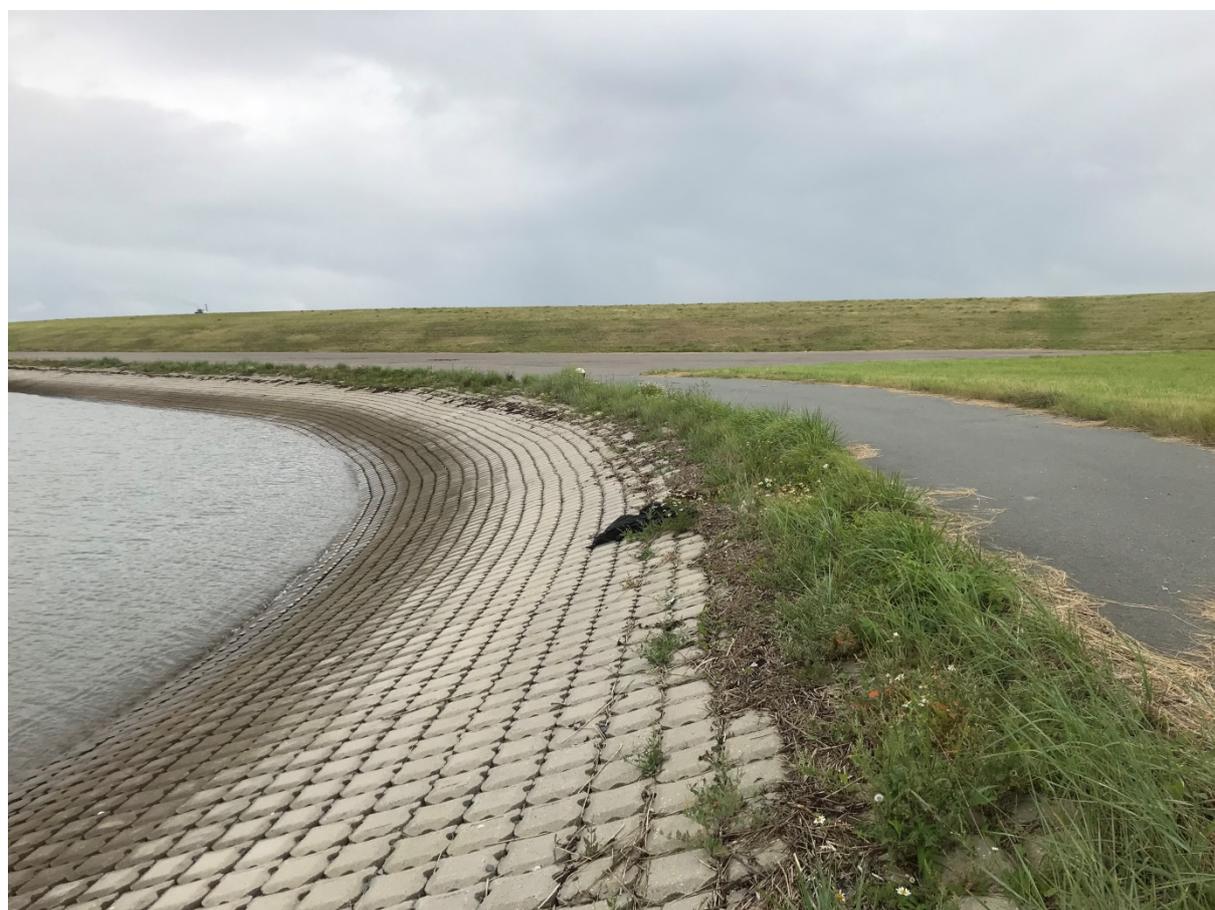
location	3
location	Veerhaven ZW-hoek
date	20-8-2021
coordinates	X=59753 ; Y=379541
number per m <sup>1</sup>	100
length of deposit	50
surface total	5,000

Nurdles idem2

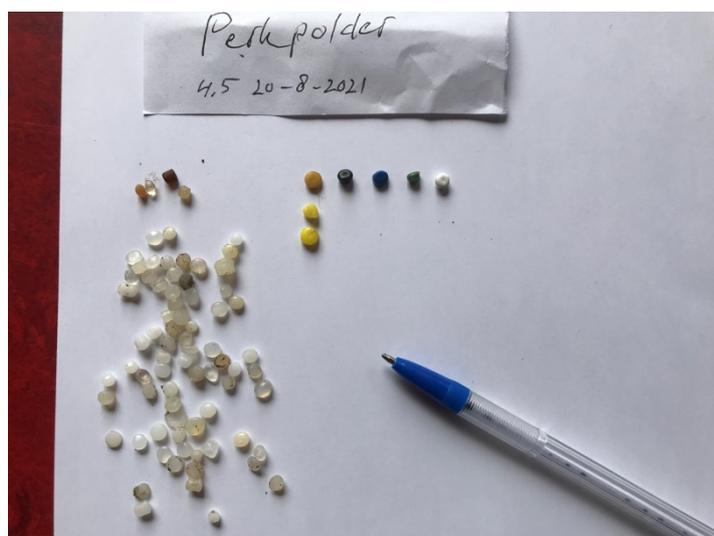
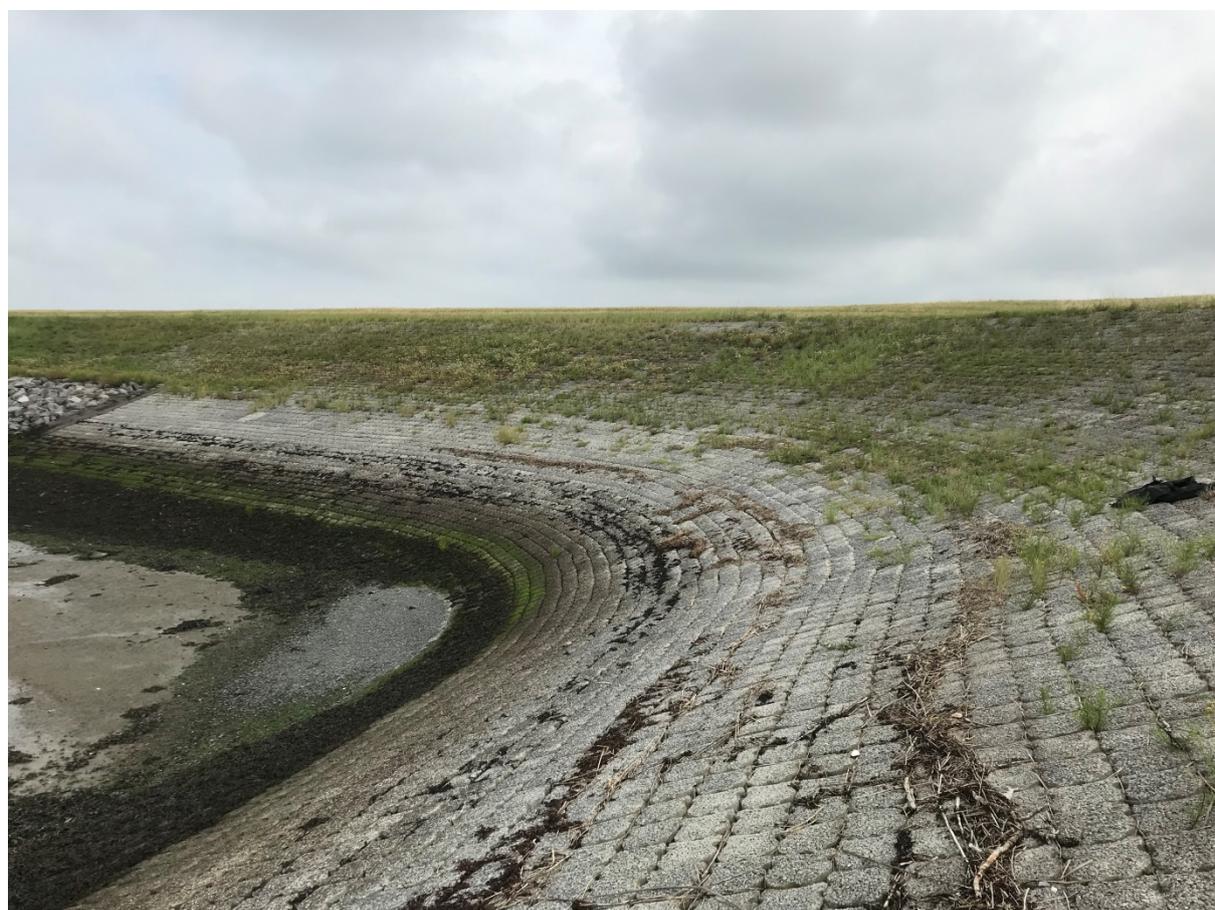
Perkpolder SE-corner

location	4
location	Perkpolder ZO-hoek
date	20-8-2021
coordinates	X=60554 ; Y=378525
number per m <sup>1</sup>	10
length of deposit	50
surface total	250

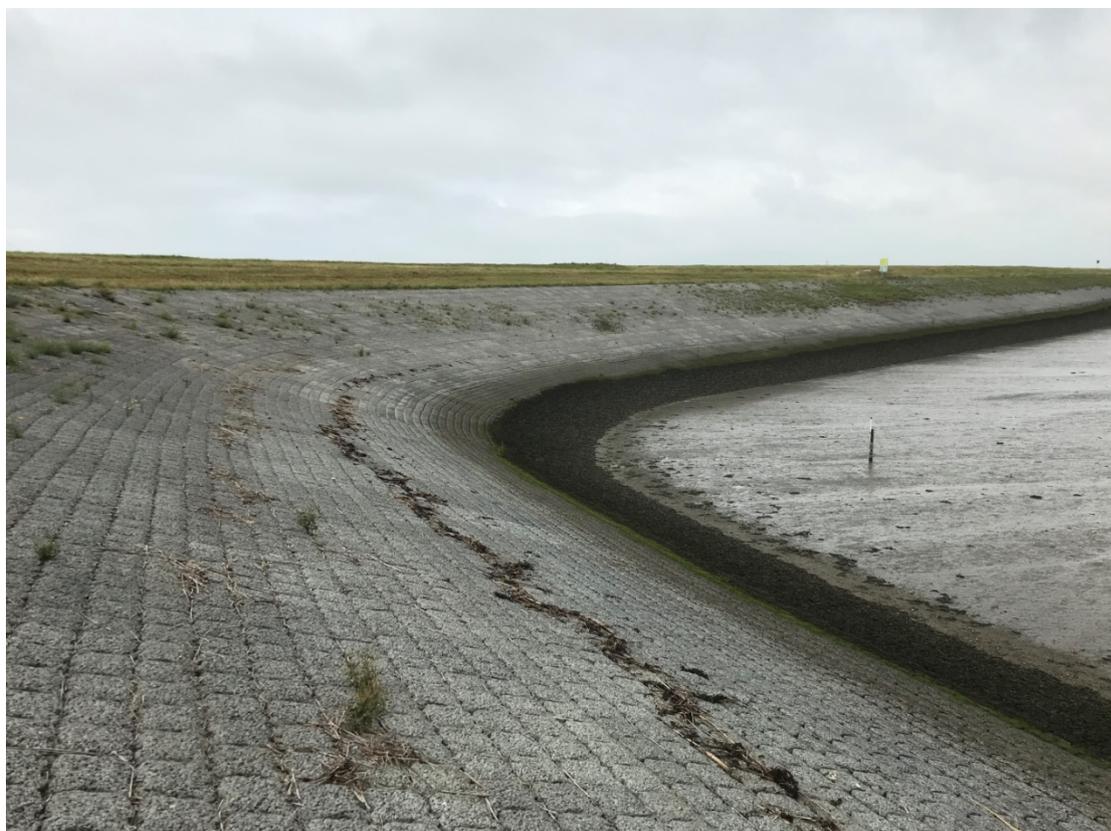
Perkpolder SW-corner

location	5
location	Perkpolder ZW-hoek
date	20-8-2021
coordinates	X=60046 ; Y=378296
number per m <sup>1</sup>	5
length of deposit	25
surface total	125

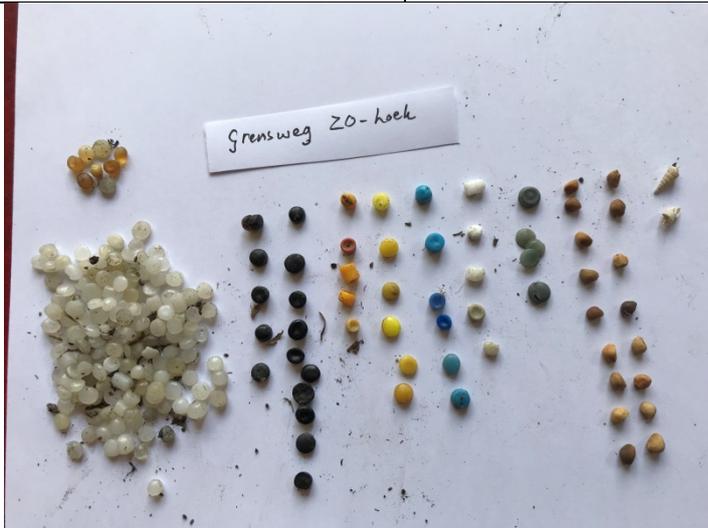
location	
location	Grensweg ZO-hoek
date	17-9-2021
Coordinates (google maps)	X=51.37976 ; Y=4.24575
number per m <sup>1</sup>	100
length of deposits	200
surface total	20,000

Multicolour. The brownish on the right (17) are plant seeds, the white on the right (2) are small shells

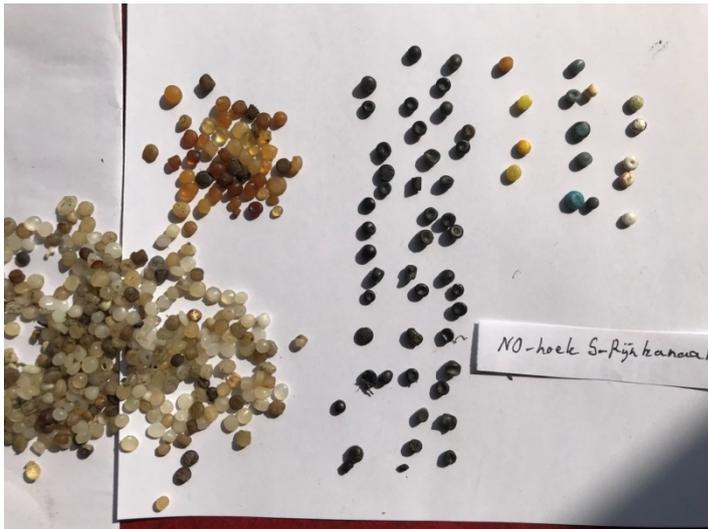
Multicolour. Relatively large amount of UV-nurdles (brown/yellow in upper left corner). Many of the nurdles are degraded: they have been floating around for years.

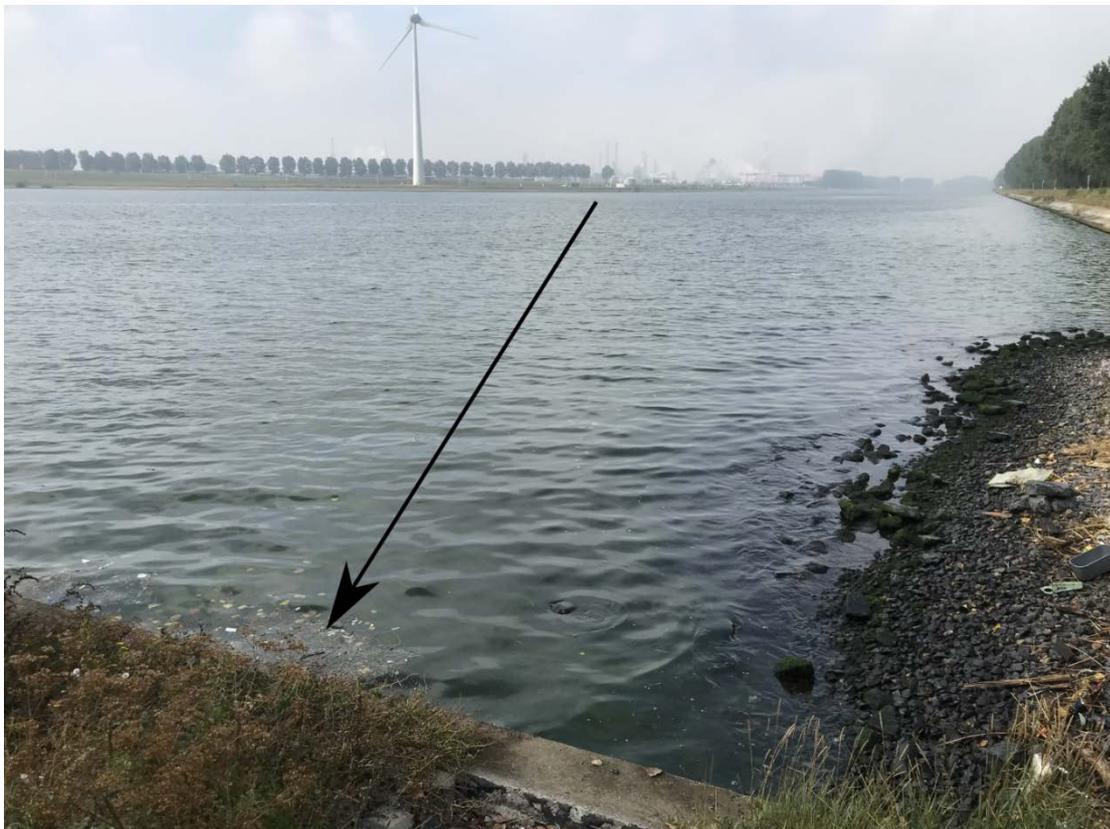
location	
location	Buitenschoor/PSA kaai 193
date	17-9-2021
Coordinates (google maps)	X=51.35571 ; Y=4.25395
number per m <sup>1</sup>	500
length of deposits	600
surface total	300,000

Upper right, indicated by the pen, 3 shells (right), 1 plant seed

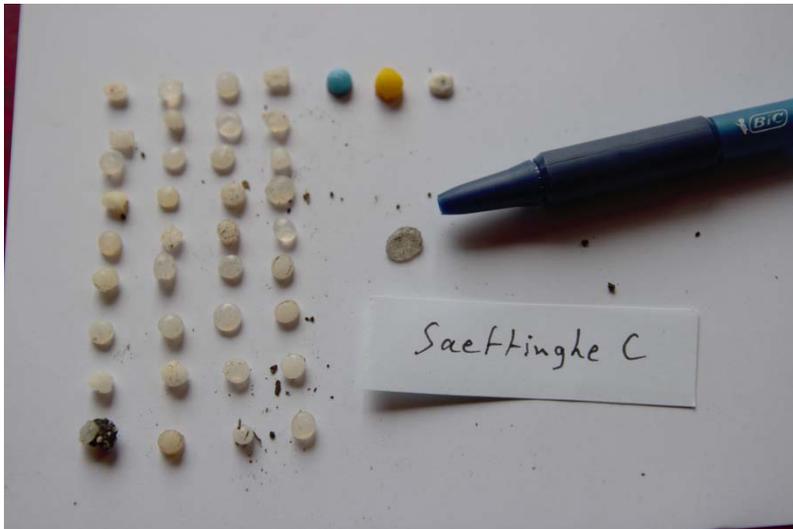
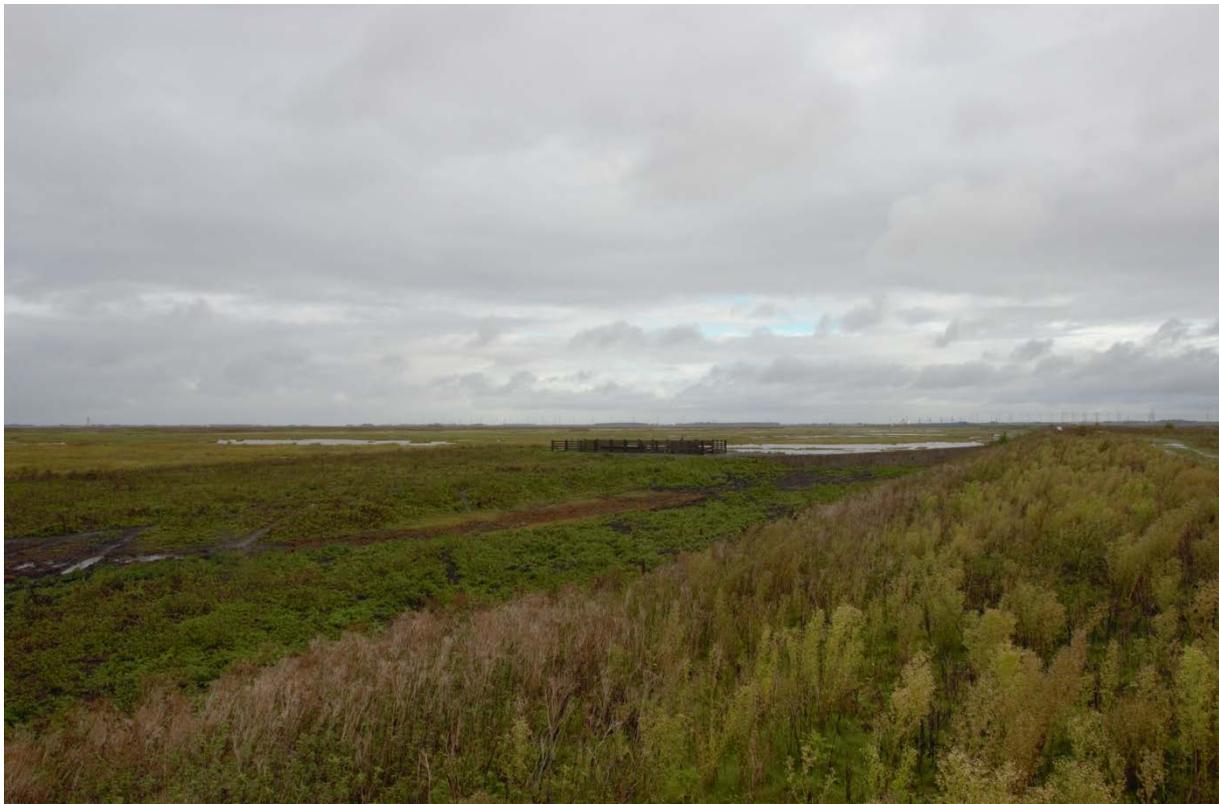
location	
location	Saeftinghe C
date	24-9-2021
Coordinates (google maps)	X=72111 ; Y=373341
number per m <sup>1</sup>	2
length of deposits	100
surface total	200

The flat nurdle indicated by the pen was run over by a tire without air/ high surface pressure like a forklift.

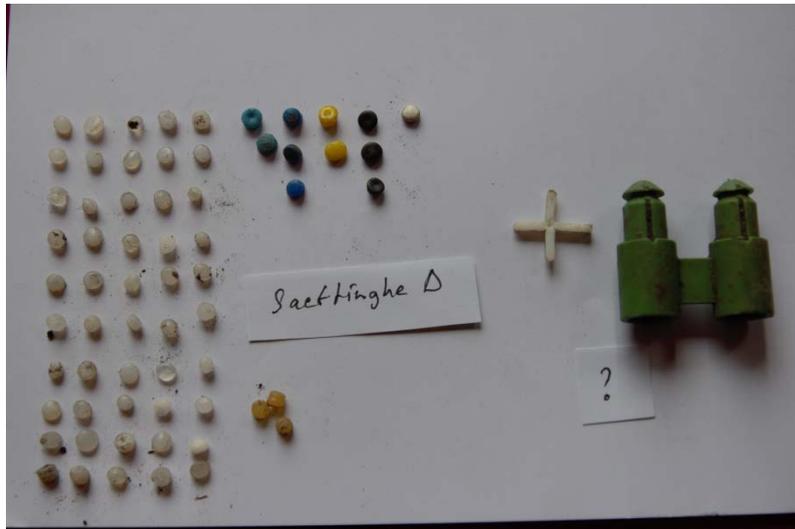
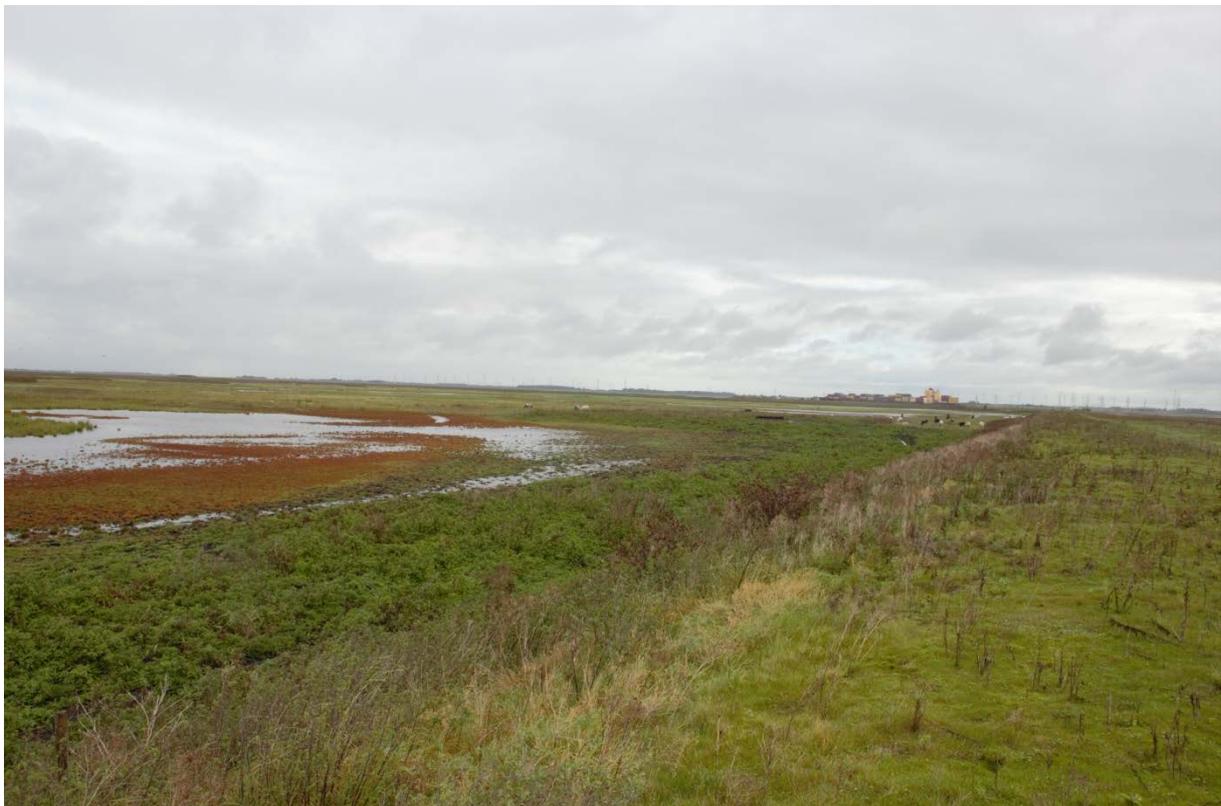
location	
location	Saeftinghe D
date	24-9-2021
Coordinates (google maps)	X=72924 ; Y=374073
number per m <sup>1</sup>	100
length of deposits	100
surface total	10,000

The crosses are used as spacers between terrace tiles and transported in big quantities (like nurdles) as a bulk good or in big bags.

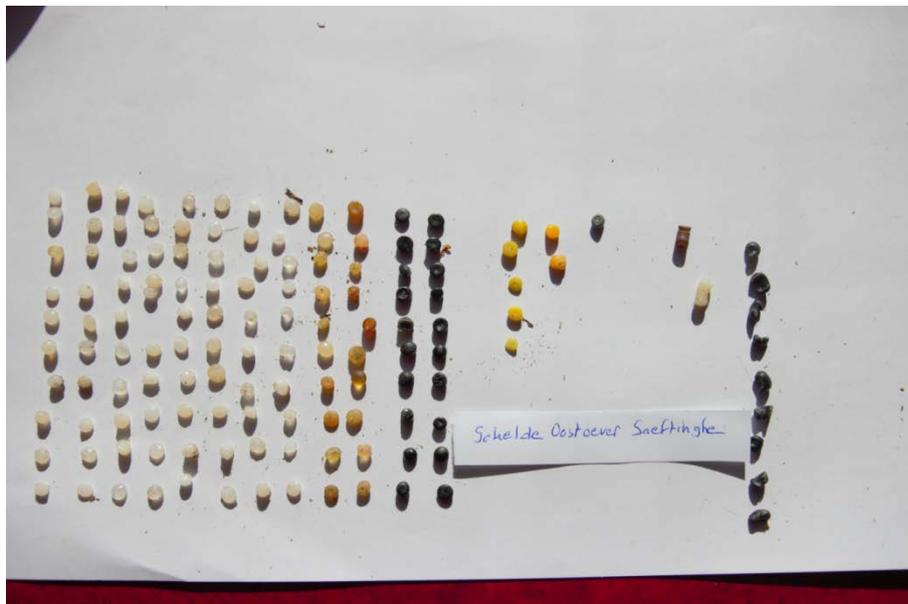
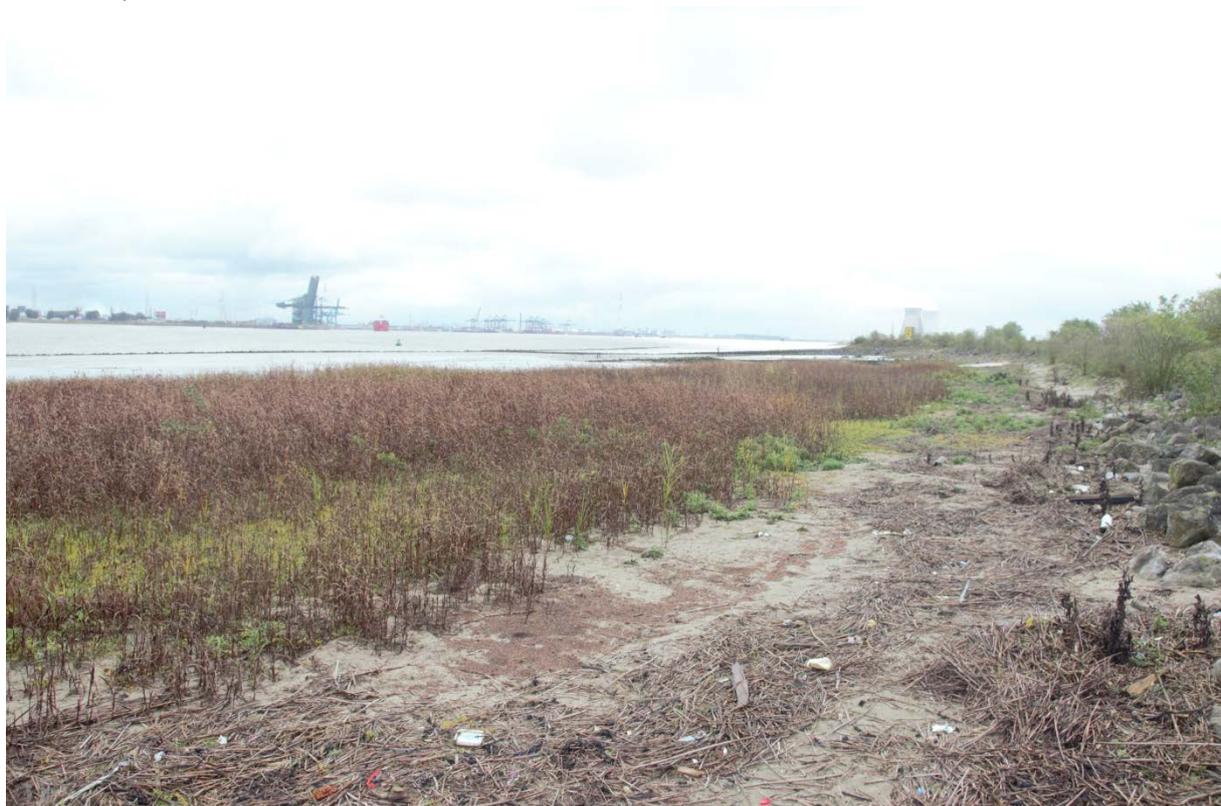
location	
location	Schelde oostoever Saeftinghe F
date	24-9-2021
Coordinates (google maps)	X=73726 ; Y=375064
number per m <sup>1</sup>	500
length of deposits	100
surface total	50,000

Unusual shapes like the comma-form of the nurdles in the right column might give the information needed to trace them back to the producer

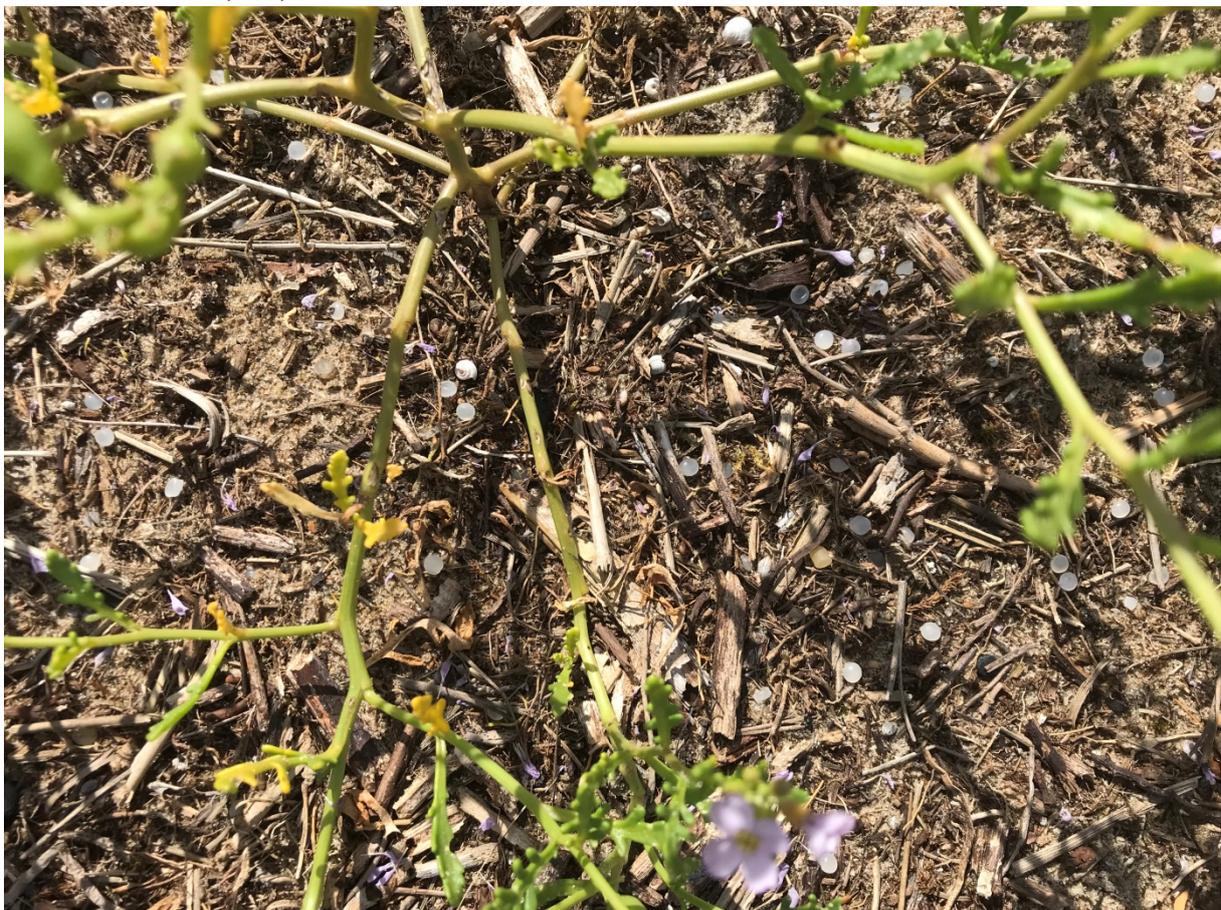
Detail of the spread under the vegetation

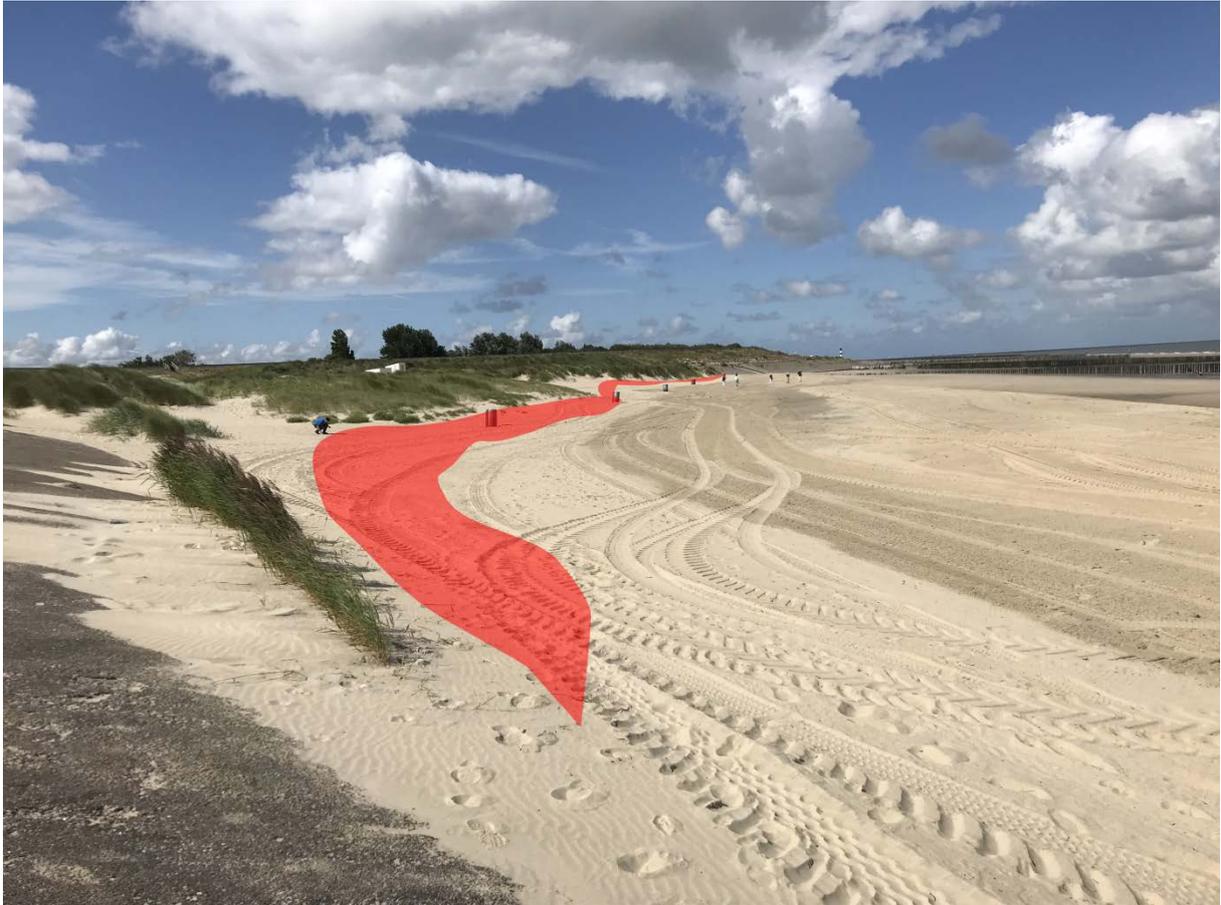
Nurdles were found in the red band on the highest, dry, part of the beach, over a width of about 3 m

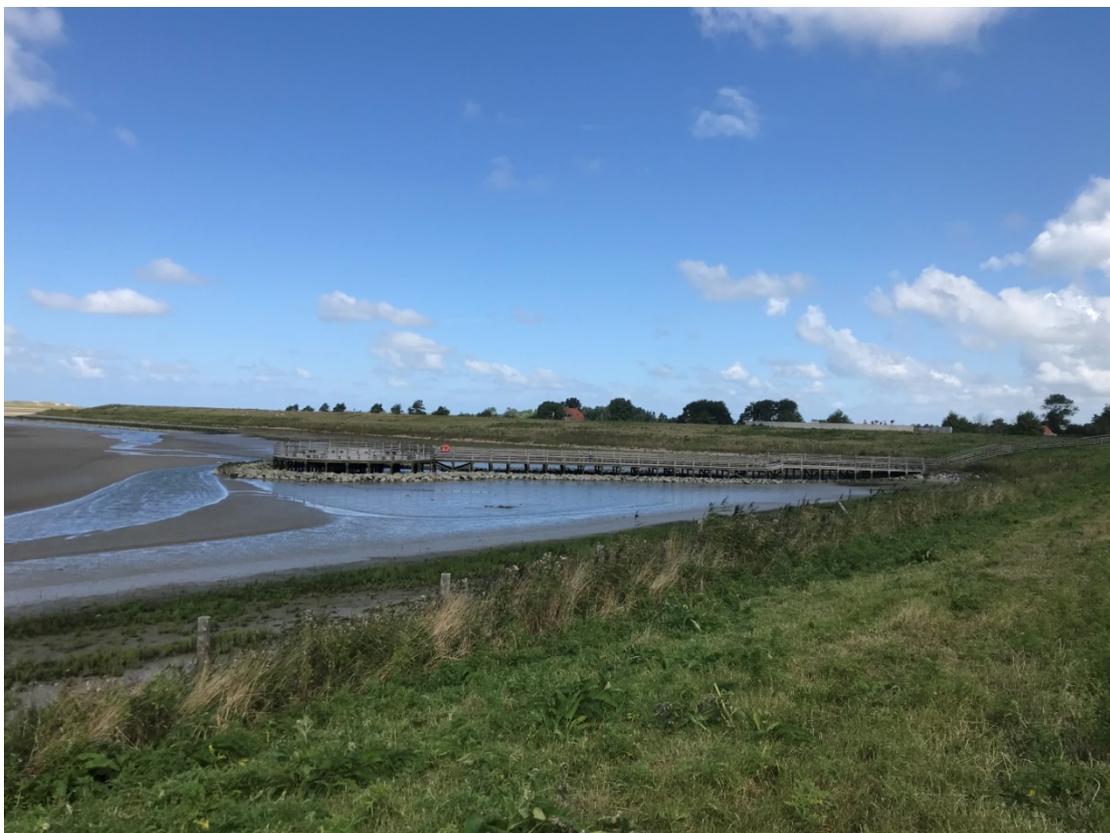
Zwin: Corner west (4 NL). The nurdles were found where the bridge meets the bank

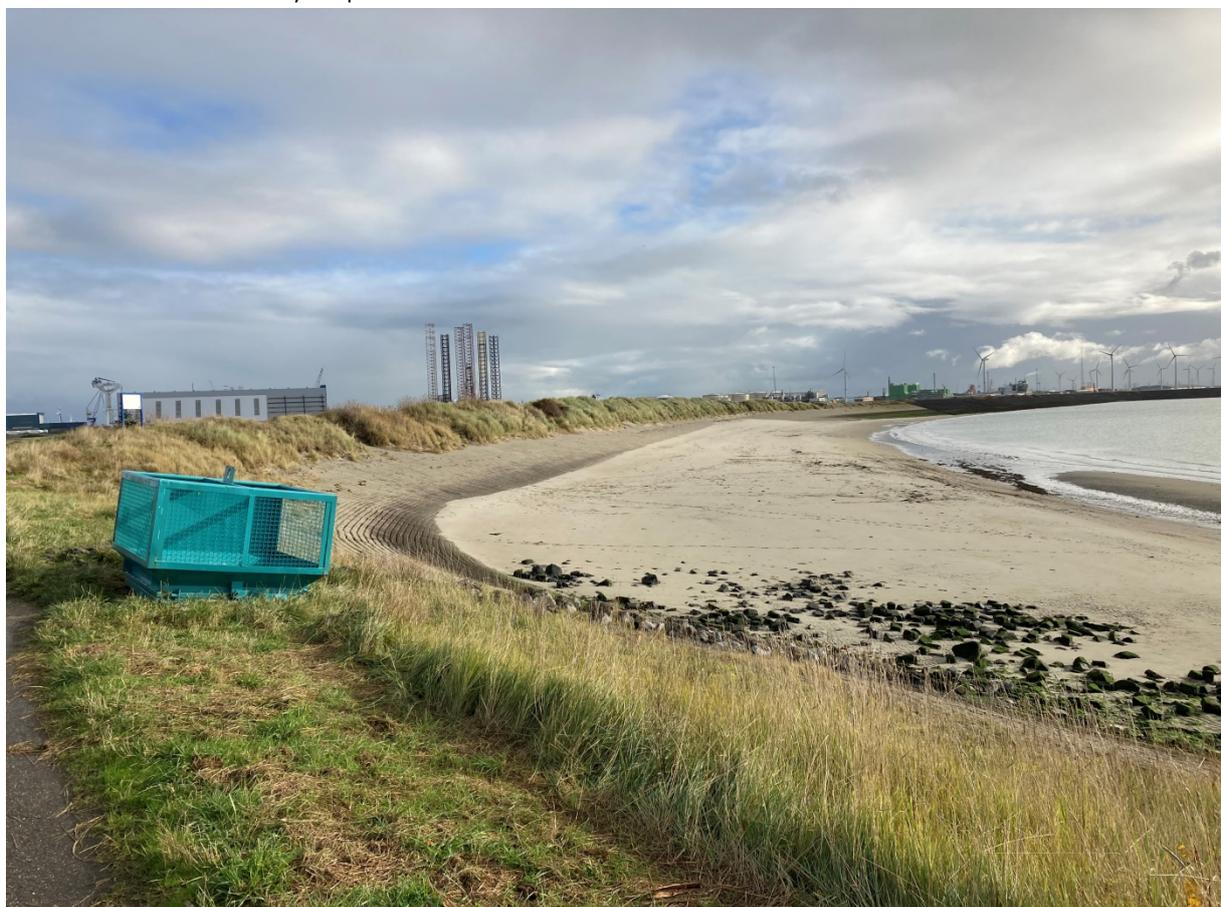
location	
location	Rammekens strekdam strand
date	05-11-2021
Coordinates	X=34874 ; Y=386208
number per m <sup>1</sup>	5
length of deposits	200
surface total	1,000

The 3 flat nurdles indicated by the pencil were run over
