# Westerschelde: plastic nurdles

Sources, transport, deposits

Autumn 2021

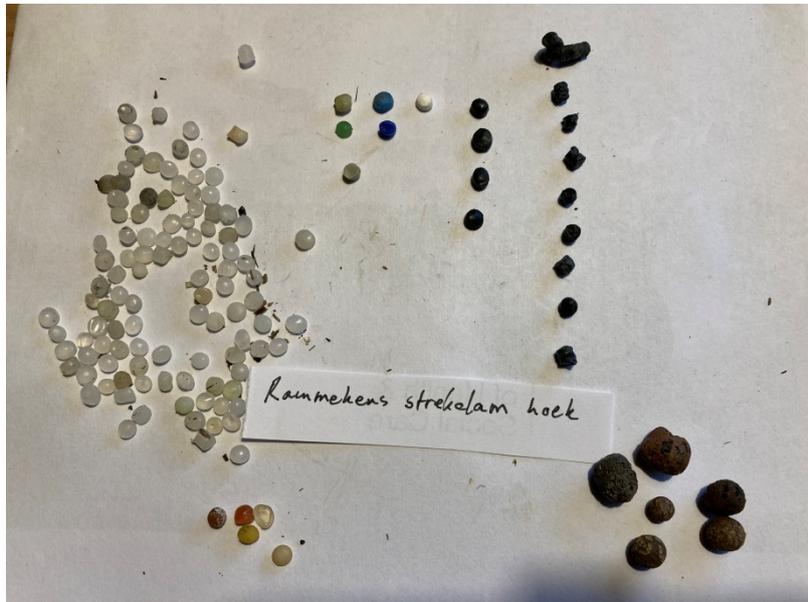
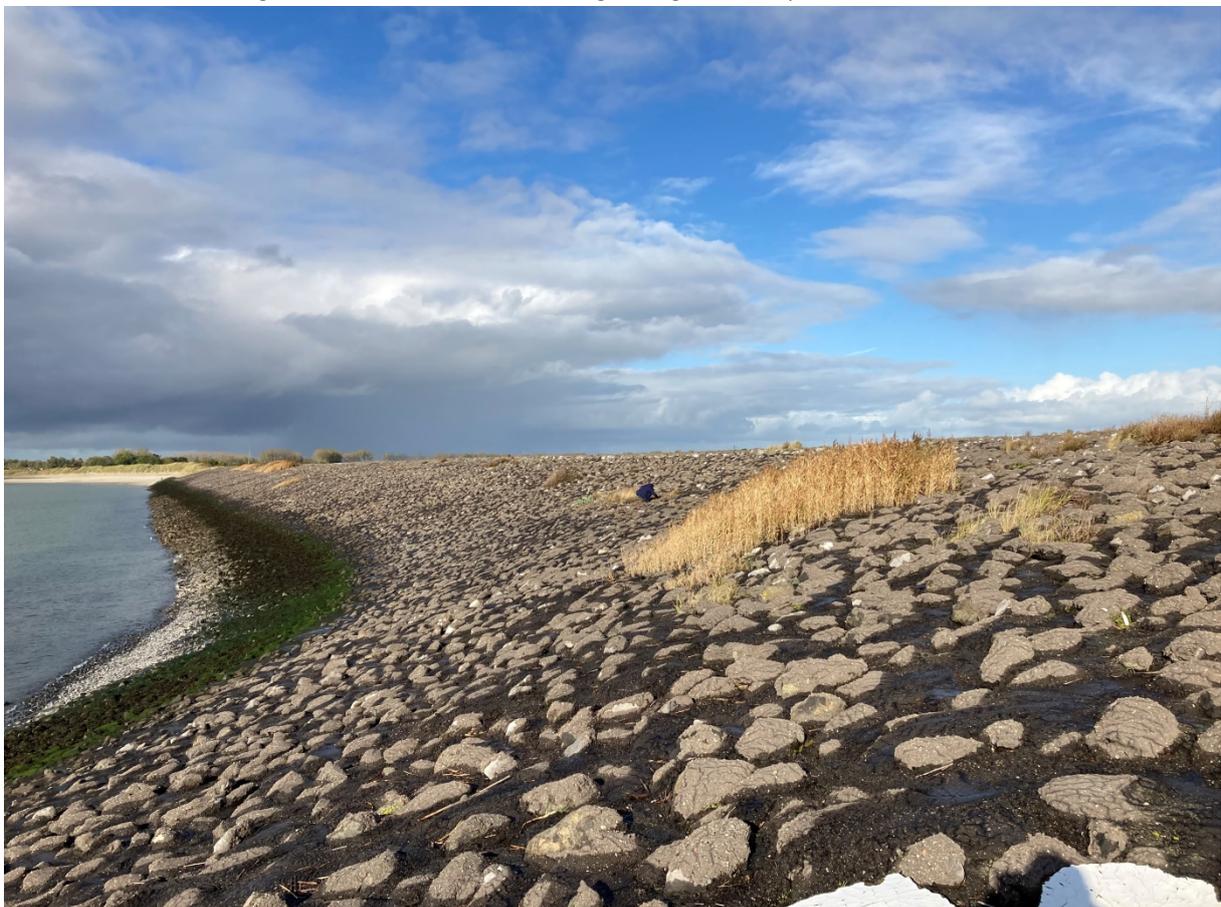
location	
location	Rammekens strekdam hoek
date	05-11-2021
Coordinates	X=35438 ; Y=385912
number per m <sup>1</sup>	corner
length of deposits	-
surface total	5,000

The black nurdles in the right column are Bio Beads. Down right are grains for aquaculture.

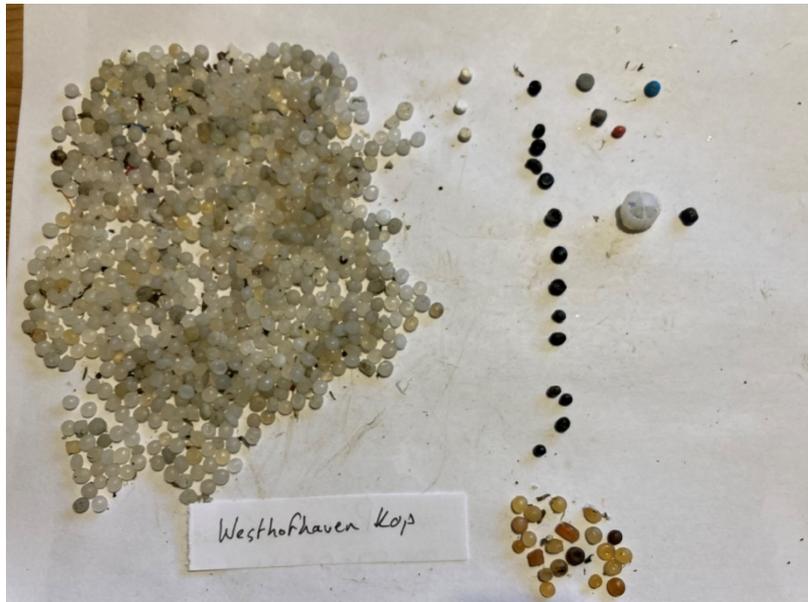
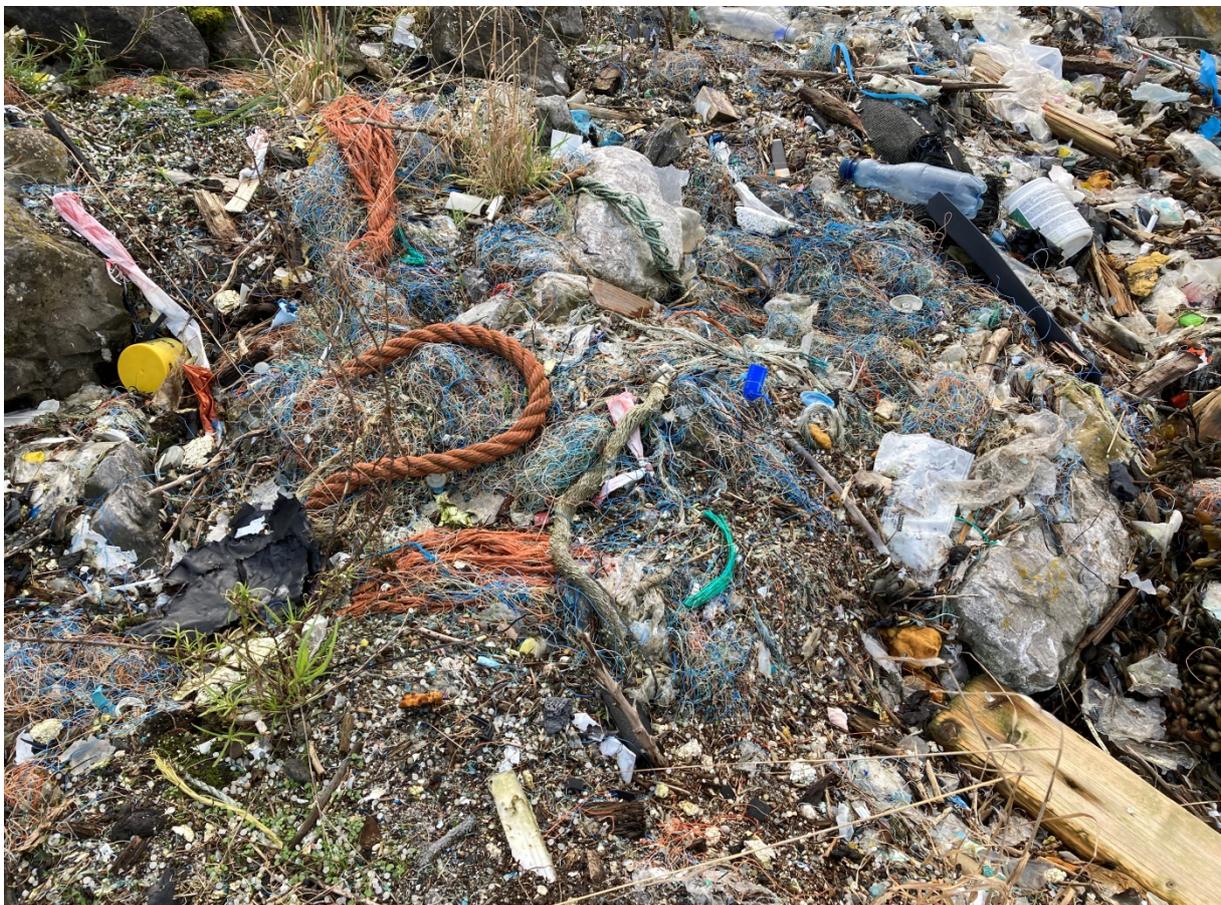
location	
location	Kop Westhofhaven
date	05-11-2021
Coordinates	X=39279 ; Y=388460
number per m <sup>1</sup>	5,000
length of deposits	200
surface total	1,000,000

1 Bio Bead, 1 bio medium

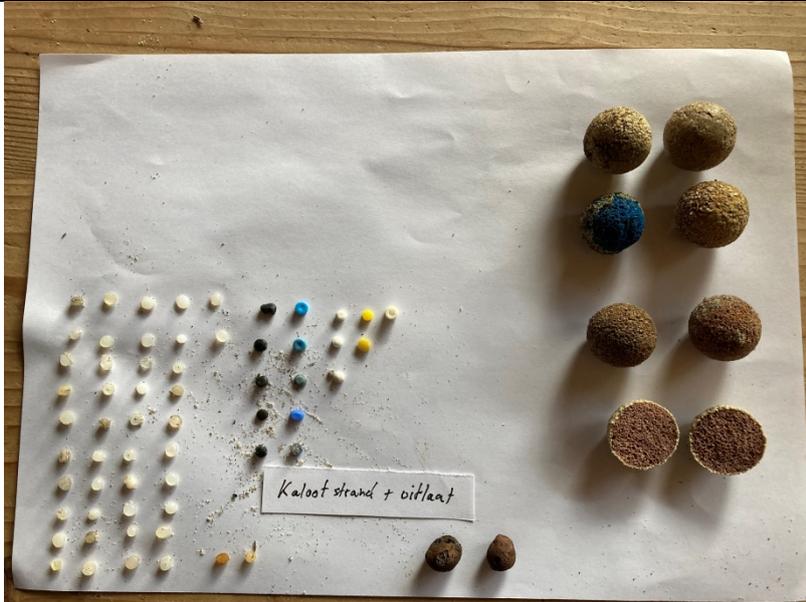
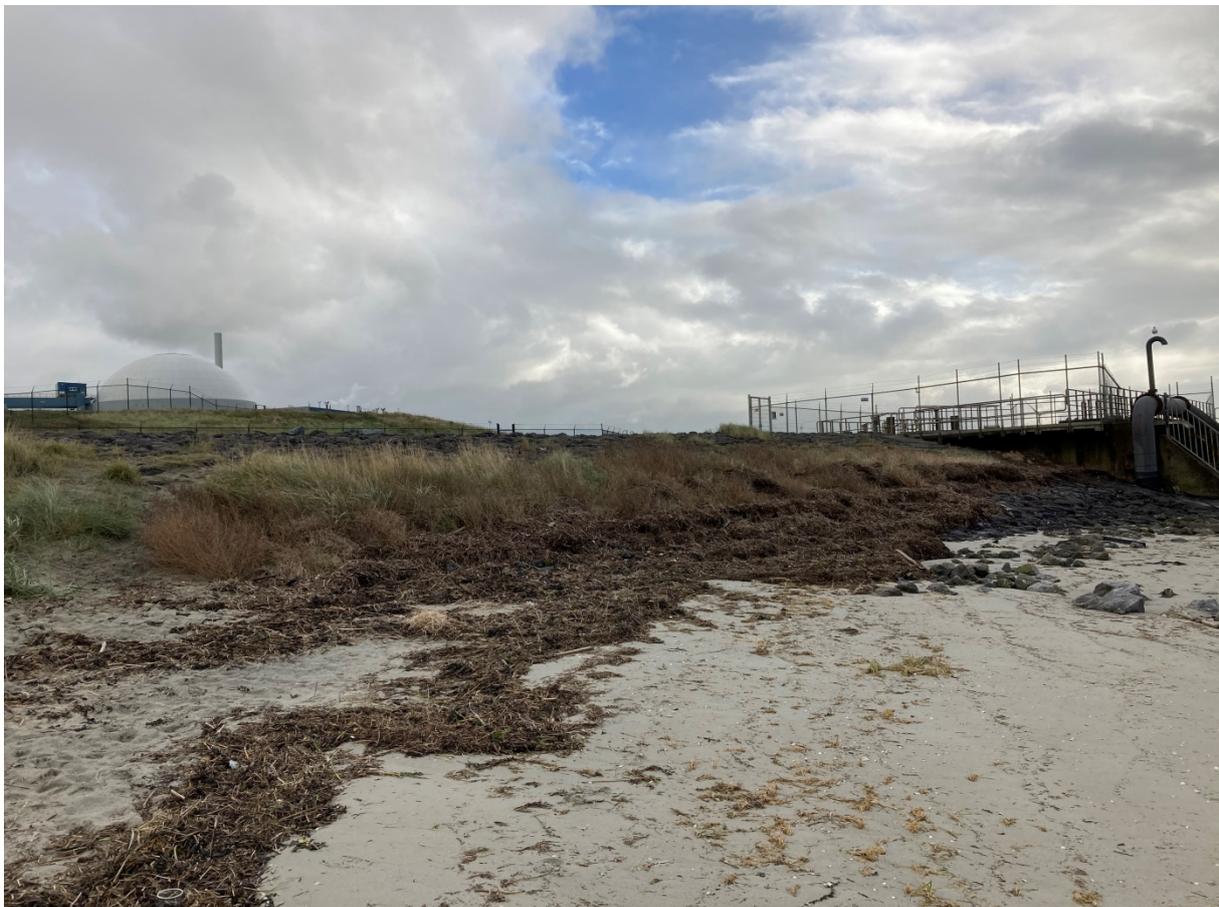
Location	
Location	Kaloot
date	05-11-2021
Coordinates	X=38566 ; Y=383847
number per m <sup>1</sup>	20 + corner
length of deposits	200 + corner outlet
surface total	10,000

The 7 balls on the right are used to blow through (clean) the water pipes of power plants.

Outlet (right) power plant EPZ Borssele . Could be the source for the balls. Sloecentrale is another power plant.

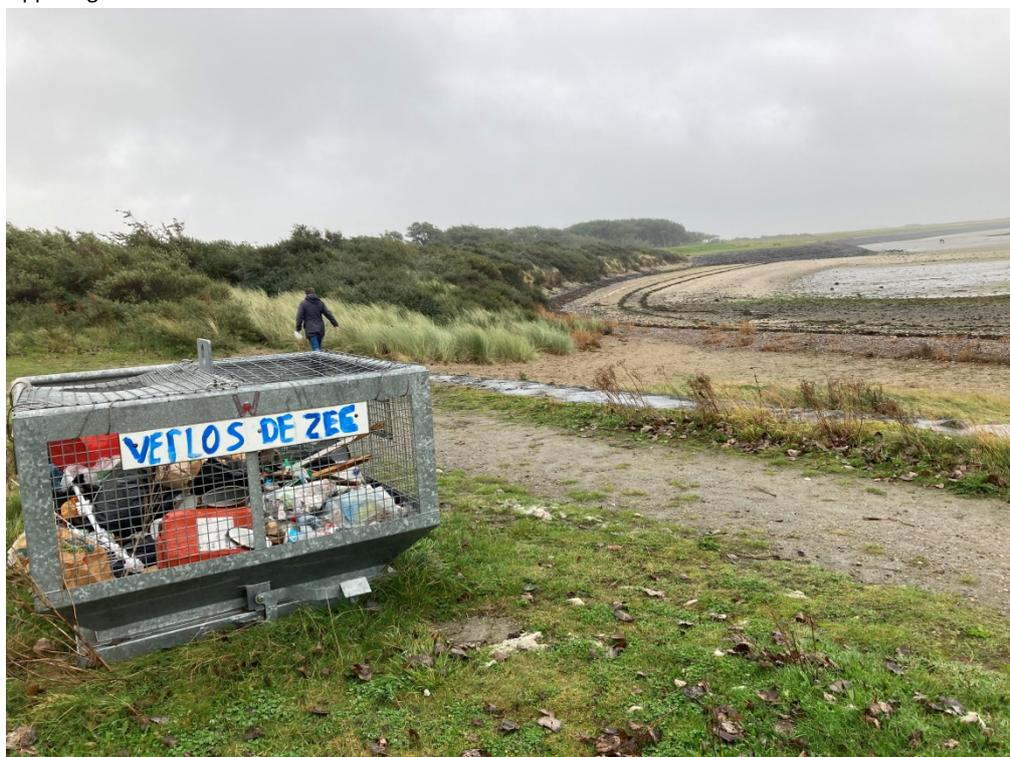
location	O3
location	Schelphoek Fritureluur
date	19-10-2021
Coordinates	X=46169 ; Y=413286
number per m <sup>1</sup>	10
length of deposits	10
surface total	100

Upper right 4 Bio Beads

Nurdles always come together with other plastics

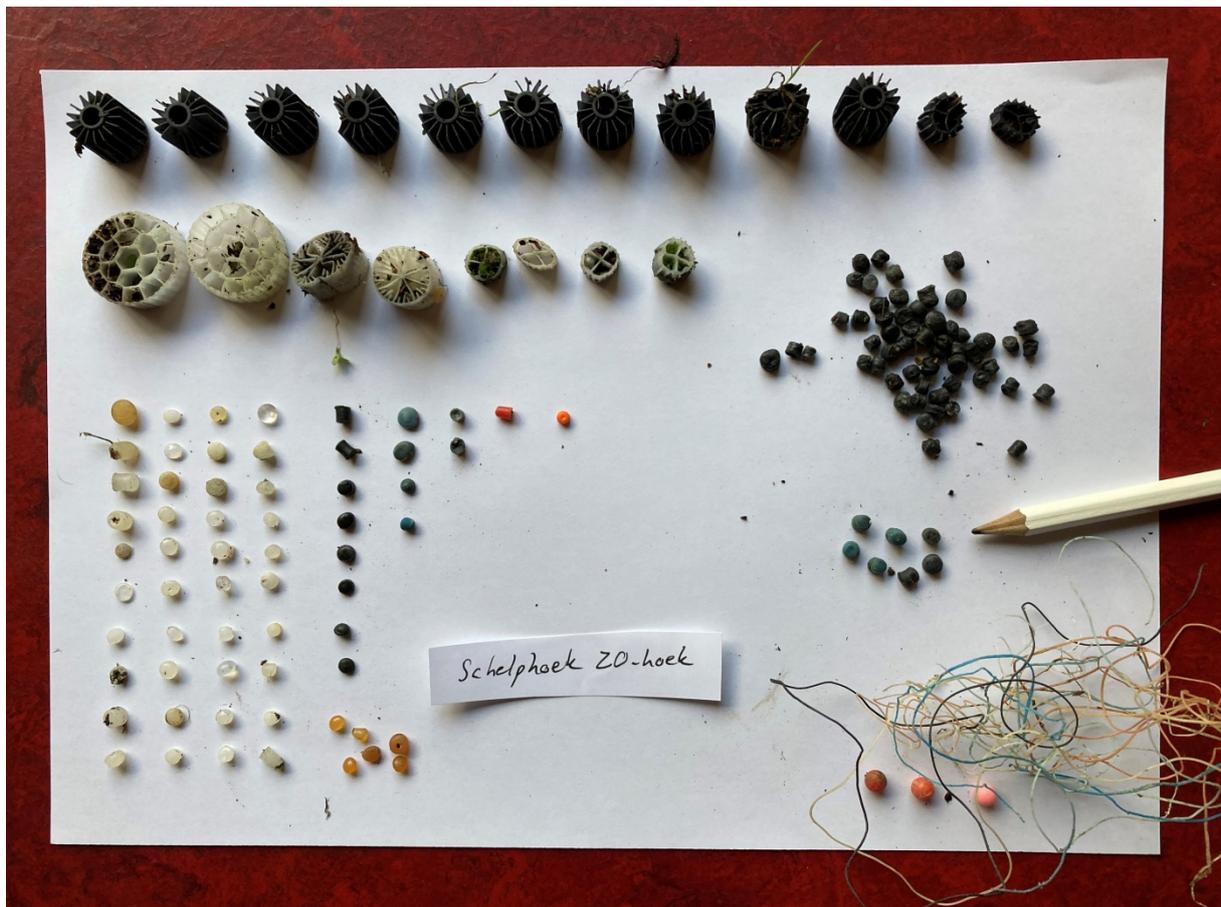
The upper two rows are Bio Media used in water purification. According to 'omroep Zeeland' the upper row (black) originate from Kingfish at Colijnsplaat

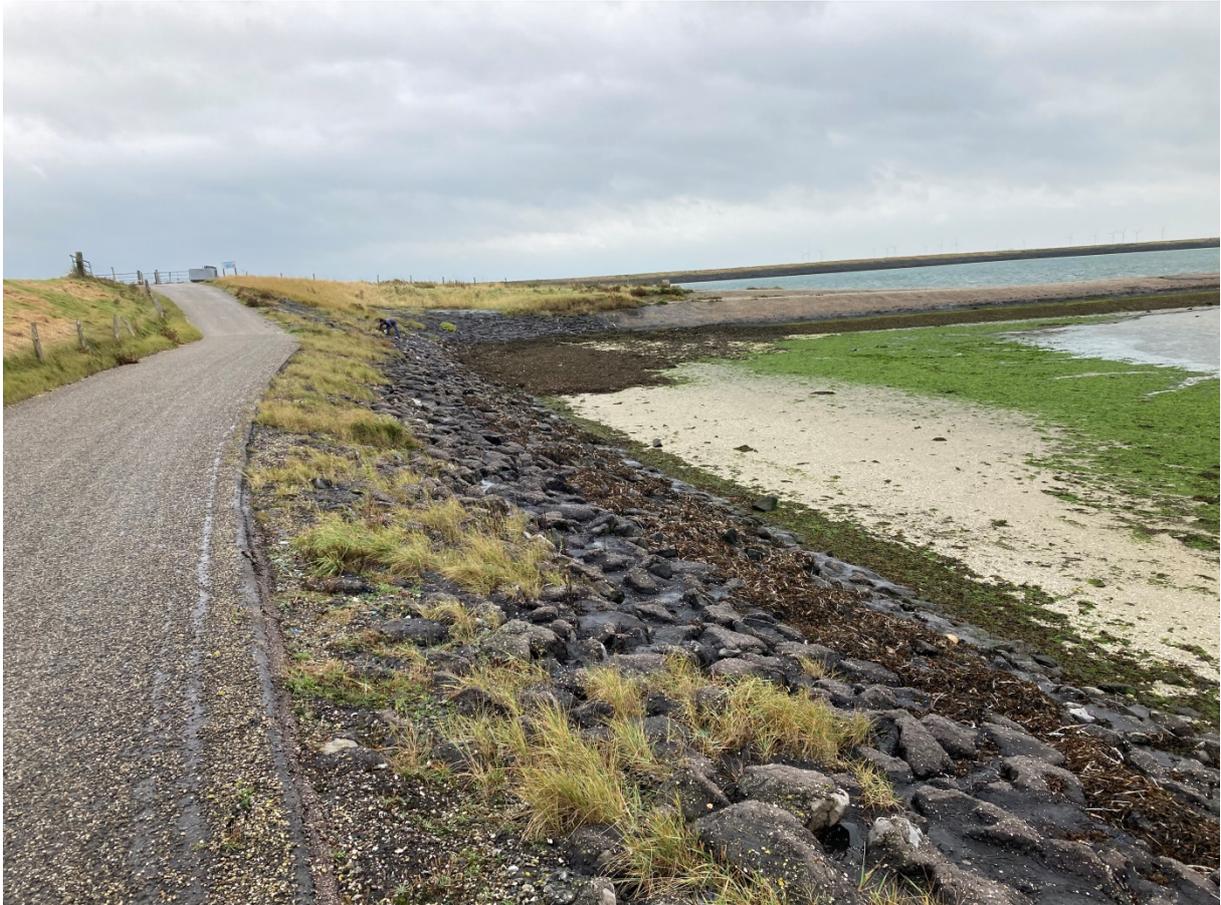
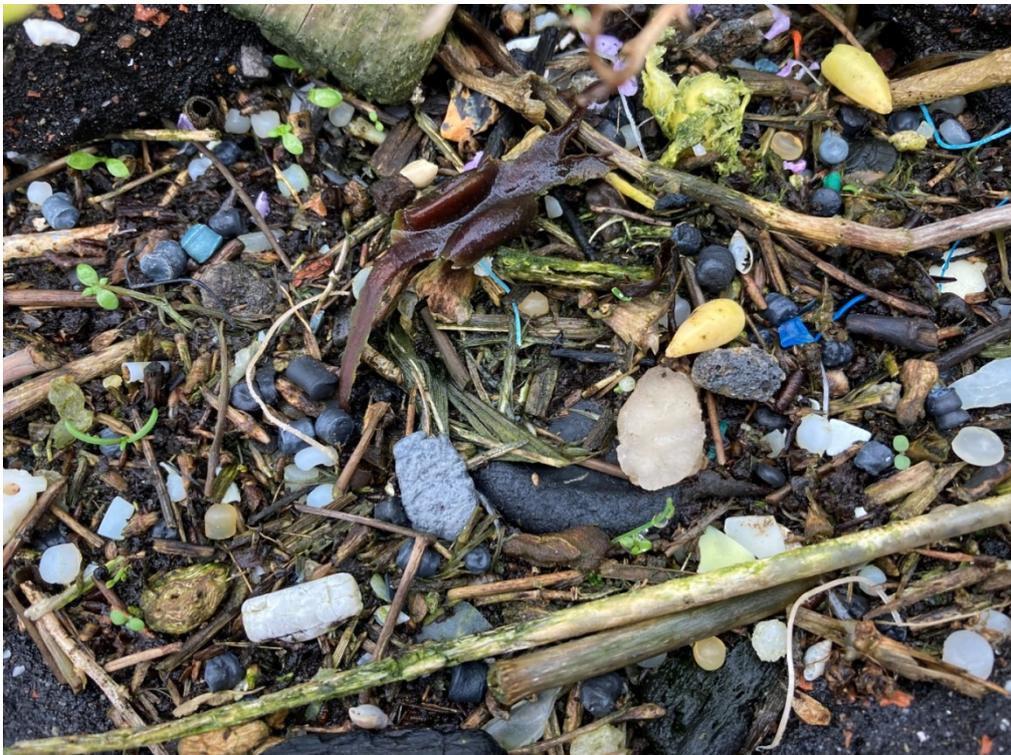
location	O4/5
location	Schelphoek ZO-hoeken (2)
date	19-10-2021
Coordinates	X=47012 ; Y=412098 X=46866 ; Y=411761
number per m <sup>1</sup>	100
length of deposits	100 + corner
surface total	10,000 + 10,000

The pencil points at what seem to be blue and grey Bio Beads. Above the pencil 'normal' black Bio Beads. Downright 3 BB-gun balls (ammunition of a children's toy).

Detail Schelphoek: nurdles south east corners

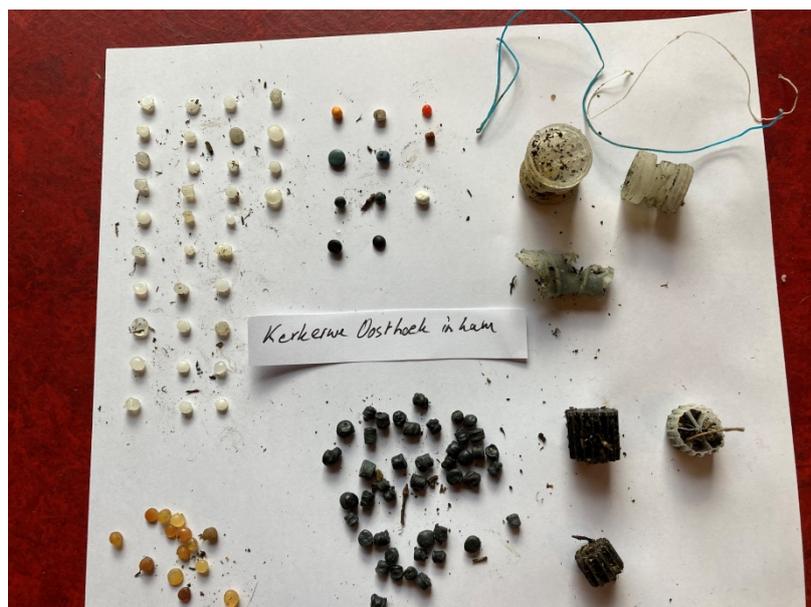
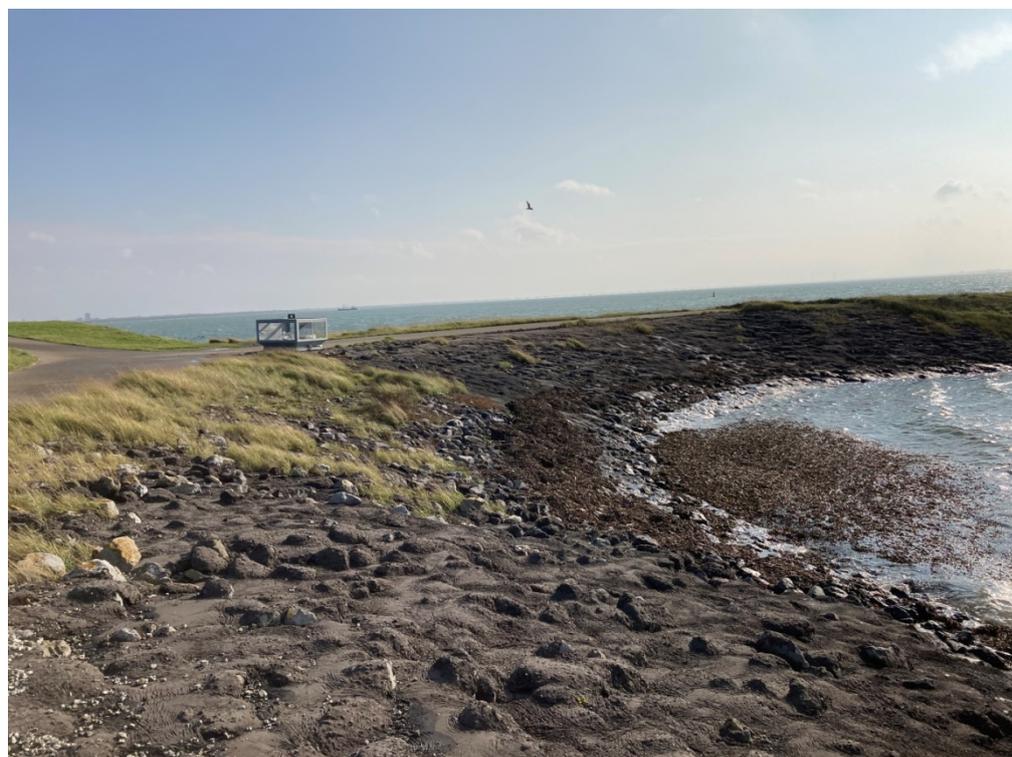
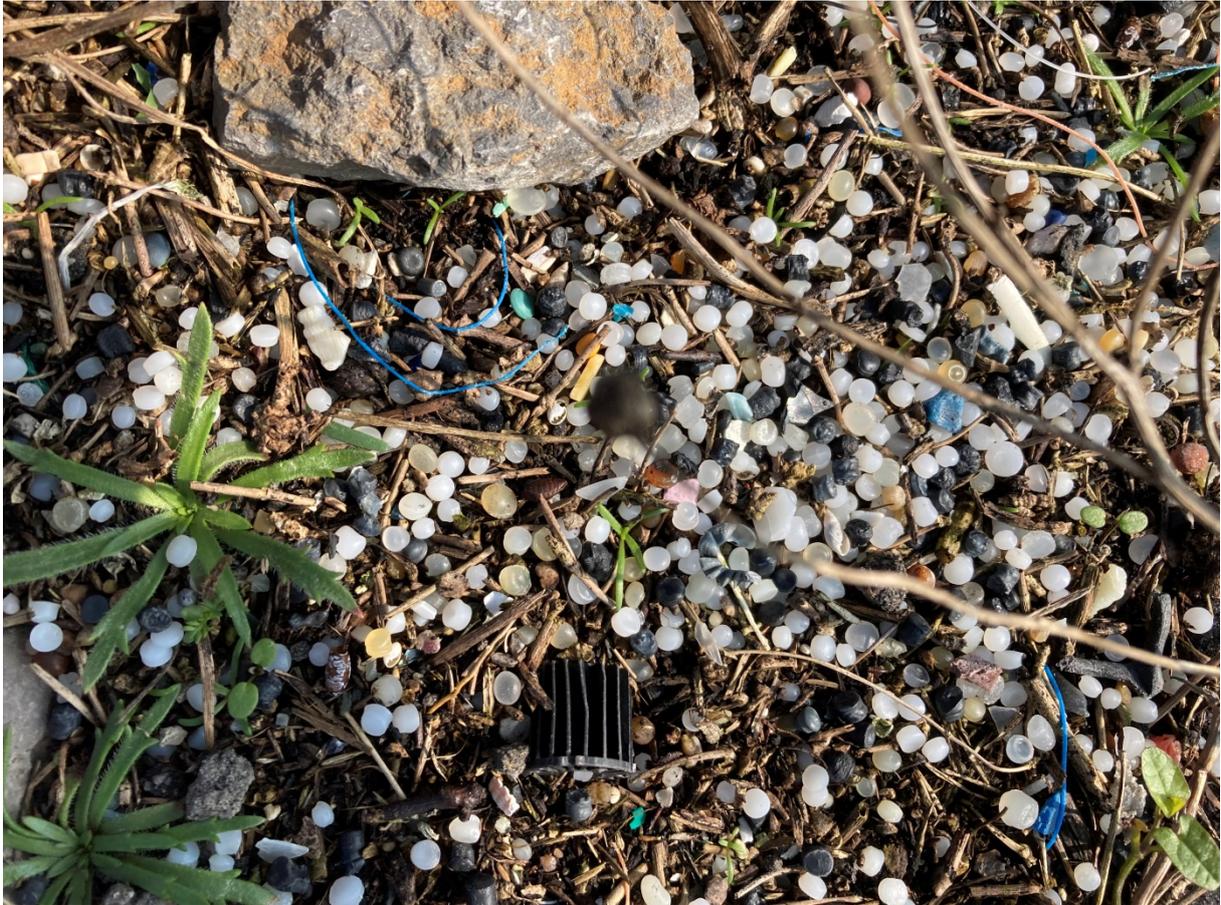
location	O7
location	Kerkerwe Oosthoek
date	19-10-2021
Coordinates	X=48702 ; Y=410931
number per m <sup>1</sup>	-
length of deposits	corner
surface total	10,000

Detail Kerkerwe 19-10-2021: This location was cleaned up thoroughly in December 2020.

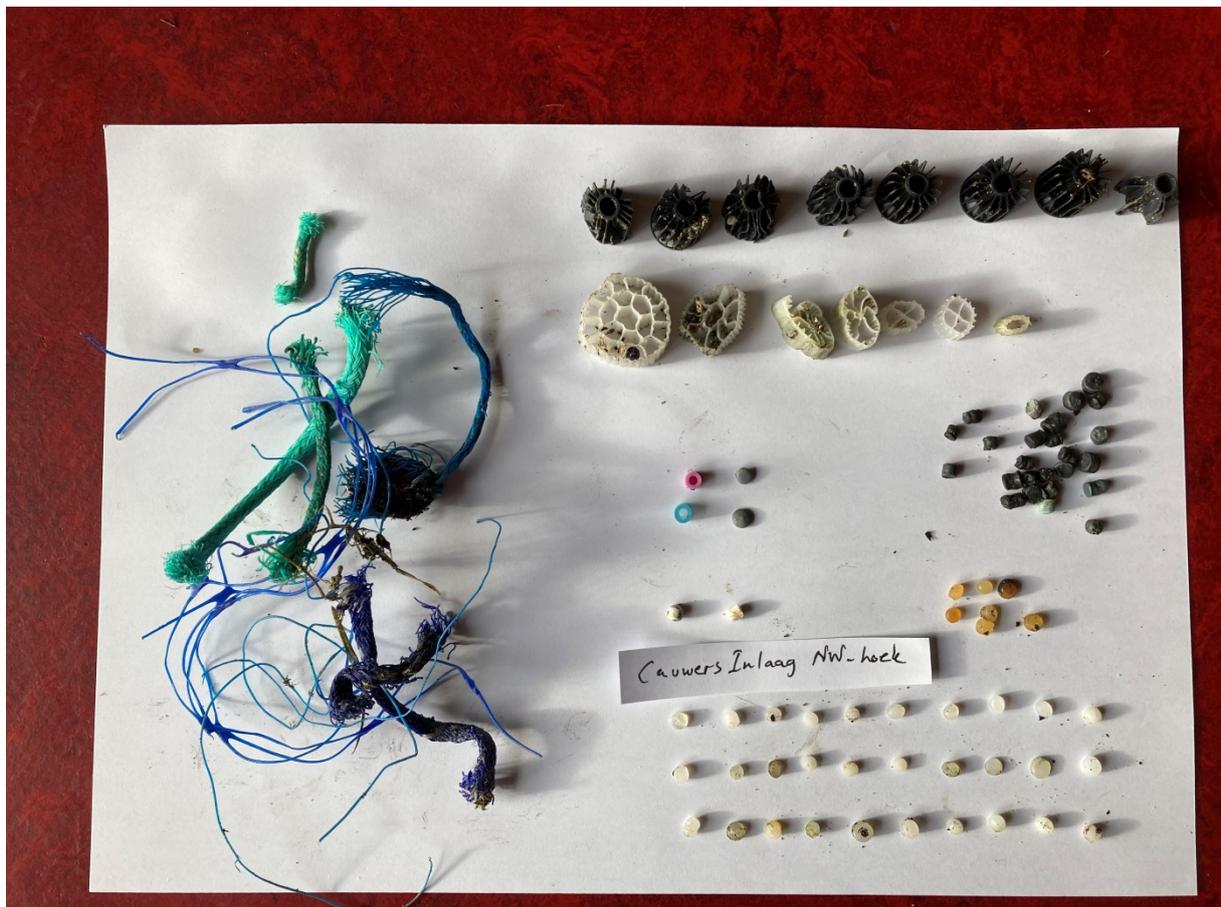
On the left found at all locations: plastic from the fisheries.

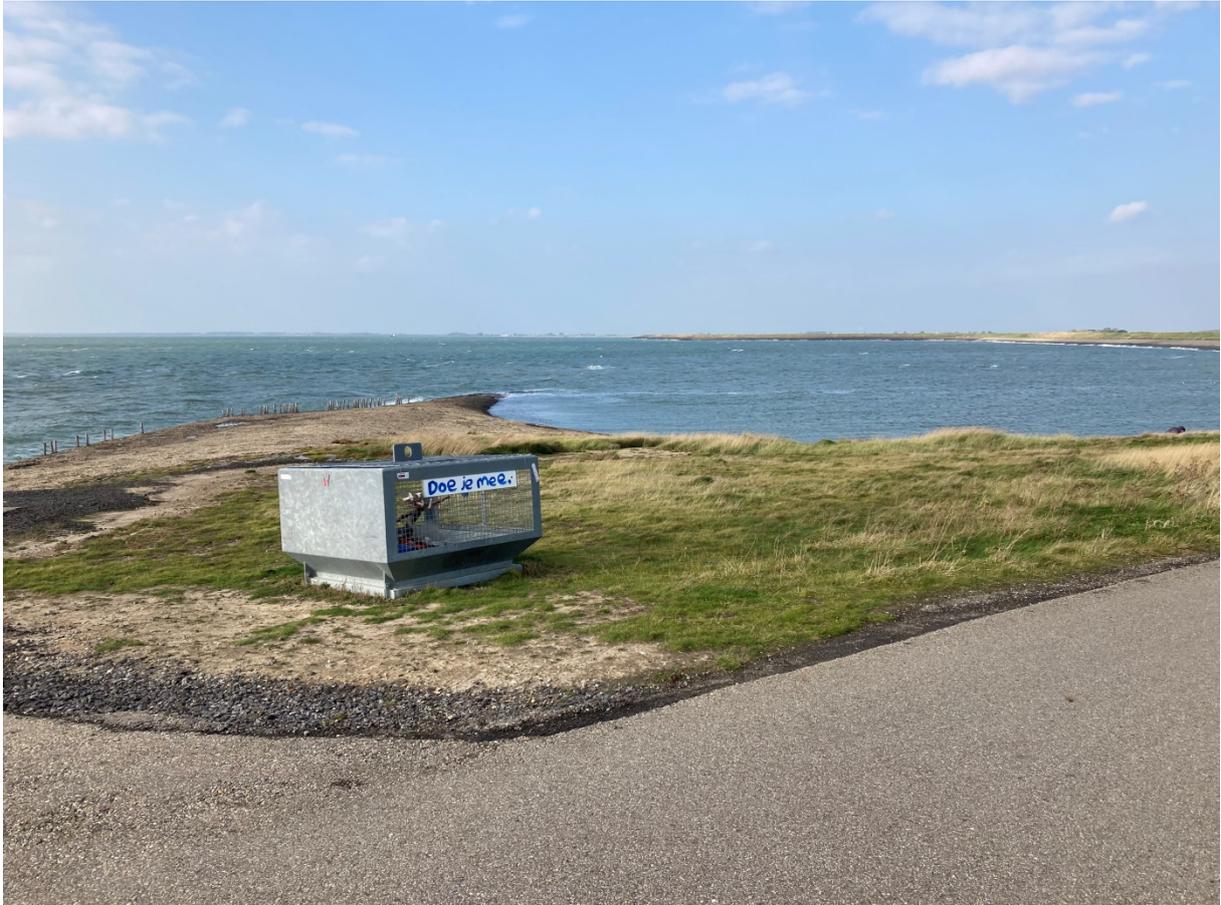
Cauwers Inlaag NW-corner

Upper right two rows, bio media for water purification. Polluting water with water purification is an anomaly.

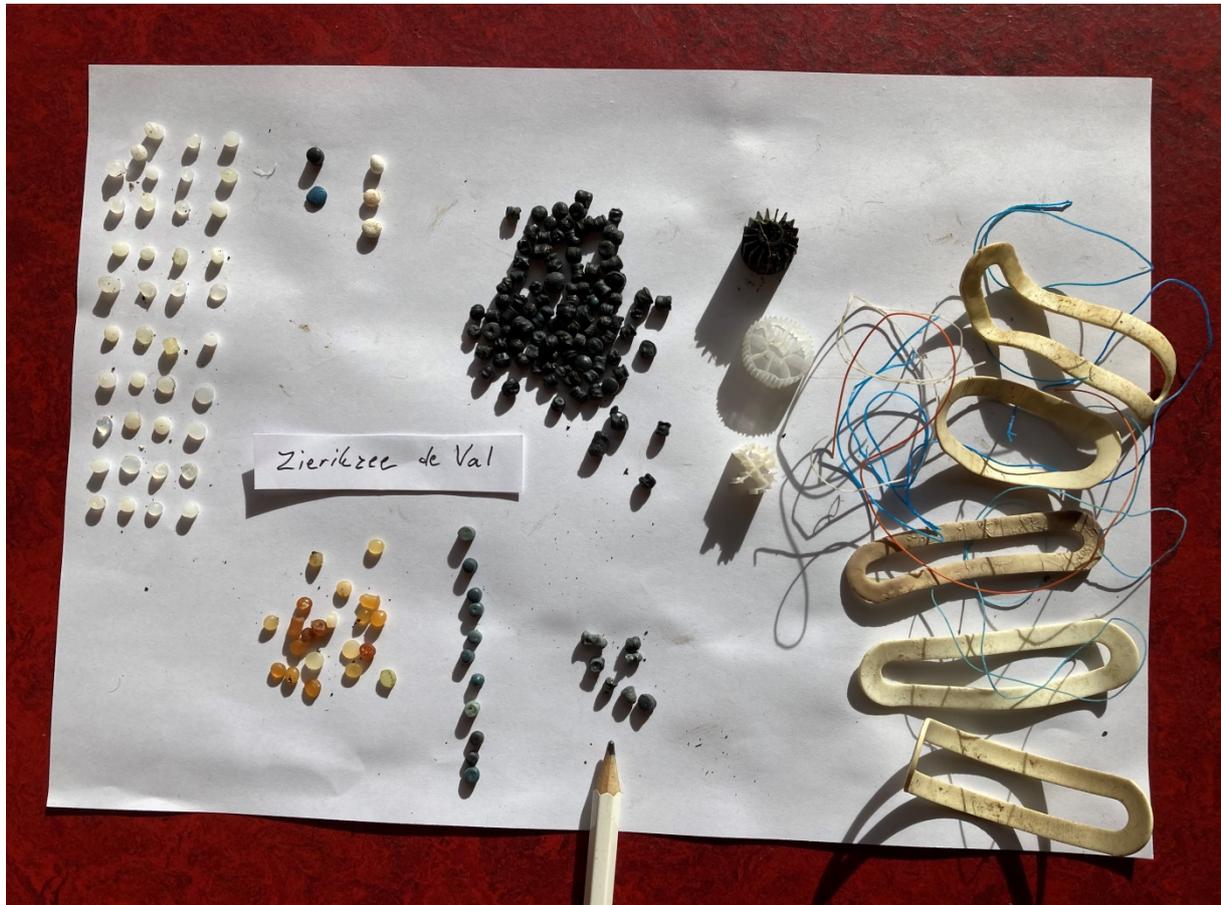
location	O11
location	Zierikzee de Val
date	20-10-2021
Coordinates	X=53842 ; Y=405630
number per m <sup>1</sup>	-
length of deposits	Corner
surface total	50,000

At the right: 'the fisheries'

In the middle: water pollution/purification. The pencil is points towards blue/gray Bio Beads. In comparison with the Westerschelde the number of Bio Beads is large and is 'deeper' in the estuary.

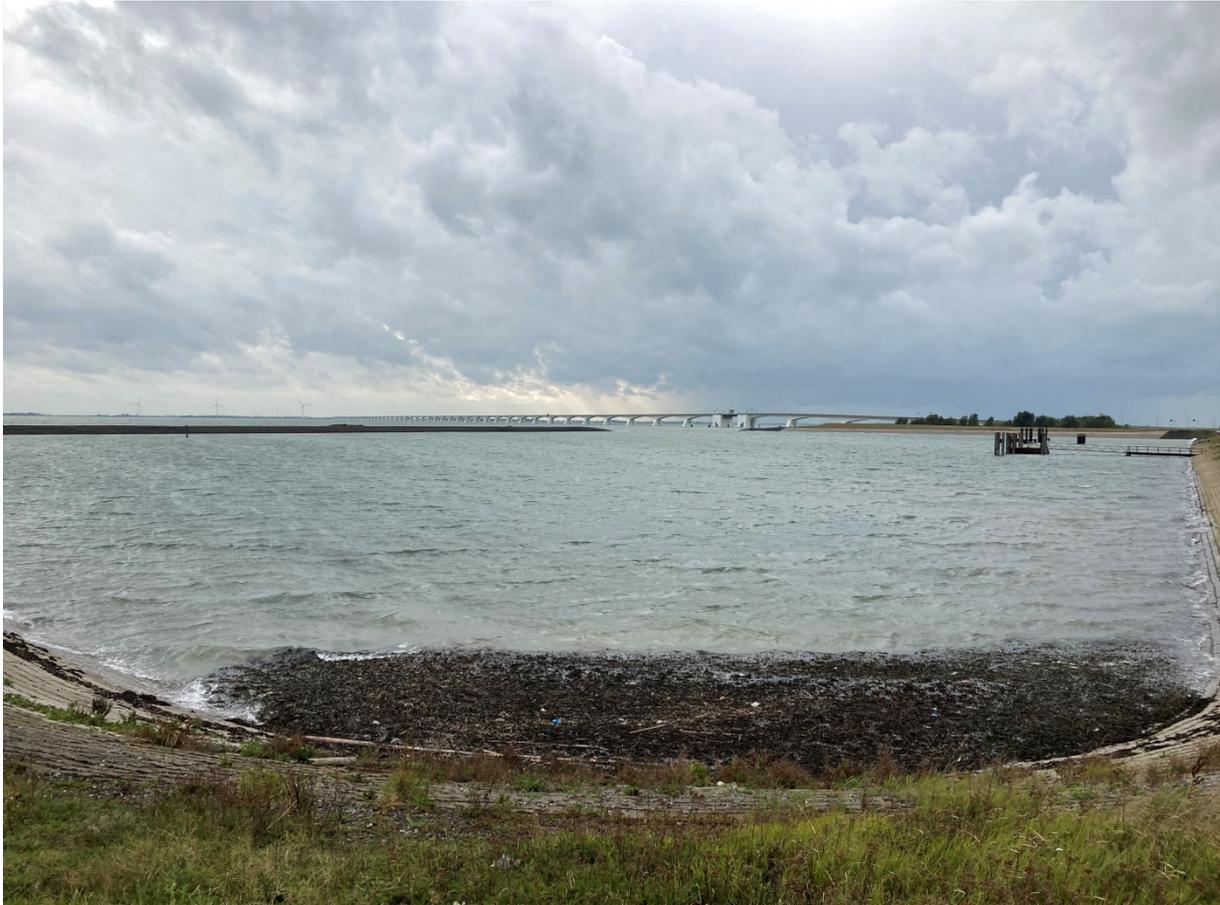
Zierikzee de Val in the background the Zeelandbrug

This is one of the hot spots. With the prevailing wind from the south west (picture was taken with south west wind) transport along the bank is from both sides into this corner. With north west storms the debris (and nurdles) will float to the south east corner but can't escape.

The configuration is very similar to the cove at Kerkerwe oosthoek and Schelphoek.

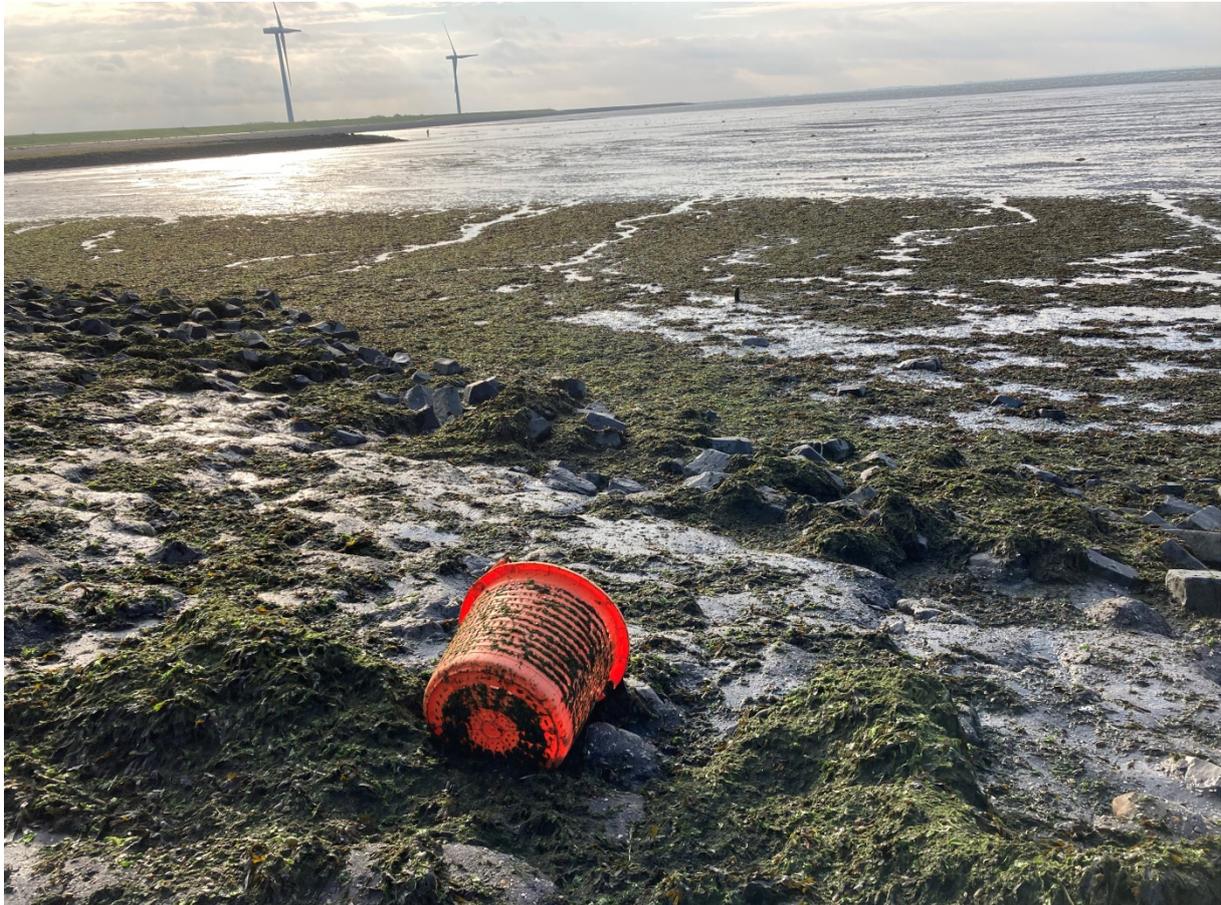
location	O12
location	Stille Strand W-hoek
date	20-10-2021
Coordinates	X=54509 ; Y=406249
number per m <sup>1</sup>	0
length of deposits	-
surface total	0

Stille Strand W-hoek: no nurdles, the orange basket is from 'the fisheries'

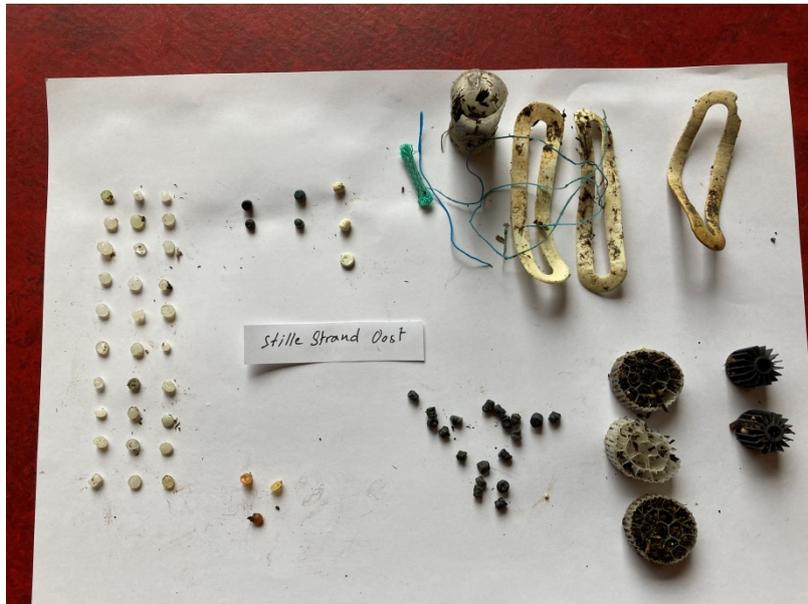
location	O13
location	Stille Strand O-hoek
date	20-10-2021
Coordinates	X=54781 ; Y=406109
number per m <sup>1</sup>	50
length of deposits	50
surface total	2,500

Upper right the rubber (plastic/ elastic) bands are used by Lenger Seafoods (the fisheries) for tying together razor clams(mesheften).

Down right: bio media.

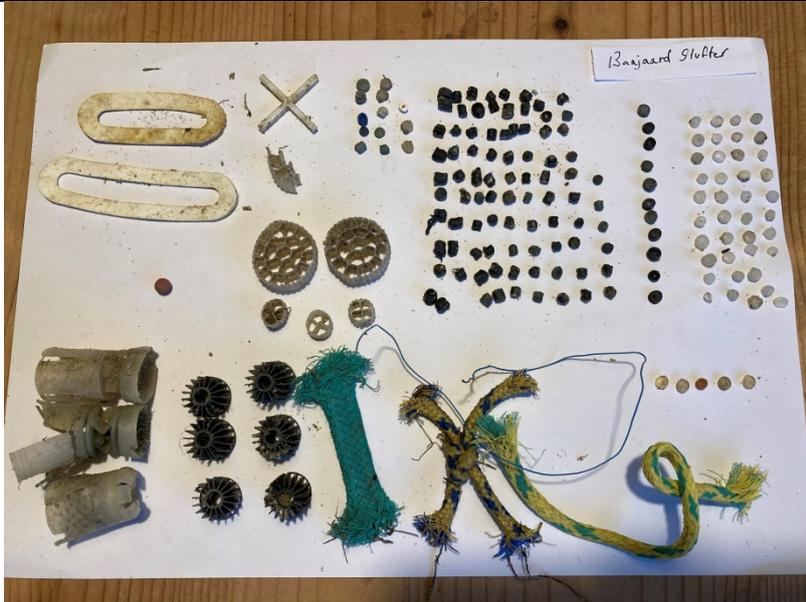
The fisheries cause a lot of plastic pollution. 56 Bio Beads.

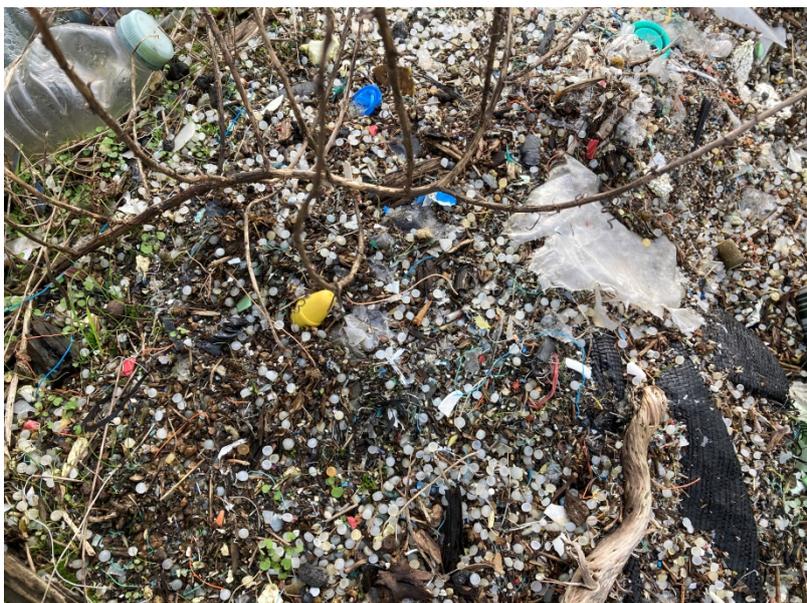
Not only the number of nurdles is high but also the piles of 'vispluis' and other plastic are considerable.

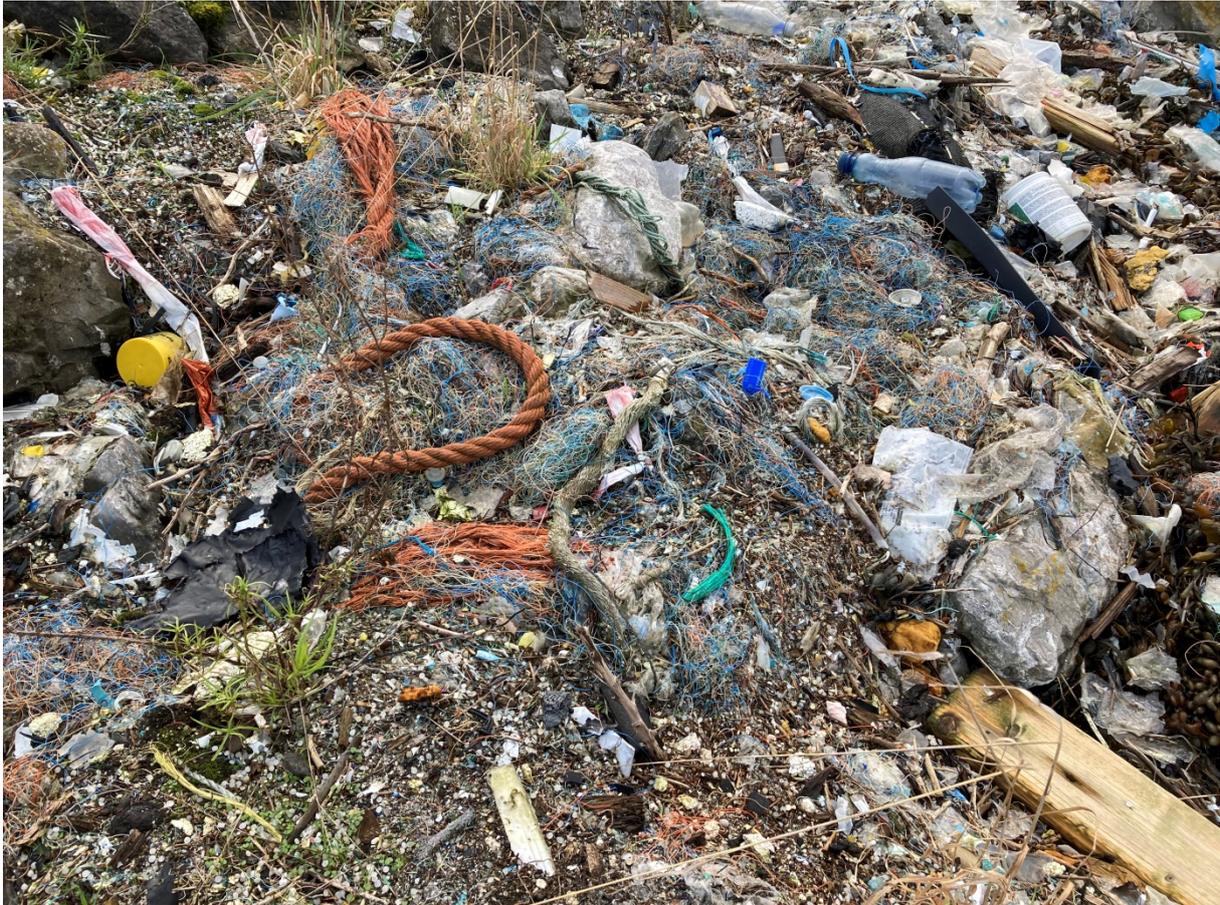
Bank of the Westhofhaven transferred into a dump
