# Westerschelde: plastic nurdles

Sources, transport, deposits

Autumn 2021

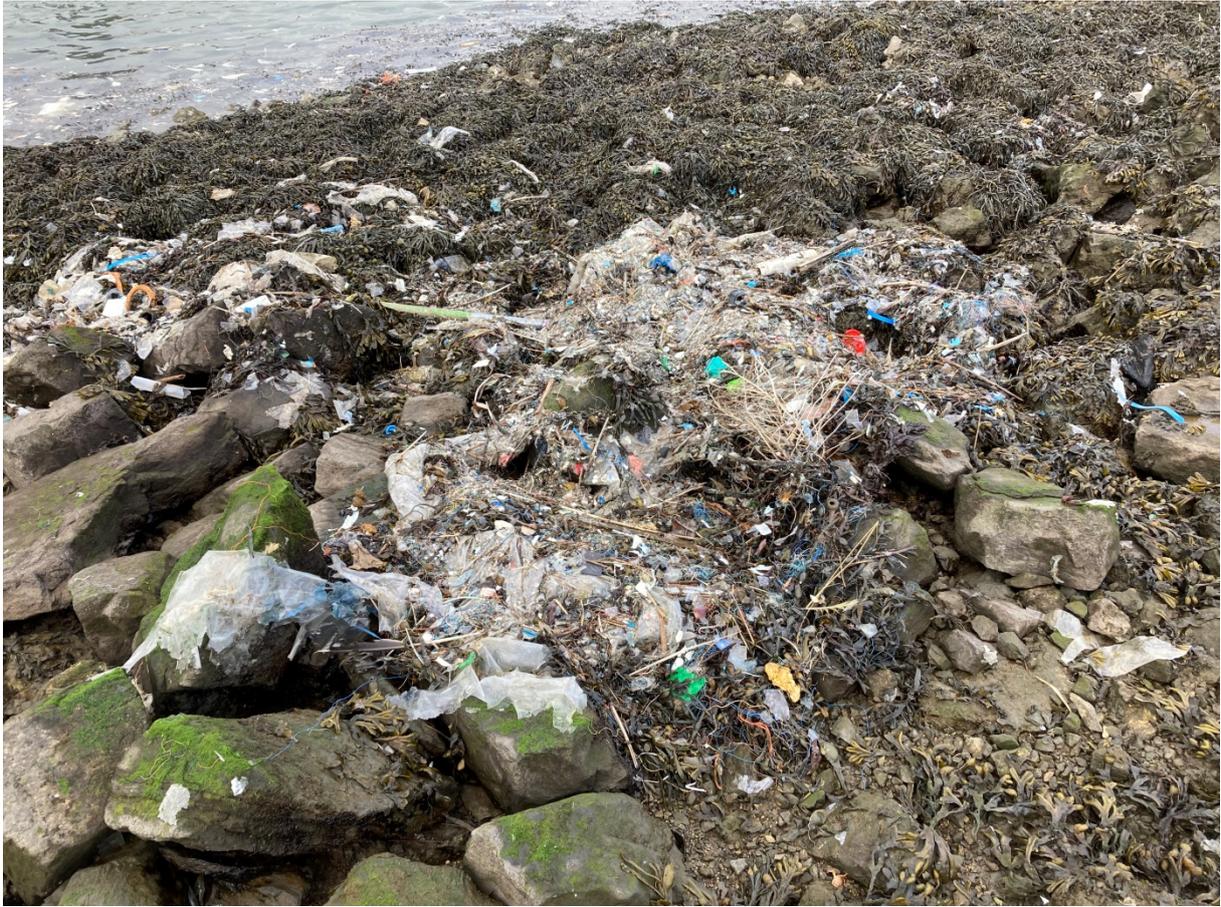
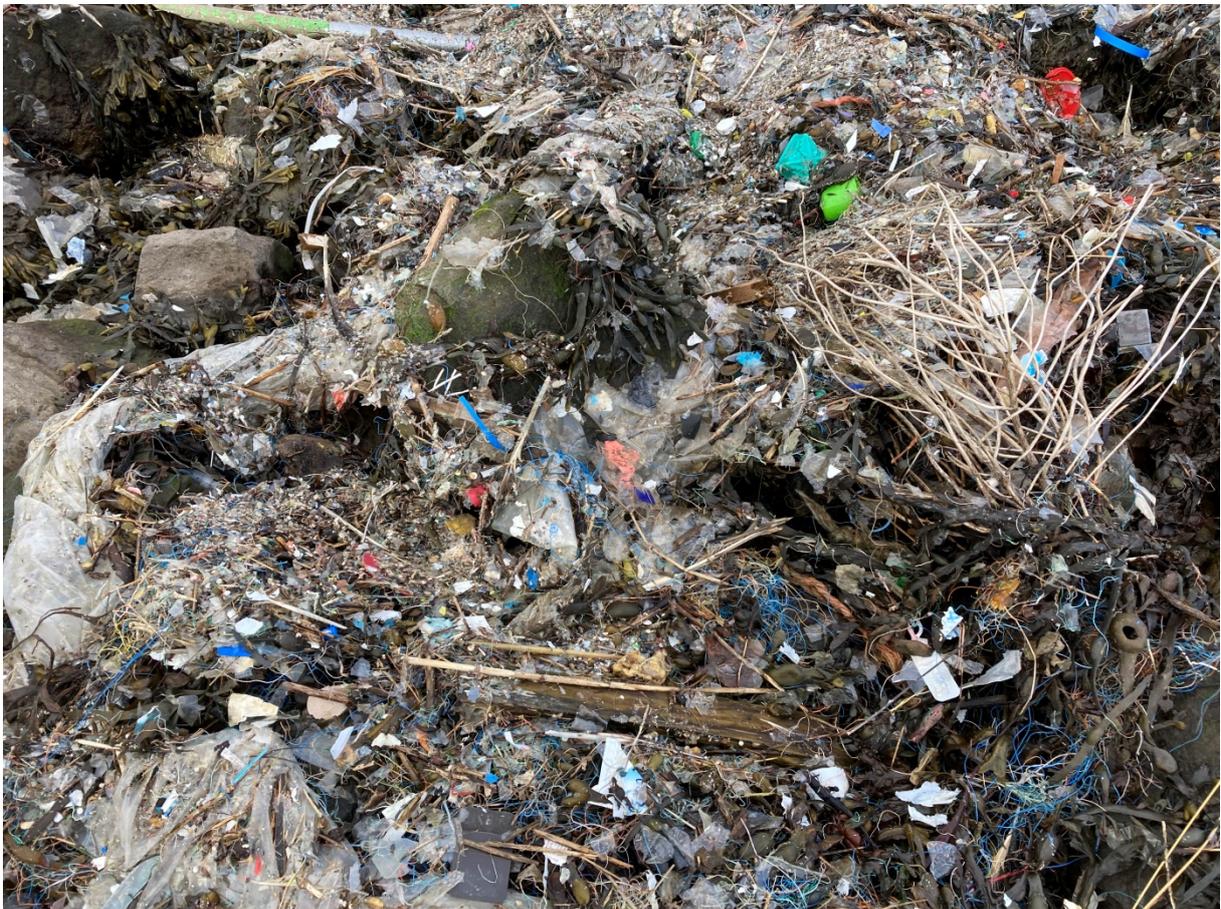
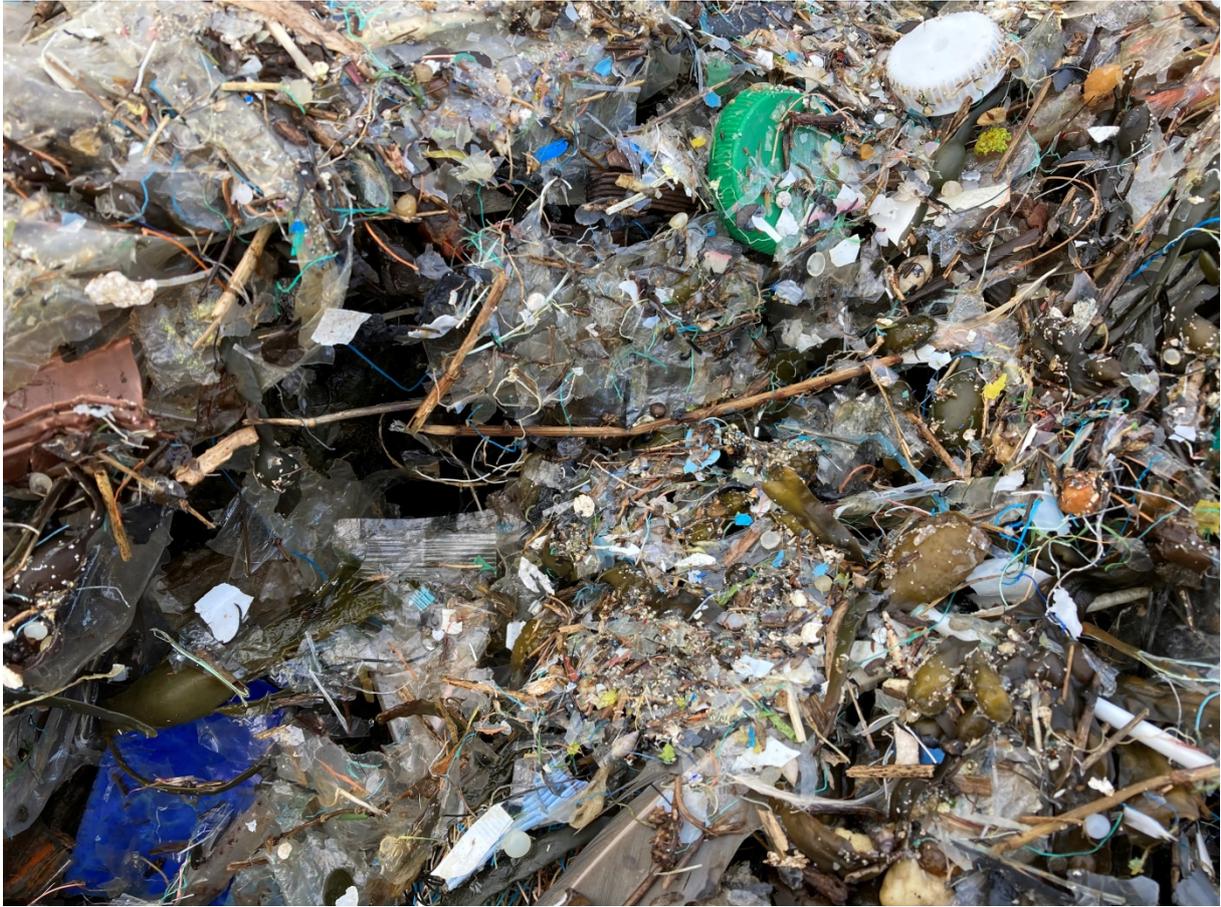
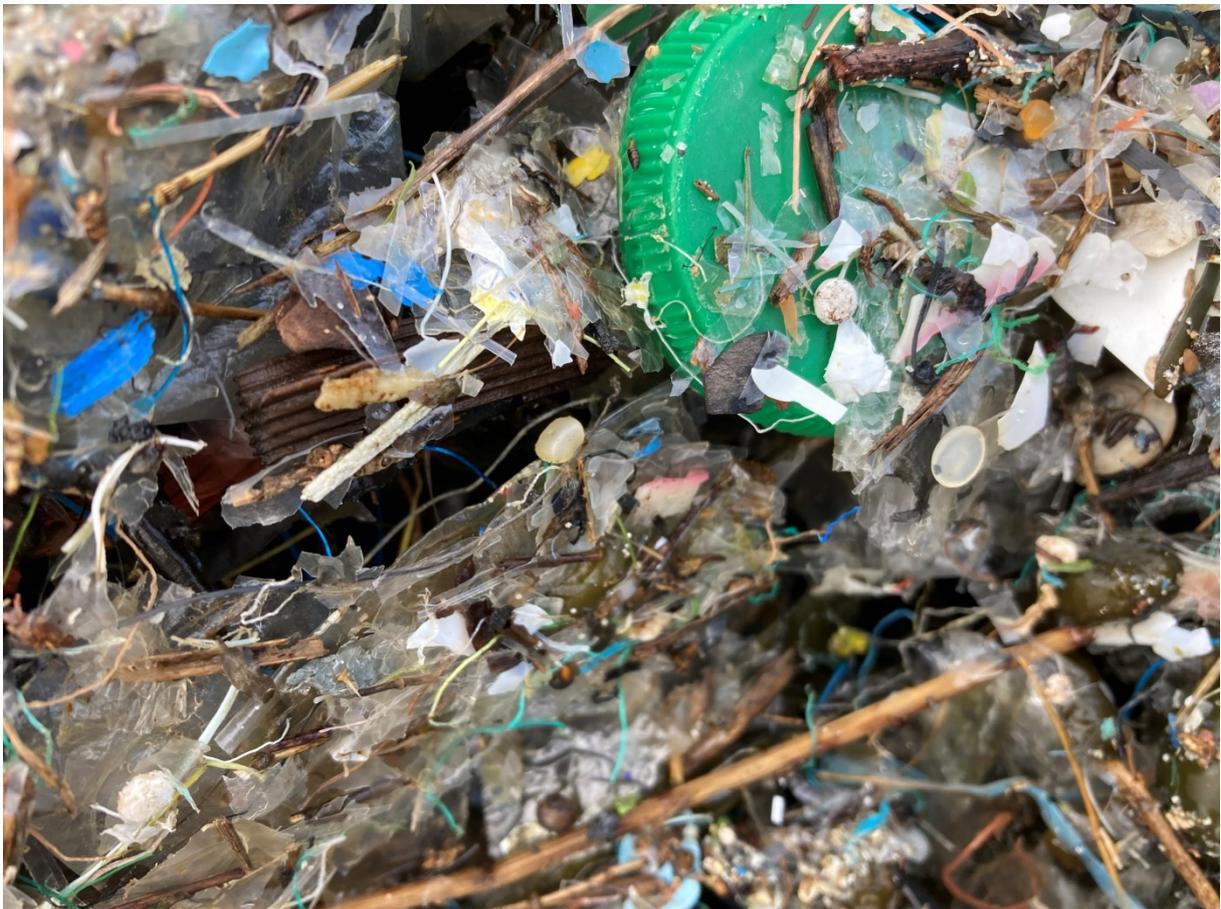
Tidal current is negligible here at the end of the port. Prevailing wind blows into this corner. With easterly winds part of the plastic might float to the west but the chance that it leaves this corner of the Westhofhaven is very small. This can also be deduced by the nature of the plastics floating around here. Hereafter a serie of 4 pictures to illustrate this observation.

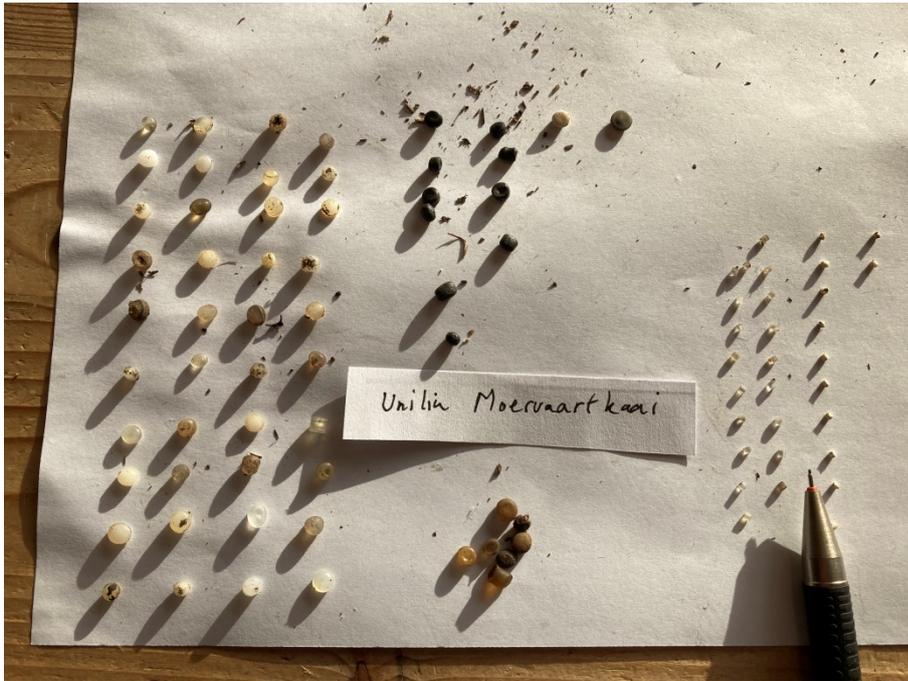
location	GT1
location	Moerkaaivaart
date	12-11-2021
Coordinates (Google Maps)	X=51.13639 ; Y=3.79358
number per m <sup>1</sup>	100
length of deposits	10
surface total	1,000

On the left of the pencil(0,5 mm)transparent nurdles?, on the right white

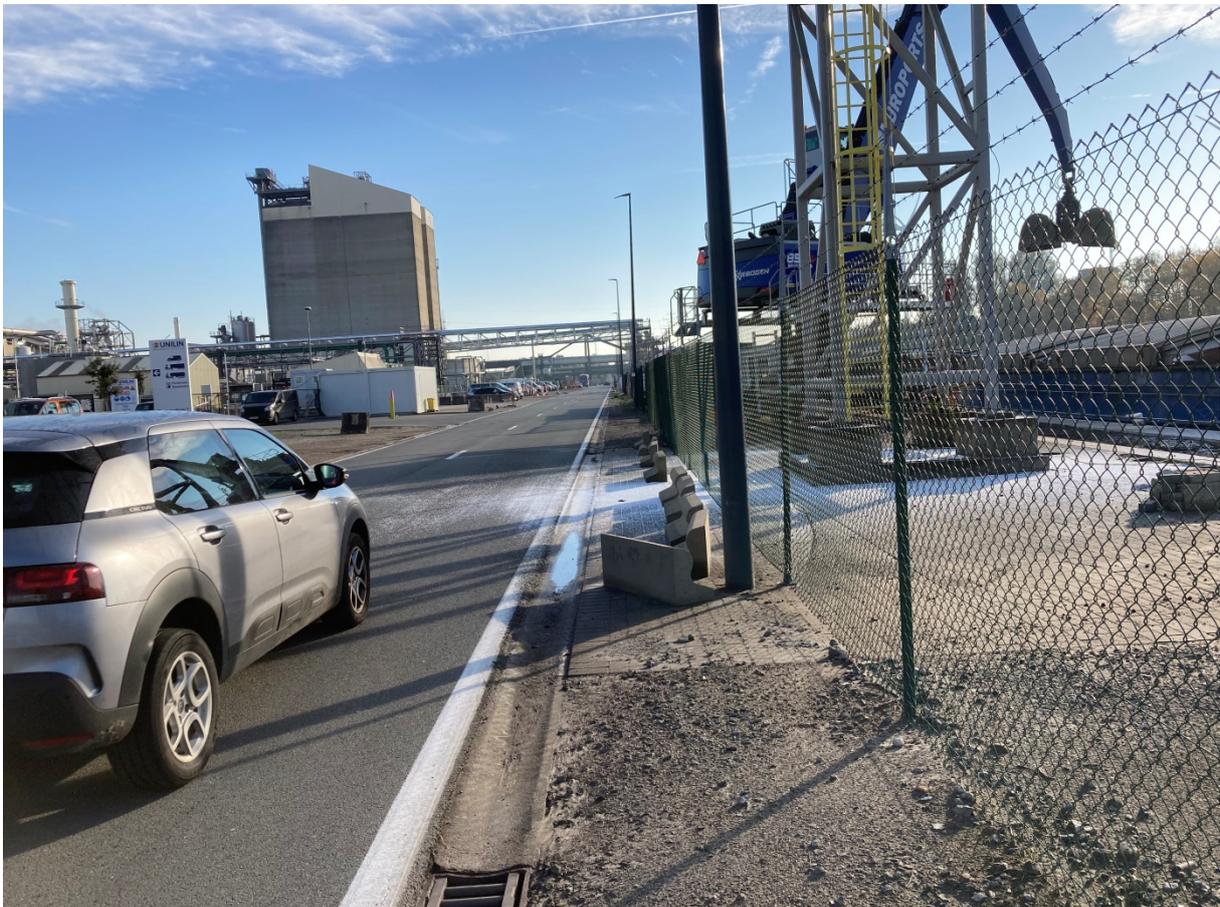
Production site UNILIN: the white cloud in front of the passing car and on the quay is spilled material

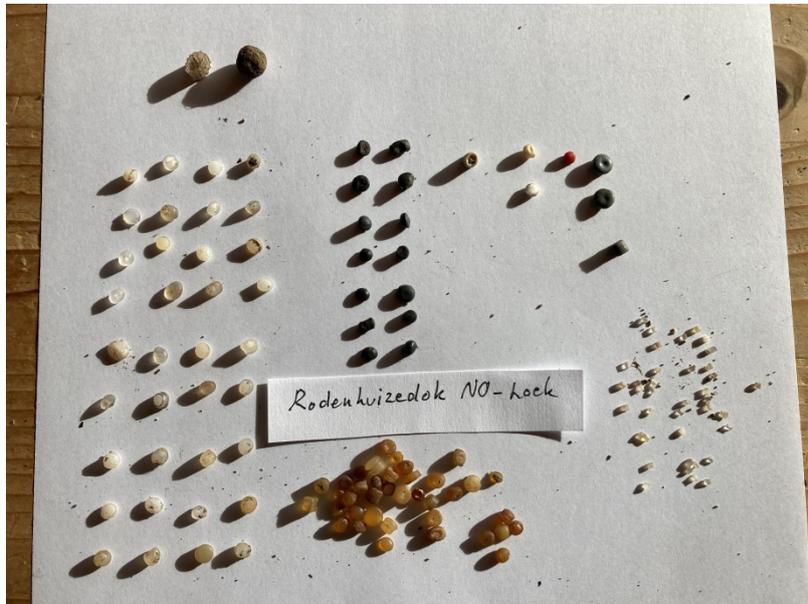
location	GT2
location	Rodenhuisdok NO-hoek
date	12-11-2021
Coordinates (Google Maps)	X= 51.14558; Y=3.79915
number per m <sup>1</sup>	100
length of deposits	20
surface total	2,000

Upper left a bio medium and an aquaculture grain. Mini-nurdles at the right. If counted they would double the score

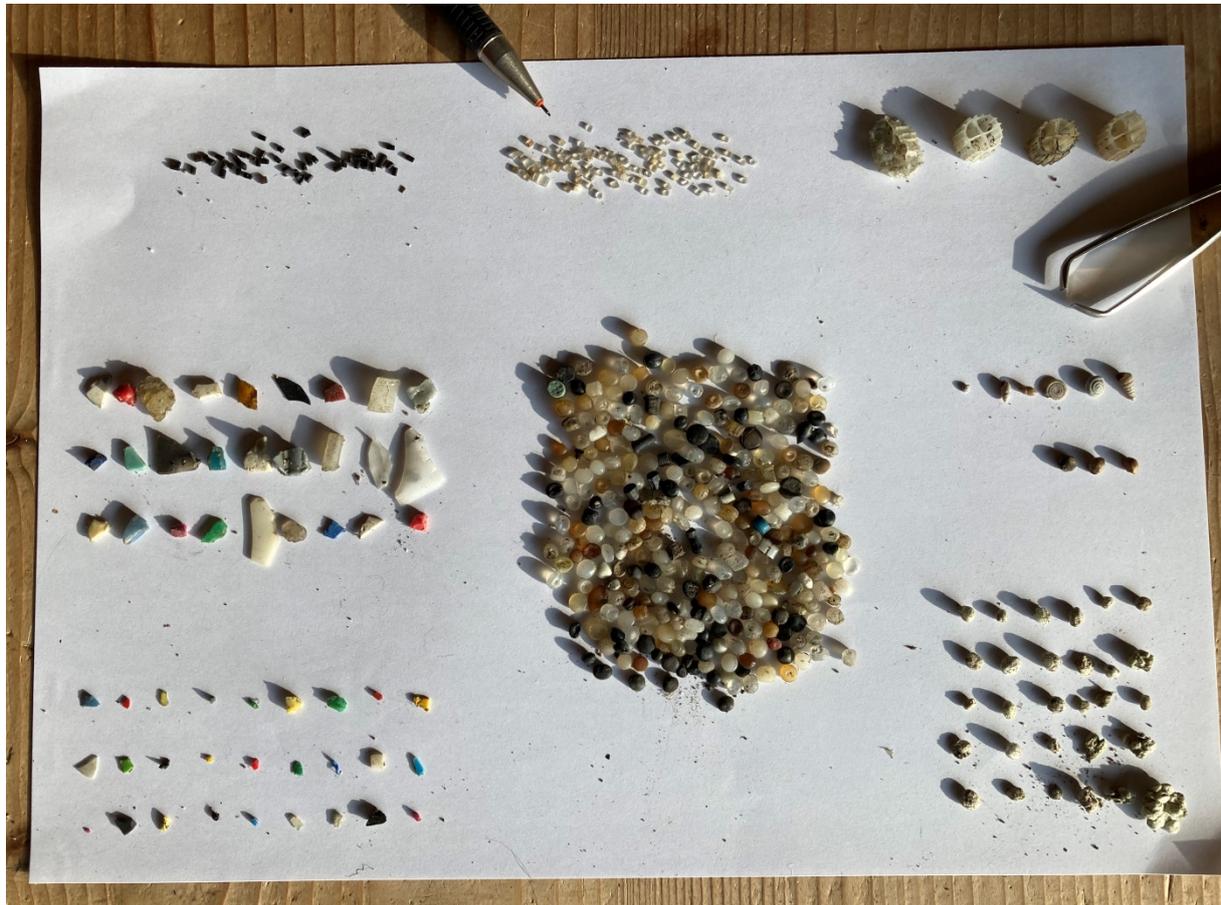
location	GT4
location	Autrichehaven
date	6-10-2021
Coordinates (Google Maps)	X=51.25625 ; Y=3.84091
number per m <sup>1</sup>	500
length of deposits	20
surface total	10,000

The pencil (0,5 mm) points at transparent mini-nurdles? At the left black ones. Under the tweezers: 5 snails and 3 plant seeds. lower right are styrofoam grains

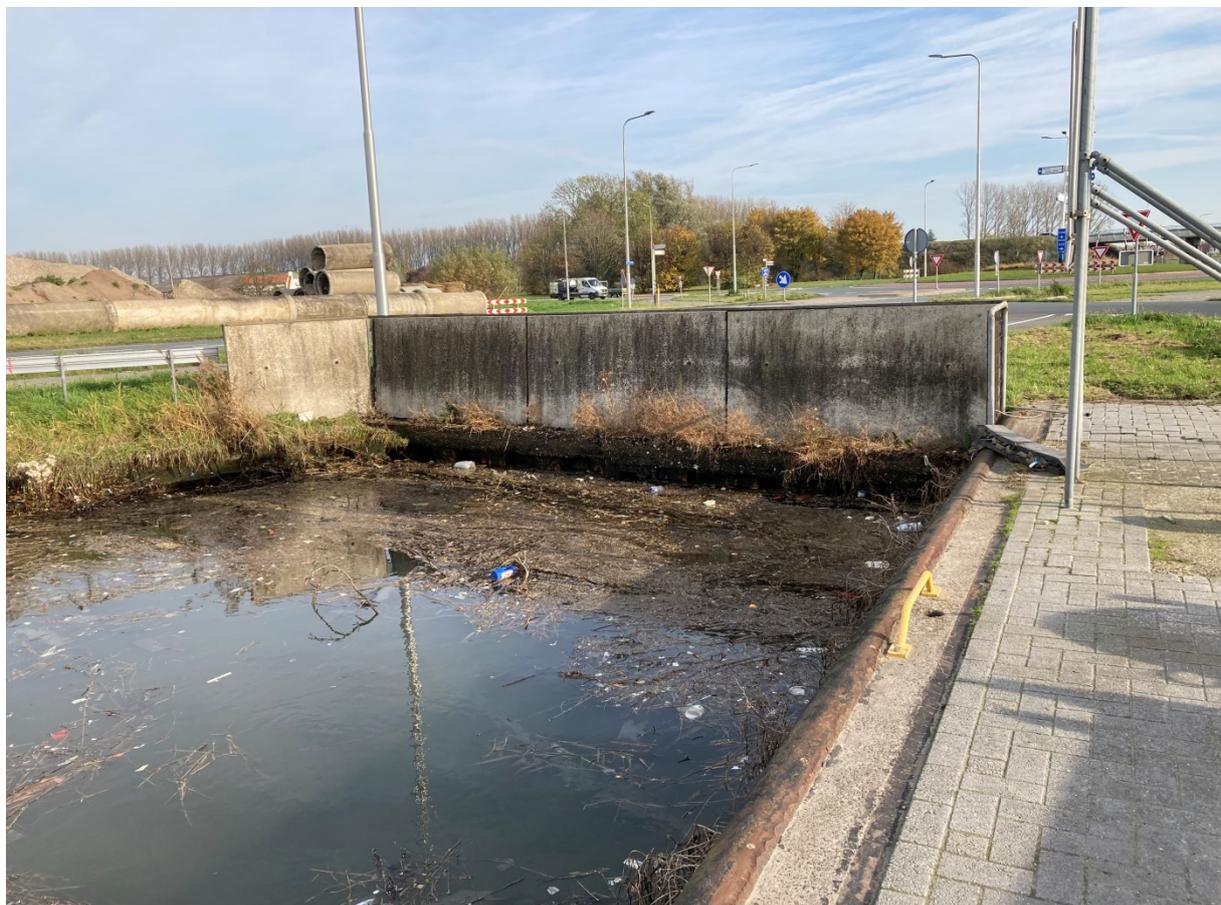
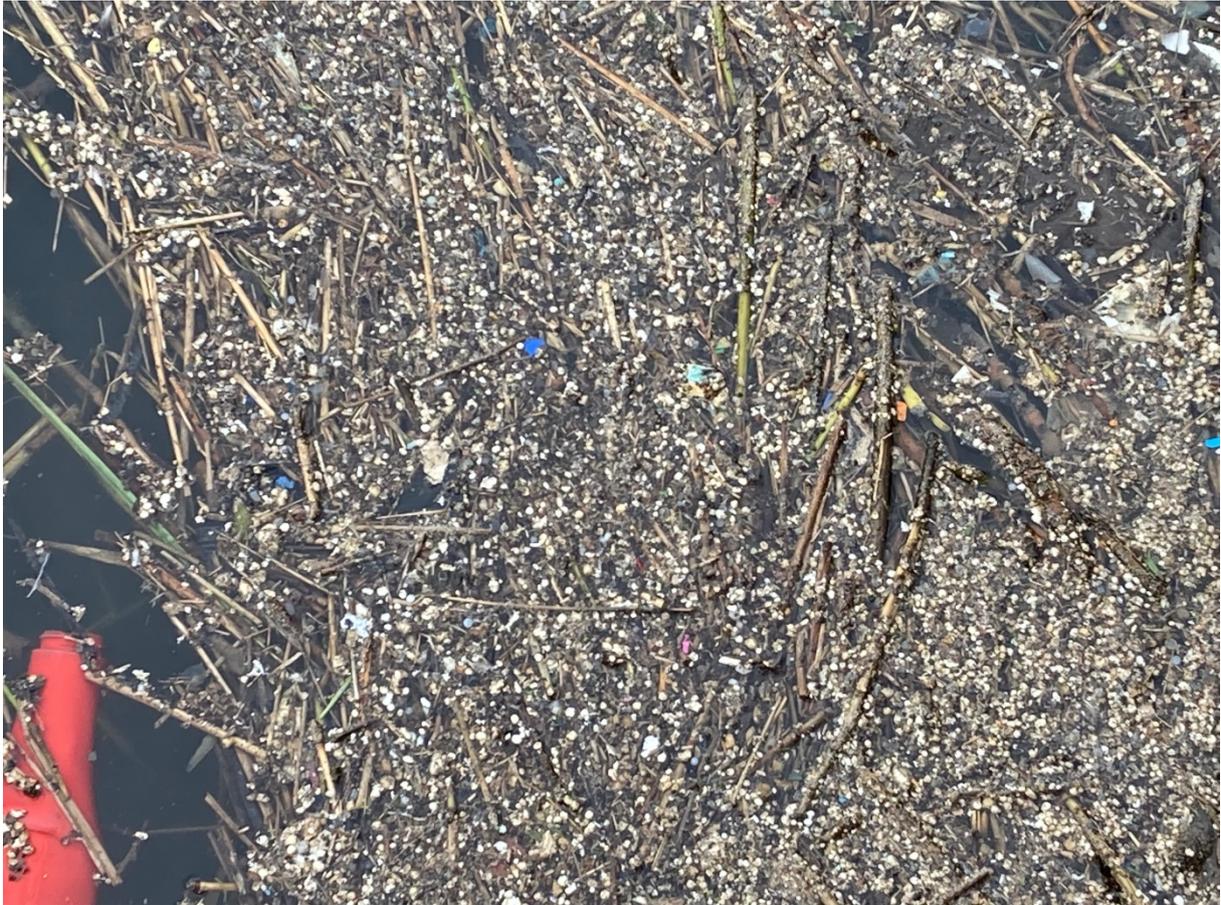
location	GT5
location	Zijkanaal C, end
date	6-10-2021
Coordinates (Google Maps)	X=51.26870 ; Y=3.87353
number per m <sup>1</sup>	End of canal
length of deposits	-
surface total	5,000

The floating mass consists mainly of Styrofoam mixed with nurdles in relatively low numbers

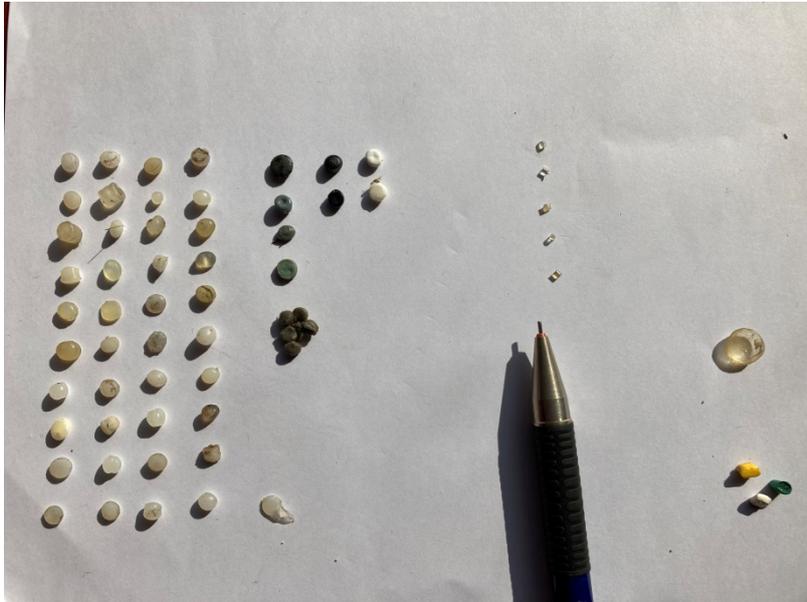
location	GT6
location	Terneuzen centrum
date	6-10-2021
Coordinates (Google Maps)	X=51.33396 ; Y=3.82643
number per m <sup>1</sup>	Floating
length of deposits	-
surface total	5,000

5 transparant mini-nurdles?

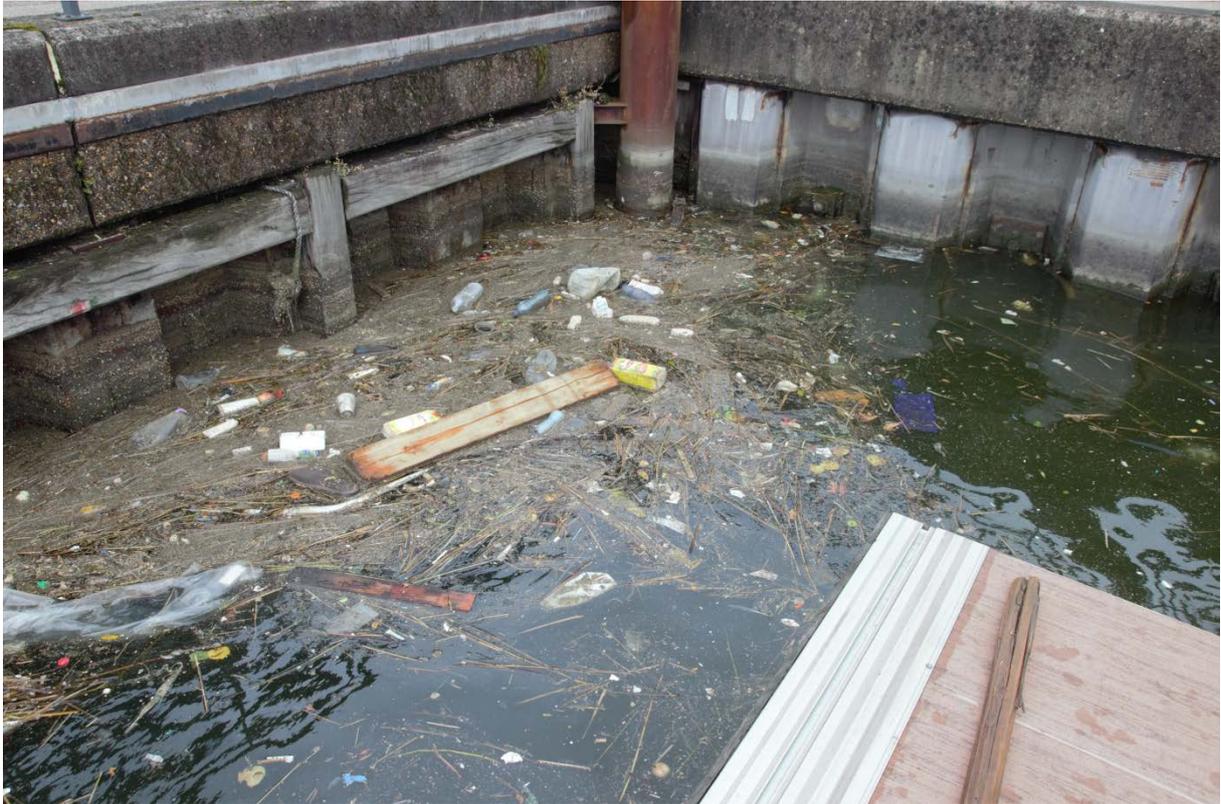
Terneuzen centrum NE-corner

location	GT7
location	Terneuzen buiten sluis
date	10-8-2021
Coordinates (Google Maps)	X= 45947; Y=373512
number per m <sup>1</sup>	10-100
length of deposits	250 m
surface total	12,500
